**Comprehensive Indiana Forestry Best Management Practices**

**Monitoring Results**

**1996-2016**

**By: Duane McCoy & Jennifer Sobecki**

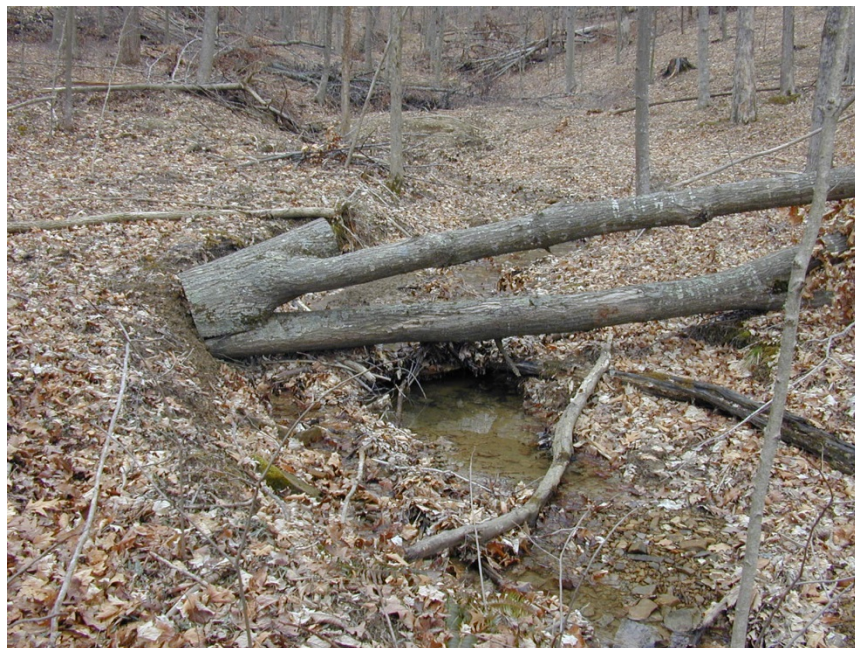
Logging debris in streams can obstruct stream flow, leading to the stream carving a new bank, which results in erosion and sedimentation going directly into the stream.
