indiana
TOLL ROAD

ANNUAL STATE OF THE ITR REPORT
JULY 1, 2014—JUNE 30, 2015

Annual State of the ITR and
Capital Improvement Programs Report
July 1, 2014 – June 30, 2015

July, 2015

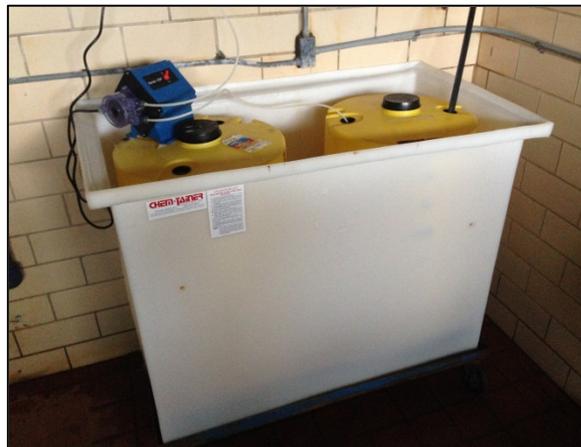
Figure 7.1: Sodium Hypochlorite in Adequate Containment

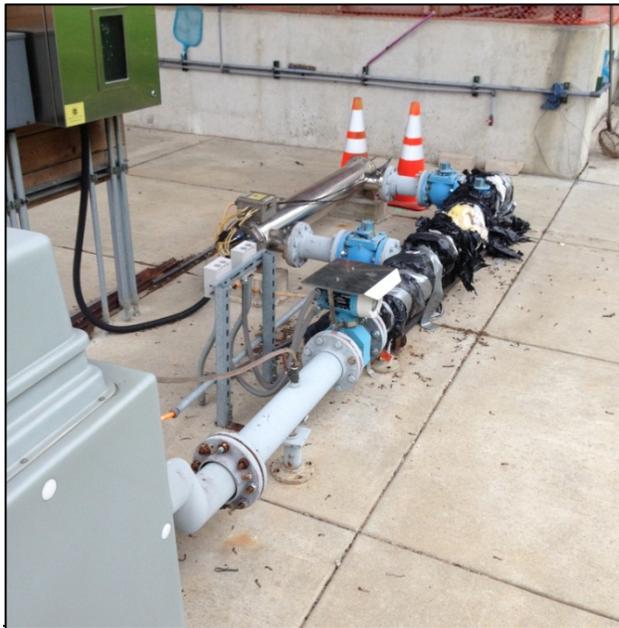
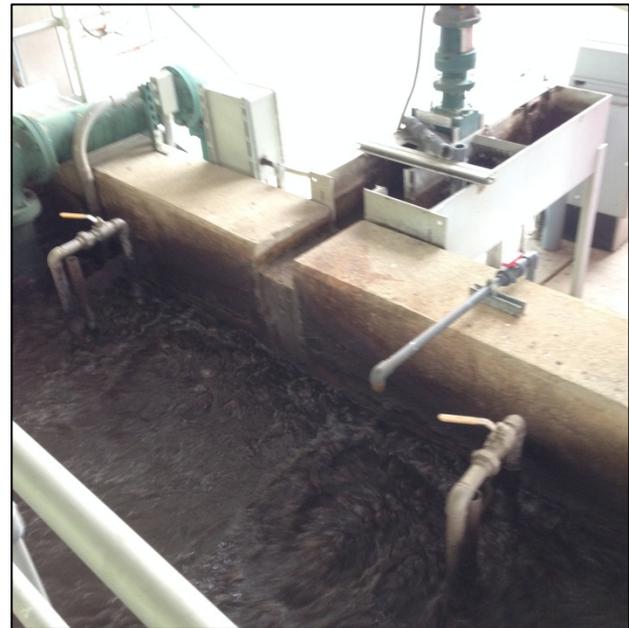
Travel Plaza 3 wastewater treatment plant uses Ultraviolet (UV) light for final disinfection before discharge to the environment. Currently, the system has only one (1) UV unit installed through which all water is treated before discharge. Given a history of clogging, a recommended best management practice ITR is considering an installation of a second UV treatment system in parallel to easily and quickly respond to backups in the main line. Future consideration should be made to incorporate the UV system into the SCADA system.

Figure 7.2: Travel Plaza 3 WWTP (a) UV Treatment Unit (b) Aeromod Selector Tank

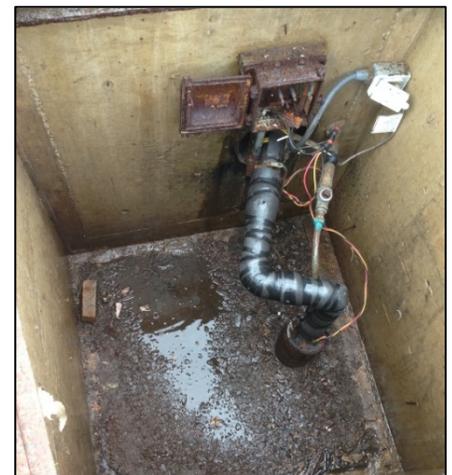
ITR is currently providing bottled water to toll plaza staff for drinking purposes in most locations with aging wells. The wells may continue to be used for all other non-drinking water purposes. The increased automation of toll plazas has significantly reduced the demand for drinking water.

Figure 7.3: Condition of Aging Pit Well

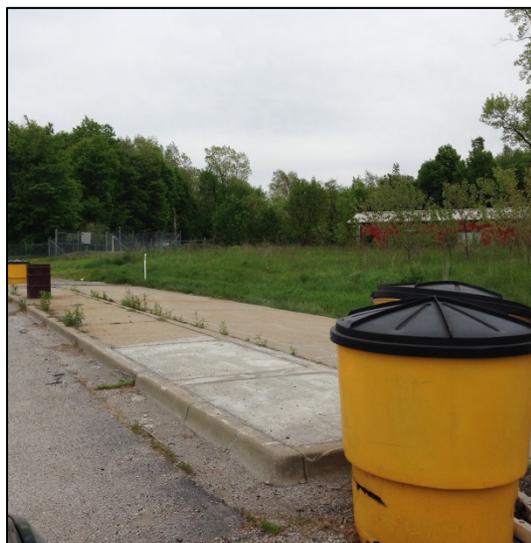
In the past, free RV dump stations were operated at Travel Plazas 3, 5, and 7 which have since been removed from use. In order to eliminate the potential for illegal dumping of materials the ITRCC has responded by permanently capping the dump stations with concrete. This action is highly commendable.

Figure 7.8: Permanently capped dump station at Travel Plaza 3
