Indianapolis Power & Light (IPL) is pleased to provide the Commission with the root cause analysis report from the 26 S. Meridian Street Network Event on August 13, 2014.

**ROOT CAUSE ANALYSIS
FOR
26 S. MERIDIAN STREET
NETWORK EVENT ON
AUGUST 13, 2014**

Prepared by T&D Engineering
Issued on October 3, 2014

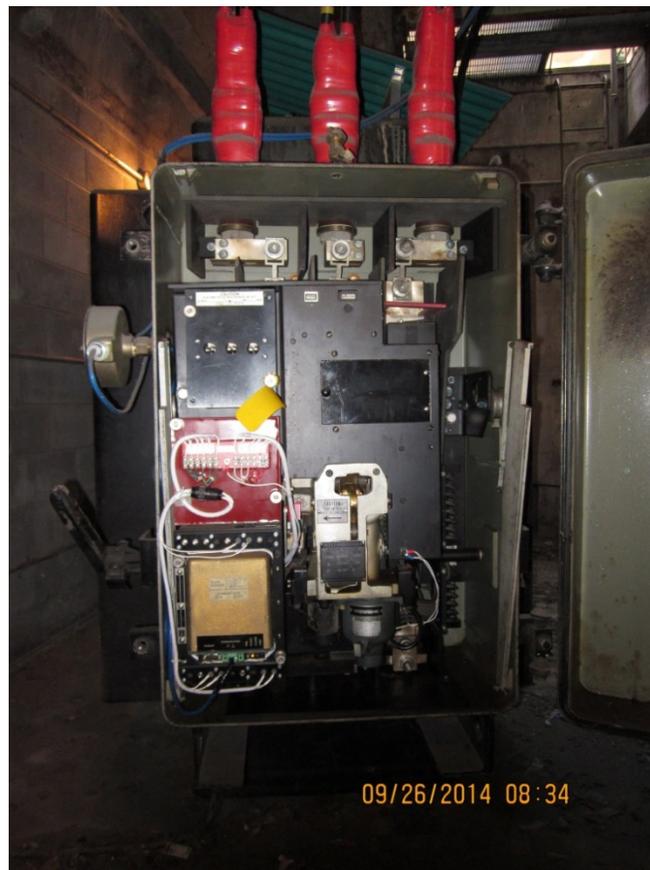
The picture below is of the UG 661 network protector at 26 S. Meridian Street. It is the same style and vintage as the UG 651 network protector. This photo shows what the UG 651 network protector would have looked like before the event on August 13, 2014.

UG 661 Network Protector – 26 S Meridian Street – Same Model and Vintage

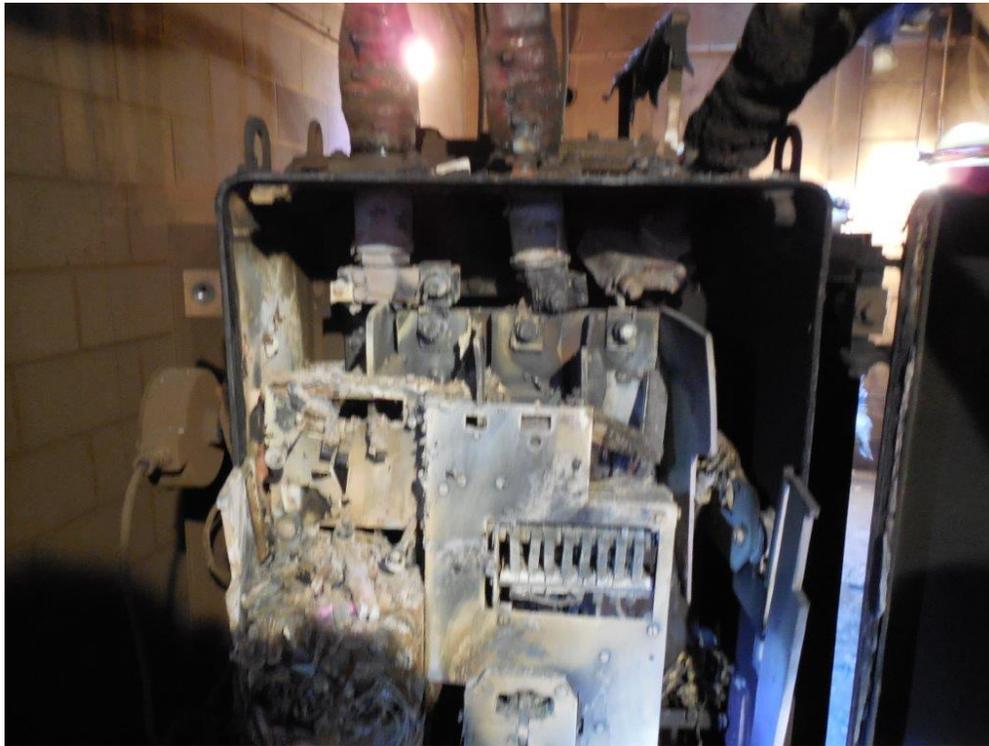
The picture below was taken when the UG 651 network protector door was first opened and shows the damaged UG 651 network protector at 26 S. Meridian Street. The picture shows the complete destruction of the interior of the network protector, including the breaker mechanism and the controls. The public heard loud banging and saw brown smoke coming from the vault. This was the result of the burning of the network protector parts that produced the loud, banging noise and brown smoke during the event.

UG 651 Network Protector – 26 S Meridian Street – Post Event – Photo 1

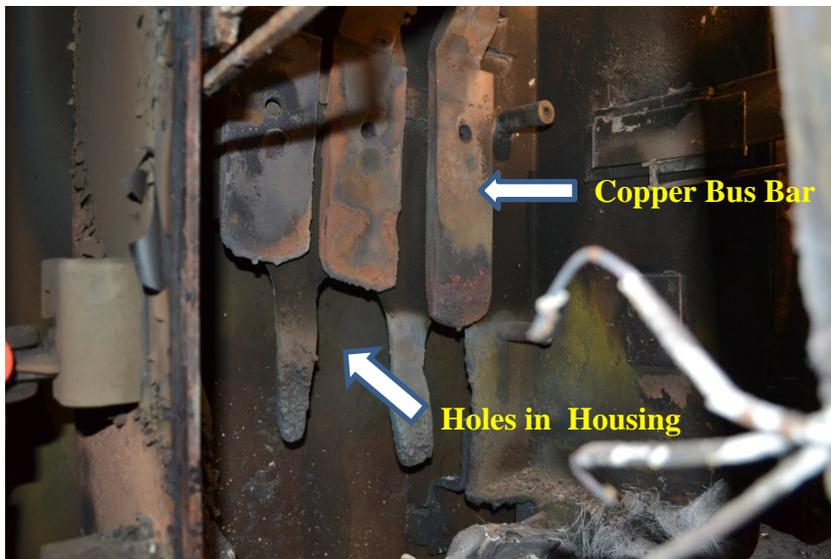
The picture below shows the damage to the copper bus in the back of the network protector. It also shows the holes that were burned in the back of the network protector housing from the arcing that occurred. This copper bus connects directly to the transformer secondary low voltage output.

UG 651 Network Protector – 26 S. Meridian Street – Post Event – Photo 2

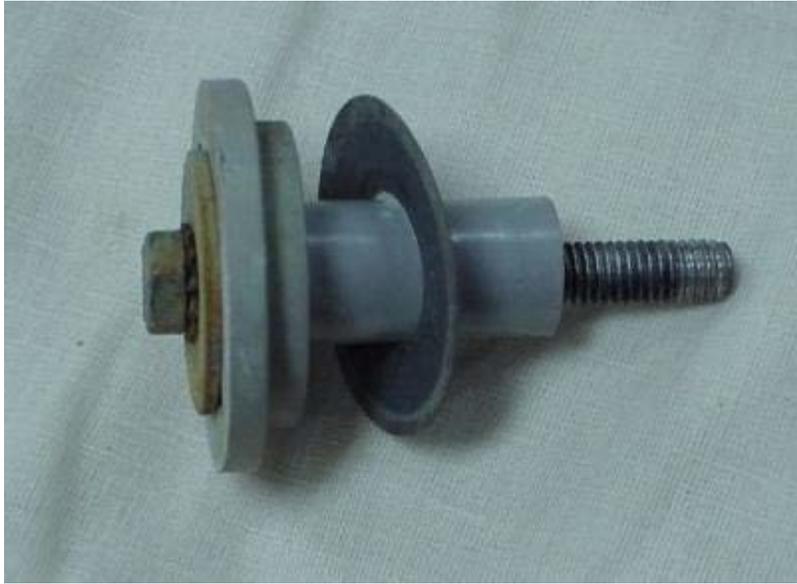
During the post-event investigation it was learned that Westinghouse had changed the design of the transformer bus support insulator in 1985. This change was made because of the possibility of a dielectric breakdown of the spool insulator that was used prior to 1985. The top half of this spool insulator is shown in the picture below. The cross-section picture shows how the copper transformer bus in the network protector would have been supported by the gray spool insulator. IPL has since learned of two other failures in 2014 at other utilities of Westinghouse CM-22 480-volt Network Protectors believed to have been caused by a failure of the gray spool insulator. It is not clear how widespread the knowledge is within the utility industry as to the potential issues with the spool insulator used prior to 1985. A quick survey of other utilities with network systems revealed a few knew about the spool insulator issue, but many others were not aware of it. IPL Engineering and Field Operations personnel were not aware of this issue until this investigation.

Westinghouse Gray Spool Insulator (Top Half)

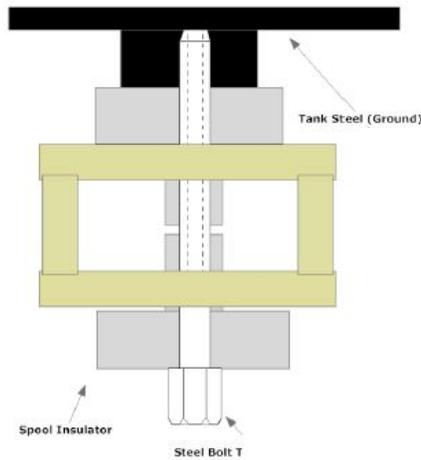
Cross Section View of Gray Spool Insulator

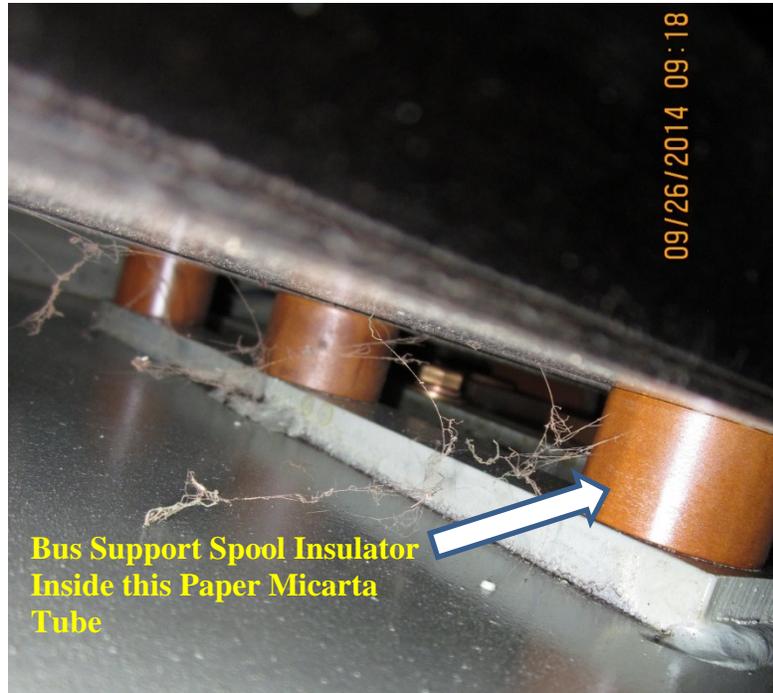
The UG 661 network protector is also a Westinghouse CM-22 with the serial number of 43Y5287-3. Based on the serial number series it also was manufactured in the 1959-1960 timeframe. The UG 621 and UG 631 network protectors in the 26 S Meridian Street vault are General Electric model MG-8. The General Electric protectors utilize a different transformer copper bus bar design than the Westinghouse protectors. The picture below show the bottom bus support spool insulators in the UG 661 network protector. The bus support insulator is located inside the paper Micarta tube which is shown as the reddish brown supports in the photo.

View of Location of Gray Spool Insulators in UG 661 Network Protector

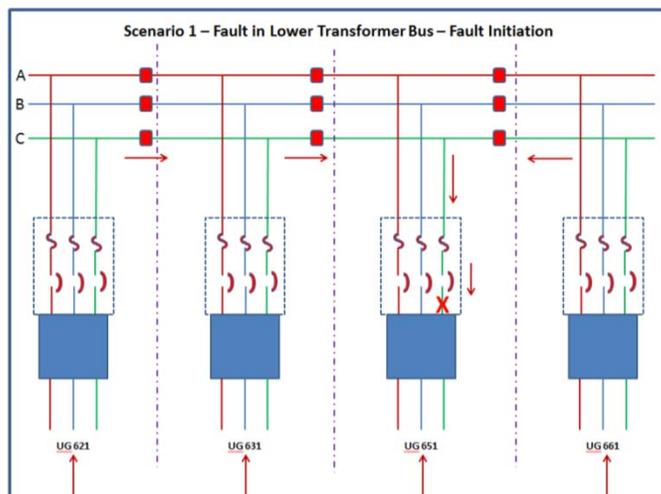
Figure 2 shows the initiation of the event. The current arcs to ground across the bottom bus support spool insulator from C phase bus bar to the grounded case of the network protector. This results in fault current flowing to that point from the low voltage side of the network transformer from Gardner Lane UG 651 and from the 480-volt collector bus being fed from the Gardner Lane UG 621, UG 631 and UG 661 network transformers. The red arrows in Figure 2 show the direction the fault current was flowing. At this point there is momentarily reverse current flow through the UG 651 network protector back towards the primary side of the network transformer. The initial 480-volt fault caused the first loud bangs that would have been heard at street level, and smoke would have been observed coming from the vault.

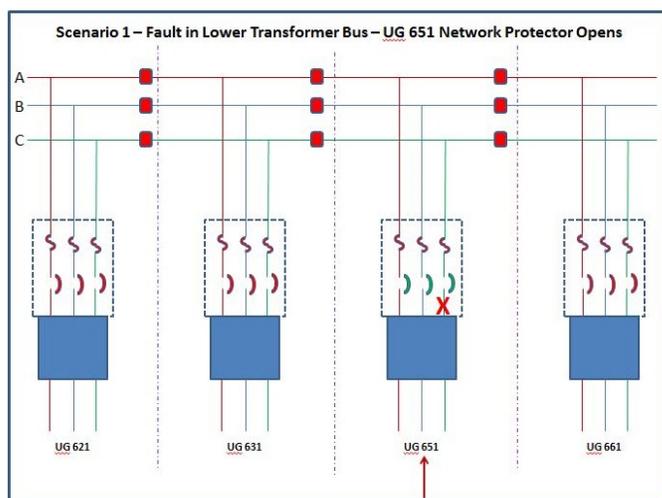
Figure 3 shows that the UG 651 network protector opens on the reverse current flow. The fault current is now being supplied only by the UG 651 Primary feeder through the network transformer. When the UG 651 network protector opened, all fault current flowing from the 480-volt collector bus would have ceased. The arcing to

ground at the C Phase spool insulator would have continued from the transformer source.

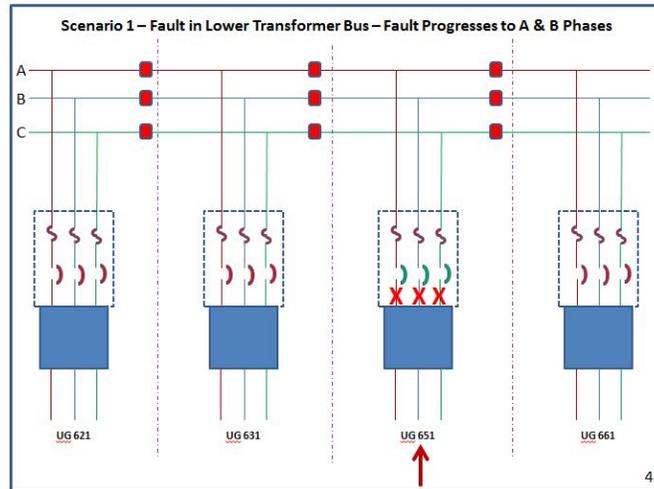
Figure 4 shows that the C Phase fault now spreads and involves A and B phases. The failure event is still contained to the transformer side of the network protector, and all fault current is still being supplied only by the UG 651 Primary feeder. The loud bangs heard at street level would continue and heavy smoke would have been seen coming from the vault.

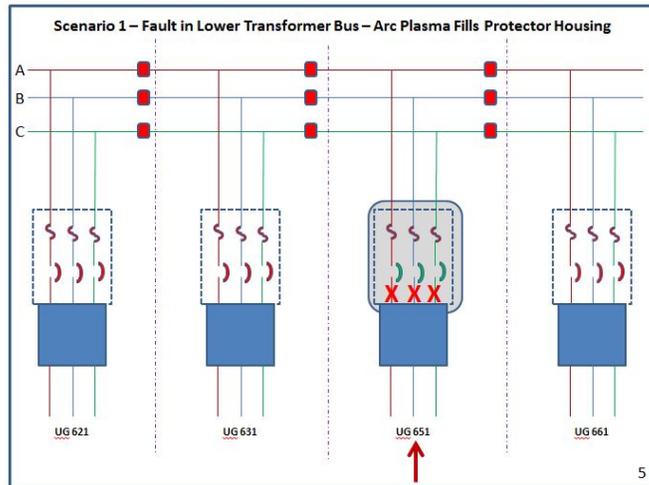
Figure 5 shows that the arc plasma, which occurs in high-energy failures, and other gases created during the arcing fault now fills the network protector housing. The arc plasma is highly conductive. The loud bangs heard at street level would continue, and heavy smoke would have been seen coming from the vault.

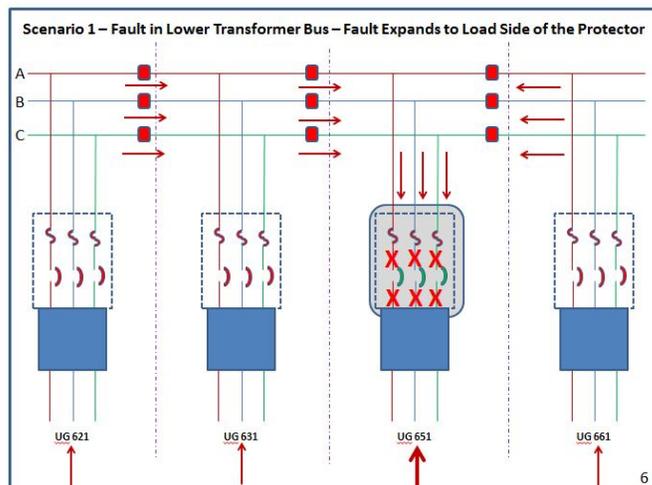
Figure 6 shows that the load side of the network protector flashes over in the arc plasma, and the fault now fills the network protector housing. Fault current now flows from the 480-volt collector bus into the multiple faults inside the UG 651 network protector. Fault current is being supplied by all four Network Primary feeders, with a larger percentage still being supplied by UG 651 as confirmed by ECS SCADA data. During this time, heavy smoke would be seen coming from the vault and numerous loud bangs would be heard from the 480-volt arcs to ground that were occurring inside the UG 651 network protector. The loud bangs heard at street level would continue and heavy smoke would have been seen coming from the vault.

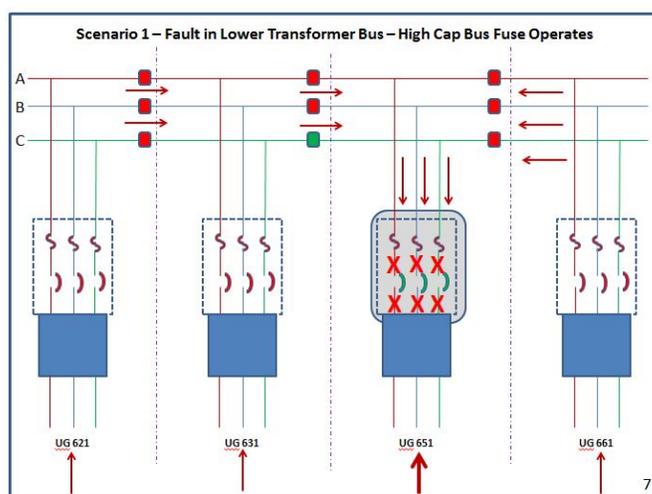
Figure 7 shows the 3,000 amp High Capacity Bus fuse between the Middle South and Middle North vault bays operates and opens due to the fault current flowing through it. That removes the fault current source for C Phase from the UG 621 and UG 631 units. Those units continue to supply fault current on A and B Phases. It is believed because of the nature of the arcing fault, these fuses did not operate. The UG 661 unit

continues to supply fault current on all three phases to the faults in the UG 651 network protector. The loud bangs heard at street level would continue and heavy smoke would have been seen coming from the vault.

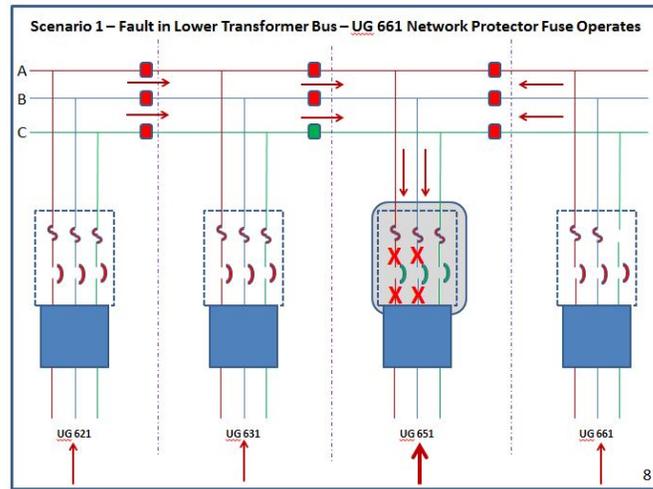
Figure 8 shows that the network protector C phase fuse in the UG 661 network protector opens due to the fault current that has been flowing through it. Fault current now ceases to flow into C phase of the UG 651 network protector. It is believed this is the time that the smoke and banging sounds die down as is seen in the various videos of the event. The timeline is approximately 5 minutes into the event. This period will last for approximately 6 to 7 minutes.

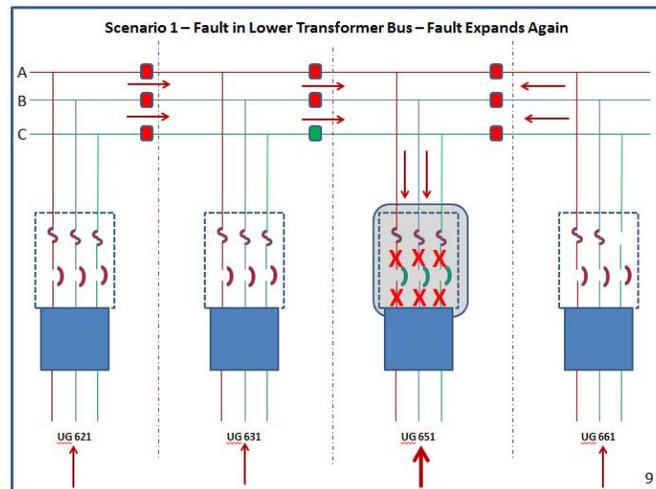
Figure 9 shows that the fault inside the UG 651 network protector begins to expand again and the smoke and banging sounds would have increased significantly. The arcing at this point has consumed the network protector breaker element and the controls. The copper transformer bus is being consumed and is melting towards the

low voltage terminals of the network transformer. Numerous arcs to ground are occurring resulting in loud bangs being heard at street level again along with a considerable amount of smoke.

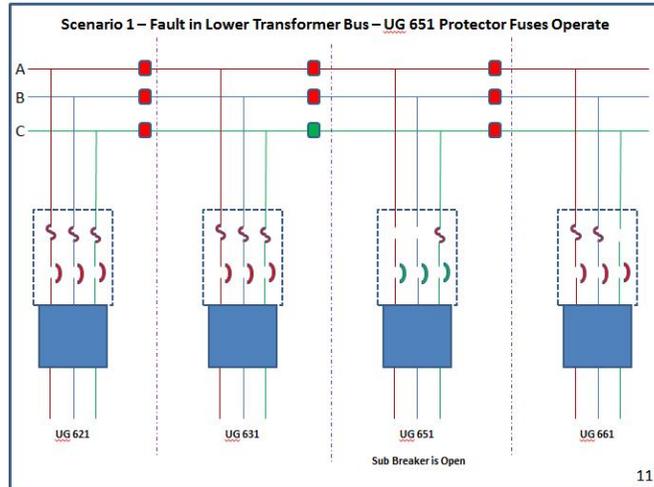
Figure 11 shows that the network protector fuses on A and B phase of the UG 651 network protector have opened. It is believed that they opened immediately following the opening of the UG 651 feeder Breaker at Gardner Lane substation. It appears that the primary current on UG 621 and UG 631 dropped back to normal level at the same time the UG 651 feeder breaker was opened. This would indicate that UG 621 and UG 631 were still supplying fault current into the UG 651 network protector fault through the 480-volt collector bus up to the point in time the UG 651 feeder breaker was opened. The network protector fuses in the UG 651 network protector would have been severely compromised at this point from the fault current that had been flowing and from the high heat in the network protector. The event is over at this point. The event lasted approximately 15 minutes from start to finish.

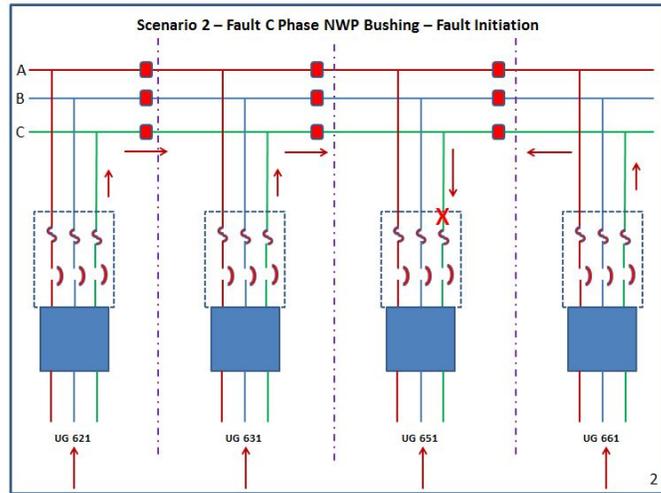
Figure 14 shows the initiation of the event. A failure occurs with the C phase bushing on the UG 651 network protector. There is a current arc to ground inside the network protector. Fault current flows from the 480-volt collector bus to the fault at the C phase bushing in the UG 651 network protector. The fault current is being fed from Gardner Lane network feeders UG 621, UG 631, UG 651, and UG 661. The initial loud bangs and the first smoke would have been heard and seen coming from the vault. The time is believed to have been 1:25 p.m. EDT.

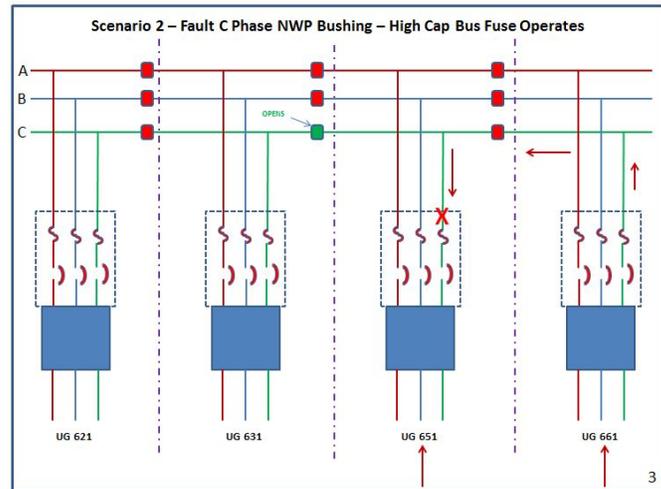
Figure 15 shows that the C Phase 3,000 amp High Capacity fuse between the Middle South and Middle North vault bays opens due to the fault current flowing through it. That removes the fault current source for C Phase from the UG 621 and UG 631 network transformers. The UG 661 network transformer continues to supply fault

current to the C Phase fault in the UG 651 network protector. While this fault is occurring, liquid metal and other by-products are falling to the bottom of the UG 651 network protector. The load banging heard at street level would continue and heavy smoke would have been seen coming from the vault.

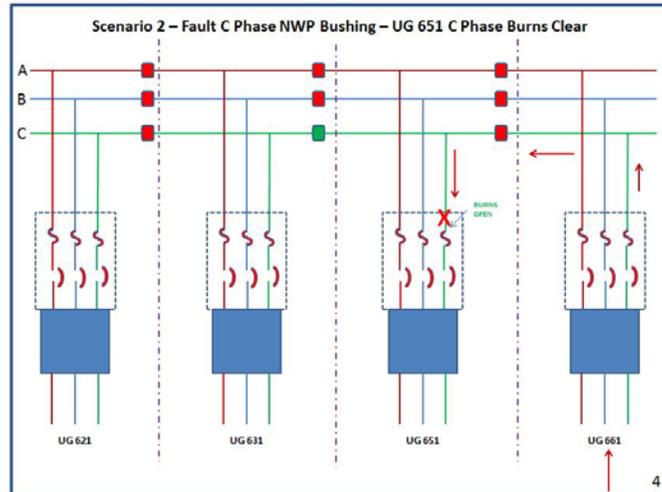
Figure 16 shows that the bottom side of the C phase network protector bushing burns in the clear above the UG 651 C phase network protector fuse. The bushing continues to arc to the case of the network protector from fault current momentarily being supplied by the UG 661 network transformer.

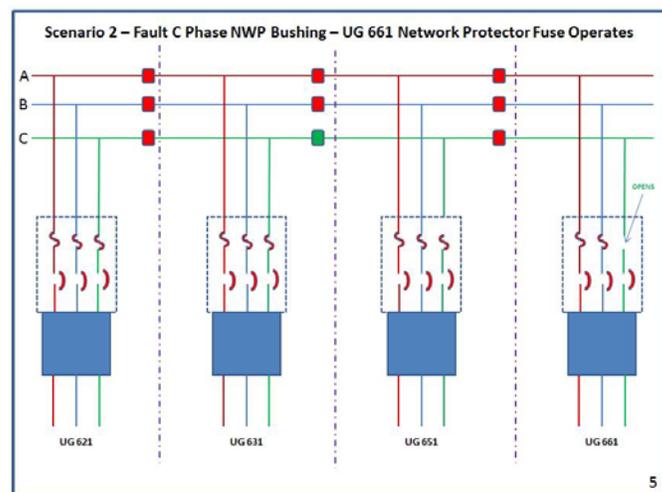
Figure 17 shows that the C Phase UG 661 network protector fuse opens from the fault current flowing through it. C Phase of the 480-volt collector bus is now de-energized in the UG 651 and UG 661 bays. All fault current from the 480-volt collector bus momentarily ceases. The loss of C Phase resulted in a partial interruption of service to customers with services connected to these two bays because only two of the three

phases were still energized. Molten metal and other by-products have collected at the bottom of the UG 651 network protector around the spool insulator on C Phase. Loud bangs continue to be heard at street level and smoke can be seen coming through the vault grating.

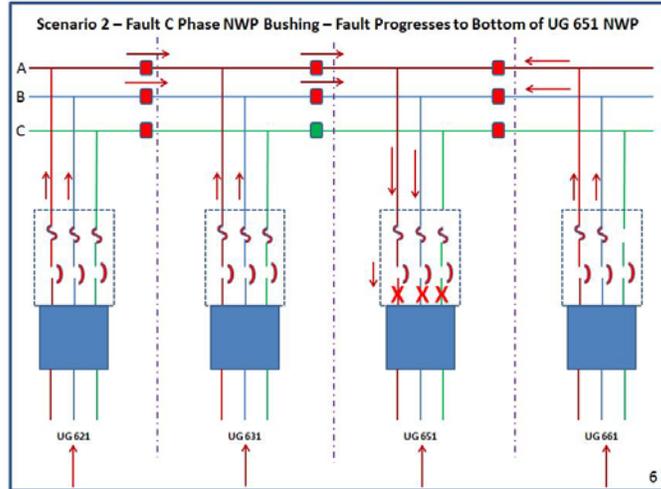
Figure 18 shows that enough material has built up in the bottom of the UG 651 network protector and C phase arcs to ground and then spreads to B Phase and then to A Phase. This occurs in a matter of cycles. There is fault current being supplied on A and B Phases from the 480-volt collector bus and from all three phases from the UG 651 network transformer. The banging sounds would now increase in intensity and the smoke would get heavier.

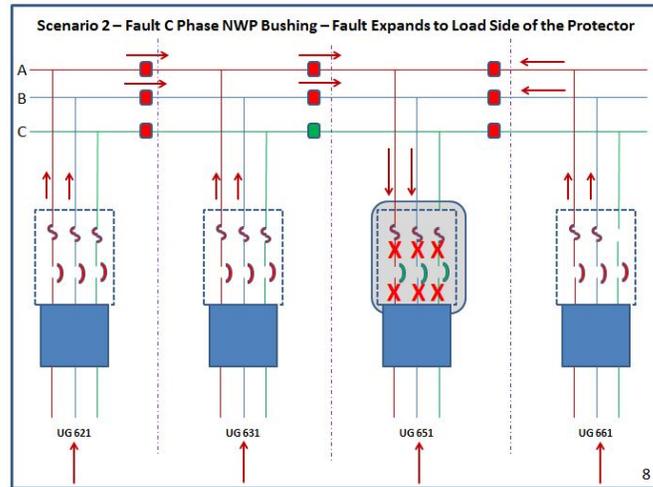
Figure 20 shows that the arc plasma, which occurs in high-energy failures, and other gases created during the arcing fault now fills the network protector housing. The arc plasma is highly conductive. The 480-volt bus inside the network protector flashes over on the load side of the open network protector breaker. Fault current again flows from the 480-volt collector bus on A and B phases from the UG 621, UG 631, and UG 661 network transformers. Fault current continues to flow from the UG 651 network transformer. The loud bangs heard at street level would continue, and heavy smoke would have been seen coming from the vault.

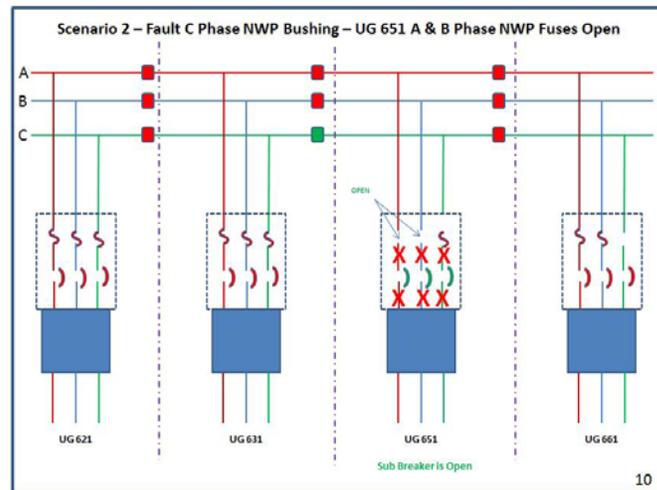
Figure 22 shows that the A and B phase network protector fuses in the UG 651 network protector have opened. This would have occurred within a few seconds of the Transmission operator opening the Gardner Lane UG 651 breaker shown above in Figure 20. The banging sounds would have stopped and the smoke would have immediately decreased. The field personnel did report a few additional bangs after the UG 651 breaker was opened at the substation. Given that the 480-volt collector bus is still energized on A and B phase up to top side of the damaged UG 651 network protector, some arcing could still have occurred just inside the UG 651 network protector.

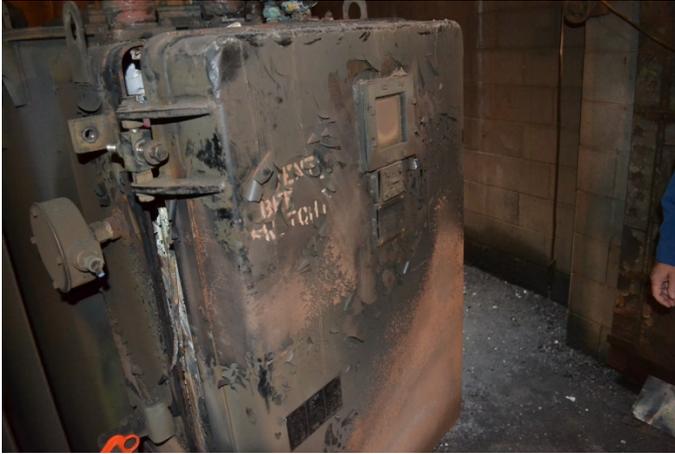
UG 651 network protector outside of the housing with the door closed post event

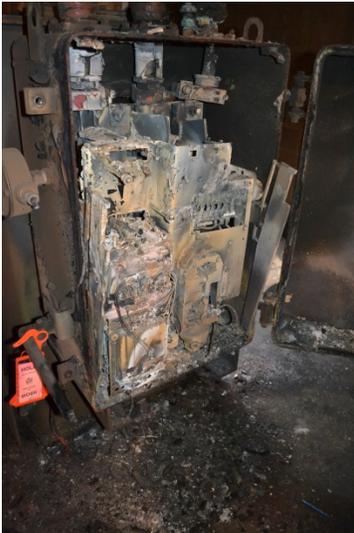
UG 651 network protector with the door open before any material is disturbed

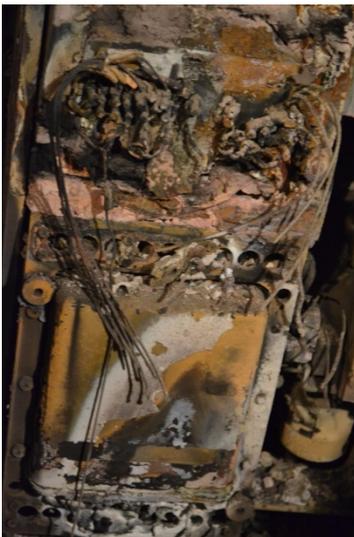
UG 651 network protector control relay and control wiring damage

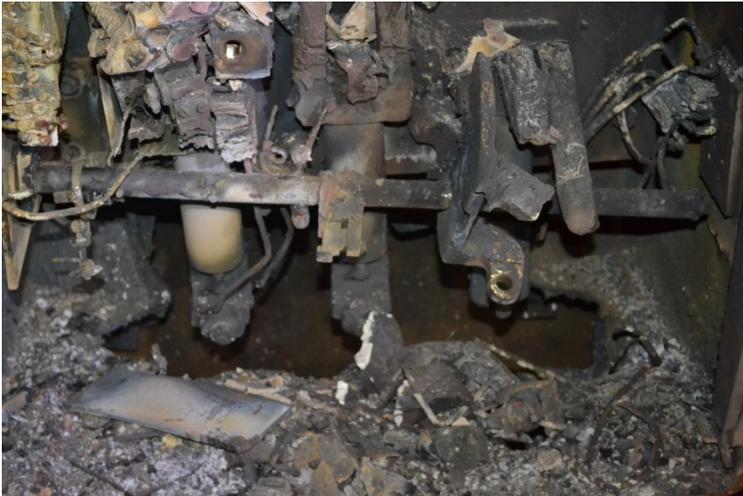
Holes burnt in the bottom the network protector housing. This is where the bus support spool insulators would have been mounted

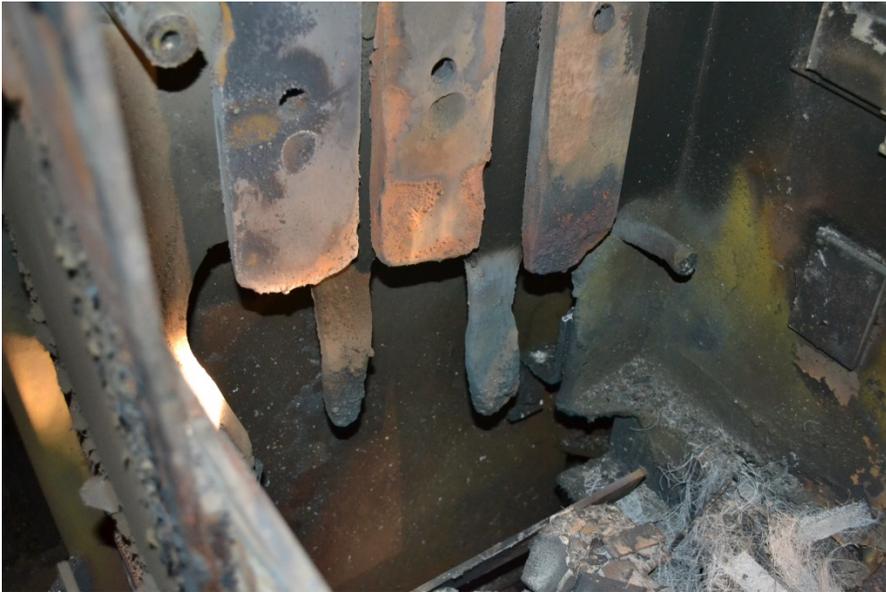
Transformer bus work damage and holes melted in the rear of the network protector housing. The holes in the remaining copper bus are where the mounting bolts for the upper bus support spool insulators would have been.

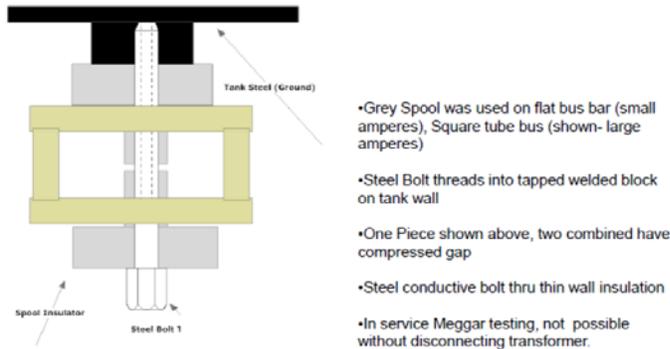
The figure below shows a top view of a section detail of area of concern. This design has been replaced by isolated standoff insulator design.
