Indiana Classified Forest & Wildlands Forestry Best Management Practices Monitoring Results for State Forest Properties

1996-2023

By: Jennifer Sobecki & Duane McCoy

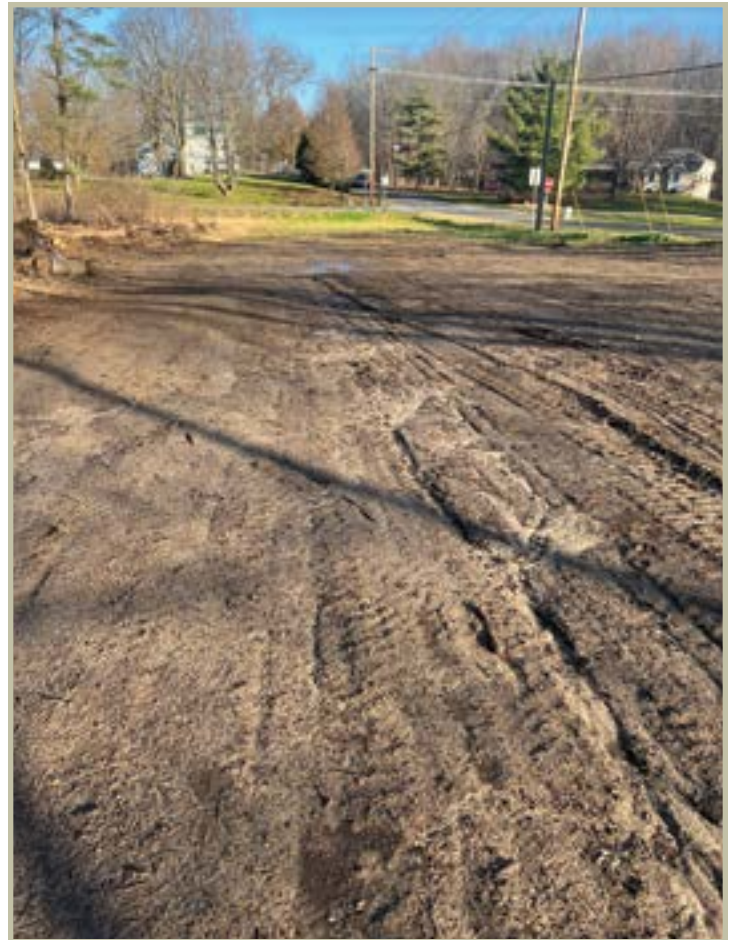
This landing was smoothed well, but not stabilized with seed or straw/mulch and therefore sheet and rill erosion is occurring. Photo by Jennifer Sobecki, DNR

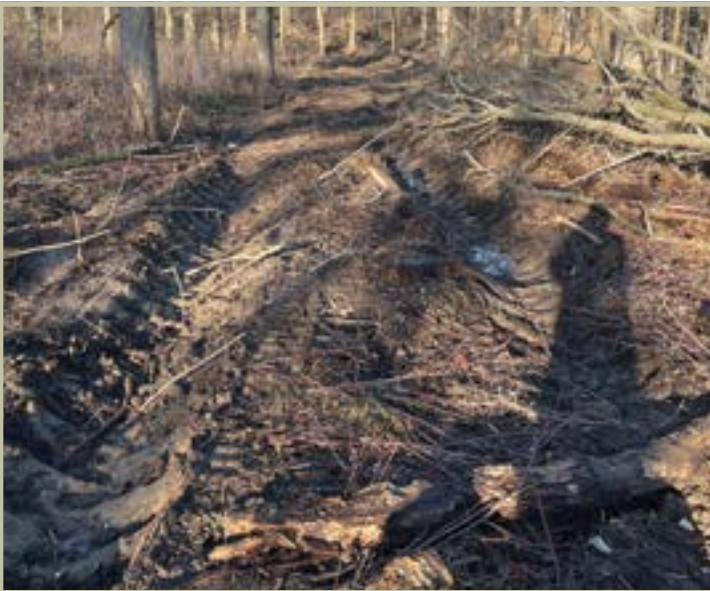
Skidding during wet conditions can create deep rutting that is difficult to repair, so avoiding those conditions if possible is the best option. *Photo by Jennifer Sobecki, DNR*

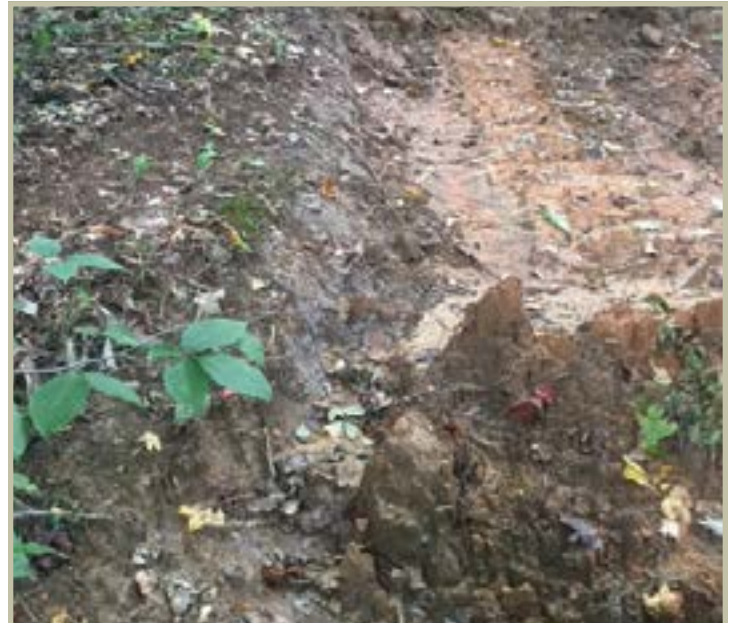
Breach of a waterbar due to lack of outlet. *Photo by Jennifer Sobecki, DNR*

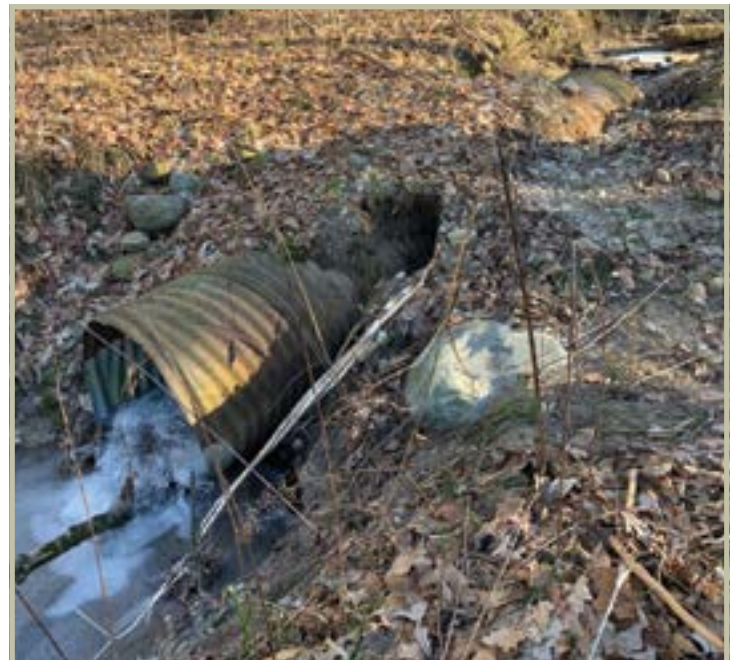
The culvert is too small for this drainage and thus is being washed out. This leads not only to sediment in the streams but dangerous crossing conditions. *Photo by Jennifer Sobecki, DNR*

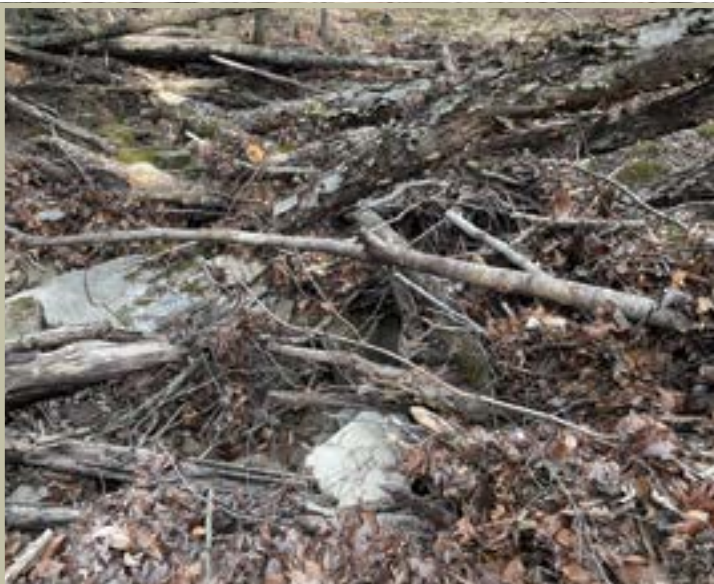
Tops felled into a stream, causing a large amount of debris to build up. *Photo by Duane McCoy, DNR*

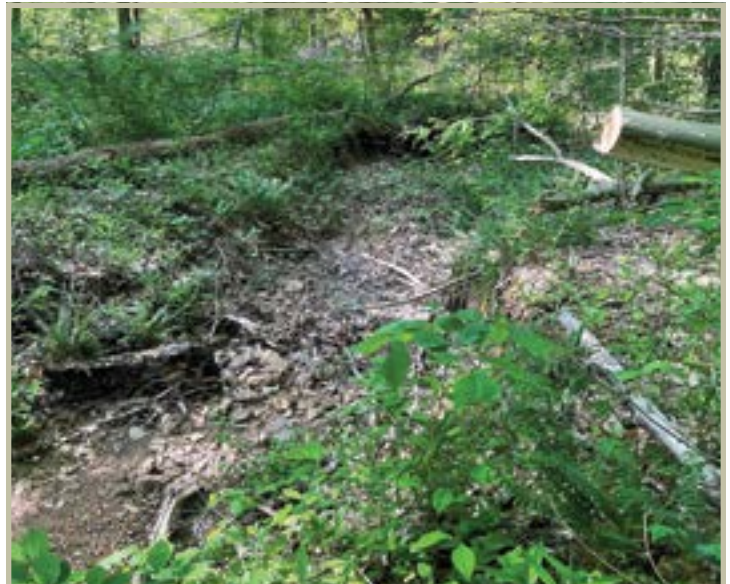
Harvest debris removed from a stream. *Photo by Duane McCoy, DNR*
