# The Portersville Bridge

## The Portersville Bridge Serving Dubois and Daviess Counties

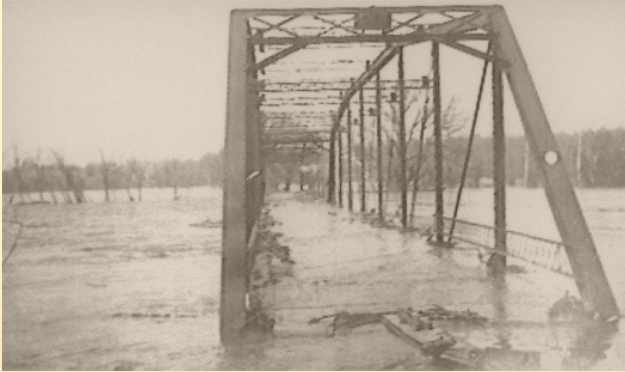
Shortly after the bridge was completed in 1912, a huge flood

on the White River submerged the bridge deck under a few feet of water. The railings and decking were removed to prevent heavy debris from becoming entangled on the bridge. After the waters receded, the bridge was raised three feet higher and opened in 1913.

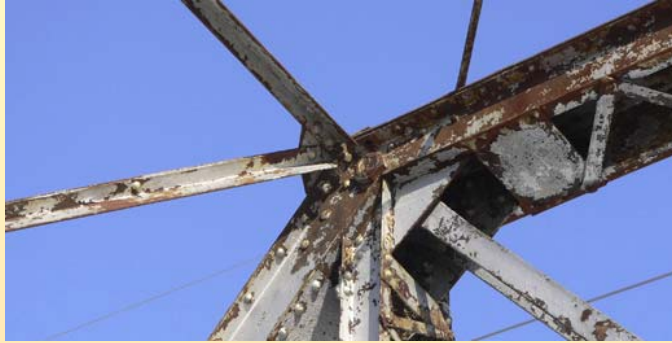
The Portersville Bridge is an example of a *pinned camelback through truss*.

**Pinned:** members of the bridge are pinned together at the joints.

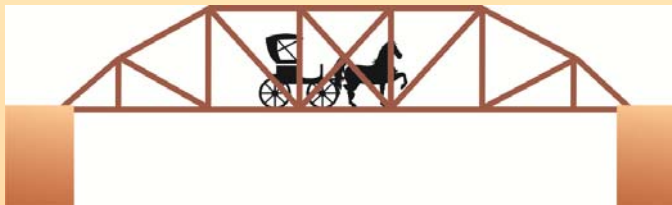
**Camelback:** The top chord curves down to meet the bottom chord creating the outline of a camel's back.

This truss style was a modification of the Parker truss. It was commonly used in the United States for railroad and highway bridges in the late 1800s and early 1900s.

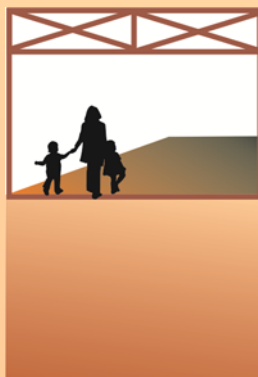
**Through Truss:** Traffic travels through the structure with overhead cross-bracing between the two parallel top chords.

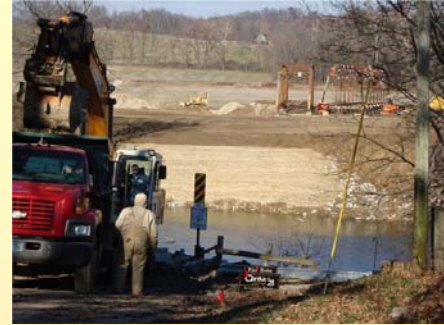
Each span was lifted by a crane and set on the ground.

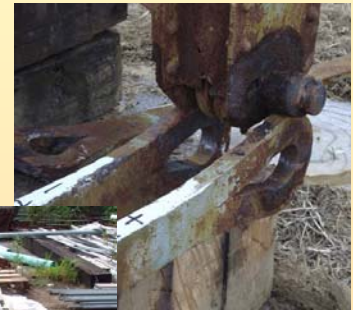
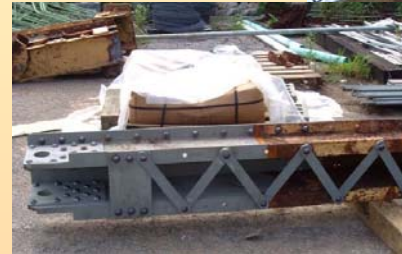
As the spans were taken apart, pieces were numbered for reassembly. Every piece was inspected, cleaned and painted.

Only 5% of the bridge trusses had to be replaced, largely due to rust. The decking and railings are new.
