## **ADA Inspection Form**

# This is an inspection form and does NOT suggest full compliance.

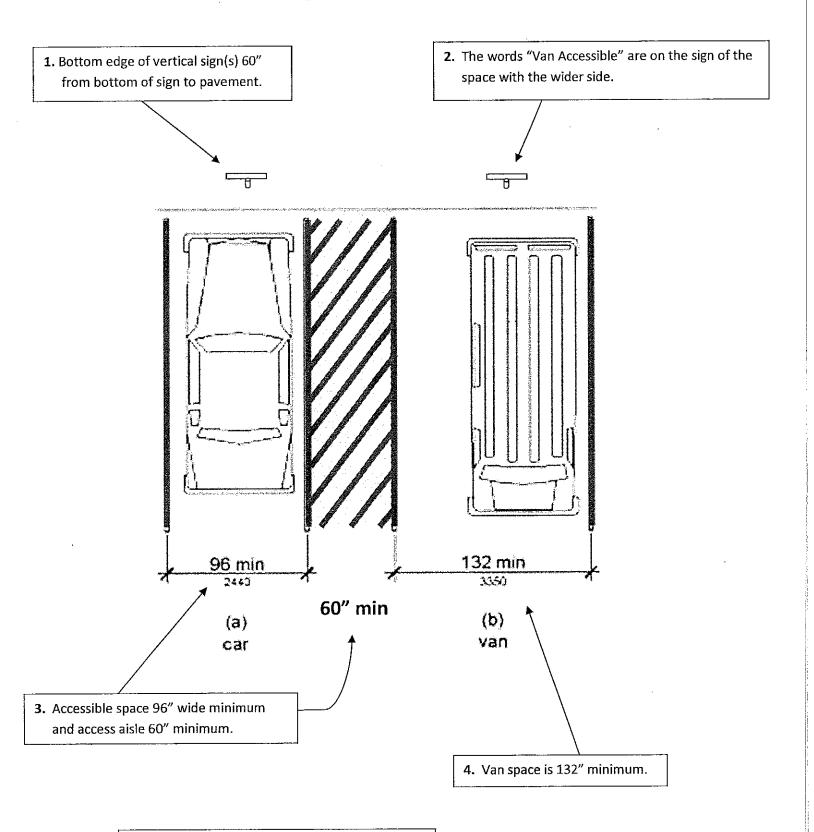
#### **Parking Space Inspection**

5. Space and access aisle marked with blue lines.

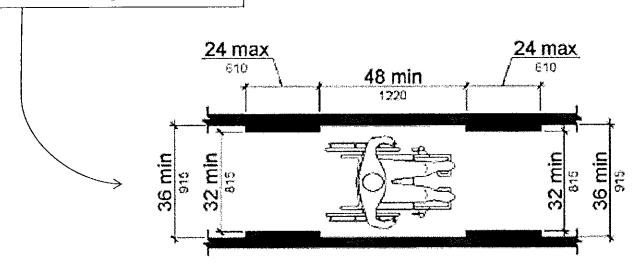
**6.** Minimum width should be 36", but can decrease to 32" for no longer than 24".

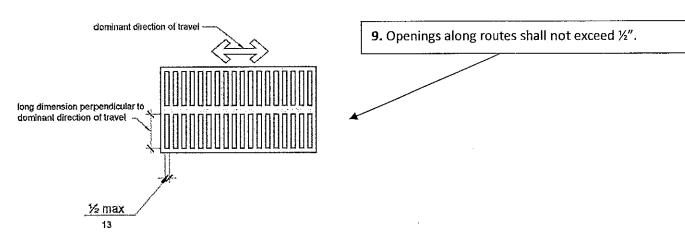
- 7. Grades and cross slopes shall not exceed 5% and 2% respectively.
- 8. Walking surfaces shall be firm, stable and slip resistant. (no large, loose stone.)

10. Changes in level cannot exceed ½".

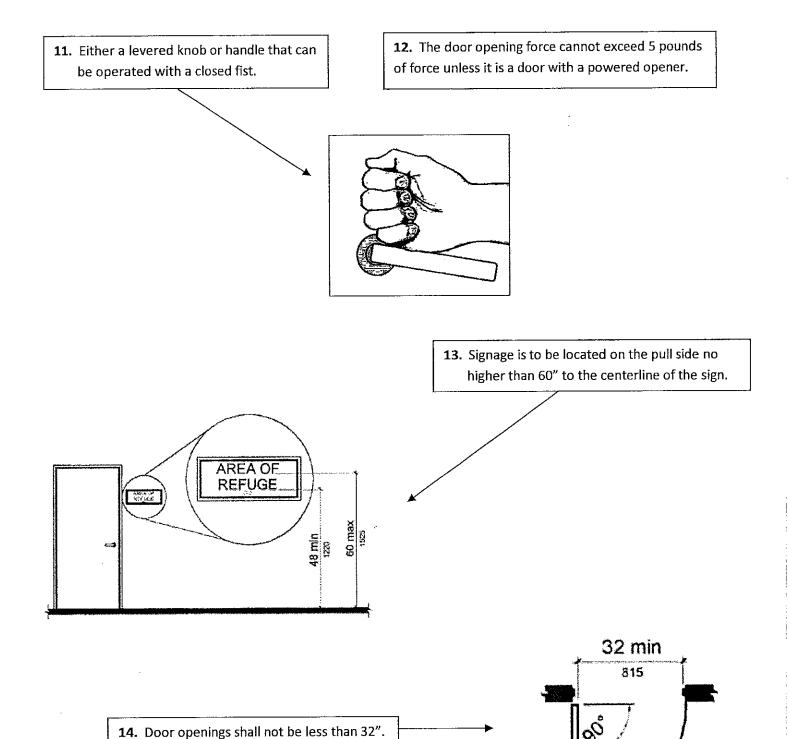
#### **Doors Inspection**

(a) hinged door
