Indian Creek Watershed -- Critical Areas

Indian Creek Watershed Plan
Appendix 3.2. Critical Areas Issues and Strategies

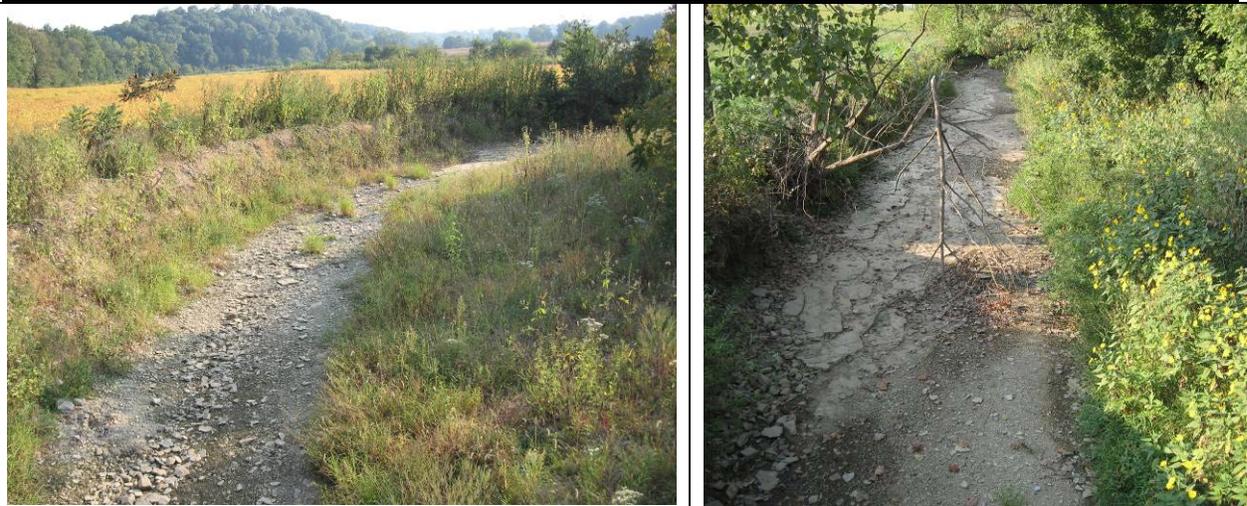
Item	Description
Monitoring Site	001
Location	Indian Creek North at Banet Road, IDEM Site OBS080-0001
Site Selection Rationale	303(d) Segment – Aquatic Life Impairment
Biological Monitoring Result	Not sampled due to severe drought conditions. Habitat assessment result was Fair (score 46) and indicated bank erosion and poor riparian zone.
Interpretation	Data gap
Cause of Impairment	
Load Reduction Required	
Pollution Source(s)	
Strategies - High Priority	
Strategies - Medium Priority	Sample this location during normal flow conditions; both IDEM data were collected during low flow and it was not possible to collect benthic data during this project Use data collected under normal flow conditions to re-assess this stream.
Strategies - Low Priority	Bank stabilization and riparian vegetation would be beneficial.

Monitoring Site 001: These photographs were taken on September 20, 2007 during the biological sampling event. Due to lack of water, this site was not sampled. The very small drainage area may contribute to biological impairment since this site is easily affected by both droughts and floods.

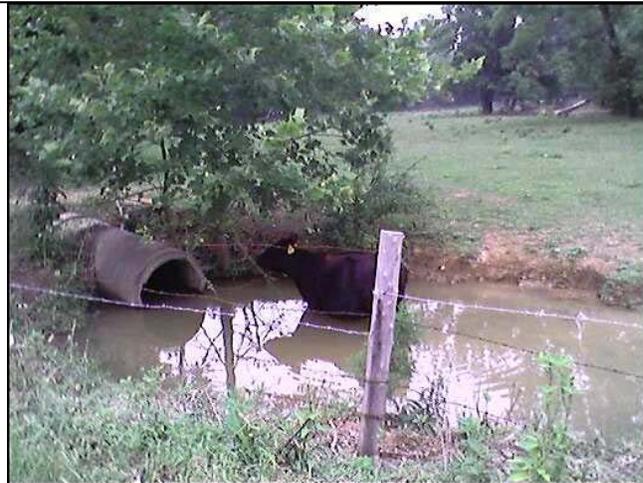
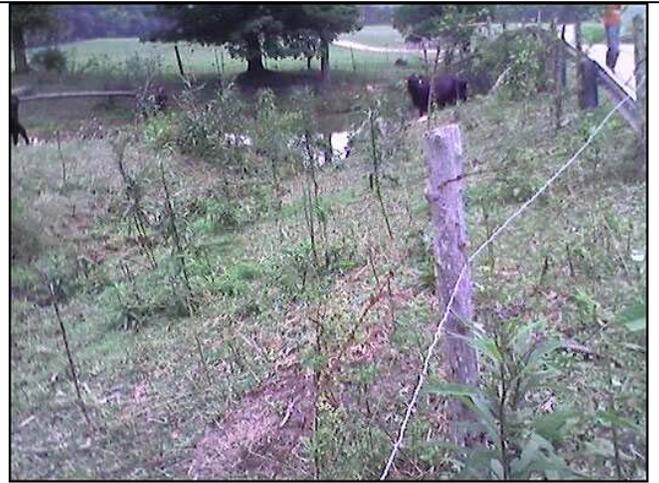
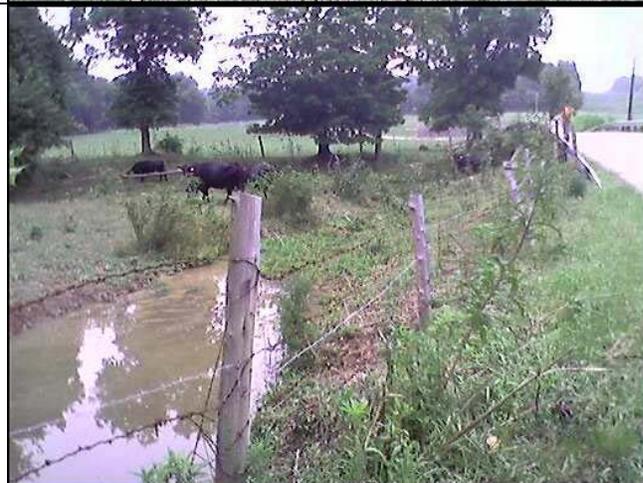
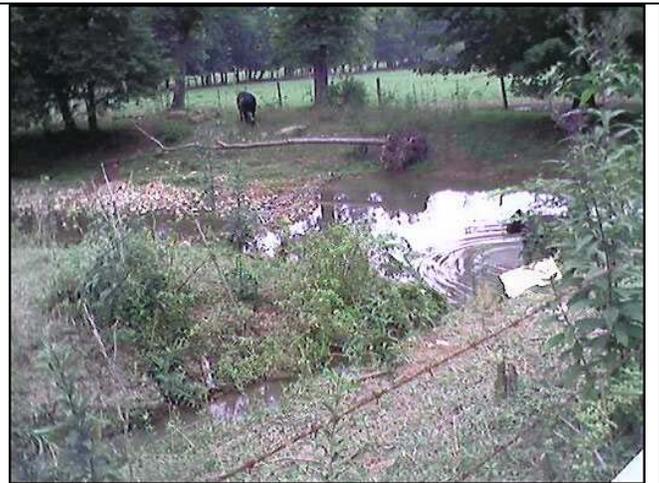
Item	Description
Monitoring Site	002
Location	Georgetown Creek below Georgetown at Malinee Ott Road
Site Selection Rationale	Unassessed reach below Georgetown
Bacteria Result (CFU/100 ml)	Geomean: 194; Maximum: 300 Estimated Existing Load: 6.7 E+12 CFU/year
Interpretation	Recreational Use Impaired
Cause of Impairment	Elevated e. coli
Load Reduction Estimates	Estimated Load Reduction: 2.4 E+12 CFU/year 35.5%
Pollution Source(s)	Cattle in creek (field observation, see photos below). Possible pasture sources and septic systems (BIT result)
Strategies - High Priority	Cattle exclusion/ alternate water supply, stream buffer / streambank stabilization
Strategies - Medium Priority	Evaluate septic systems as a possible pollution source in Georgetown Creek; address through maintenance, repair, and replacement as needed.
Strategies - Low Priority

Monitoring Site 2. Georgetown Creek below Georgetown at Malinee Ott Road. These field photos document cattle access to the creek, which could be addressed by cattle exclusion fencing and alternate water supplies. The photos also show poor riparian buffer. This site was not included in the benthic macroinvertebrate sampling, but clearly riparian buffer and bank stabilization would be beneficial here.

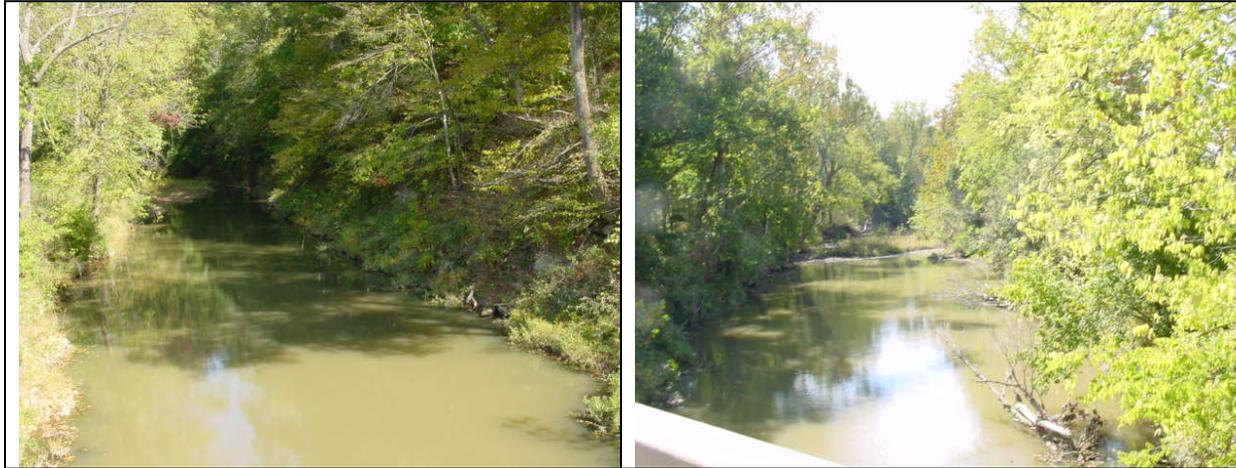
Site 003 Upstream and Downstream. This site has a well-forested buffer and little evidence of disturbance near the sampling site.

Strategies - Medium Priority	Evaluate septic systems as a potential source of bacterial pollution using methods such as dye and smoke testing, fecal coliform / fecal strep ratios, optical brighteners.
Strategies - Low Priority

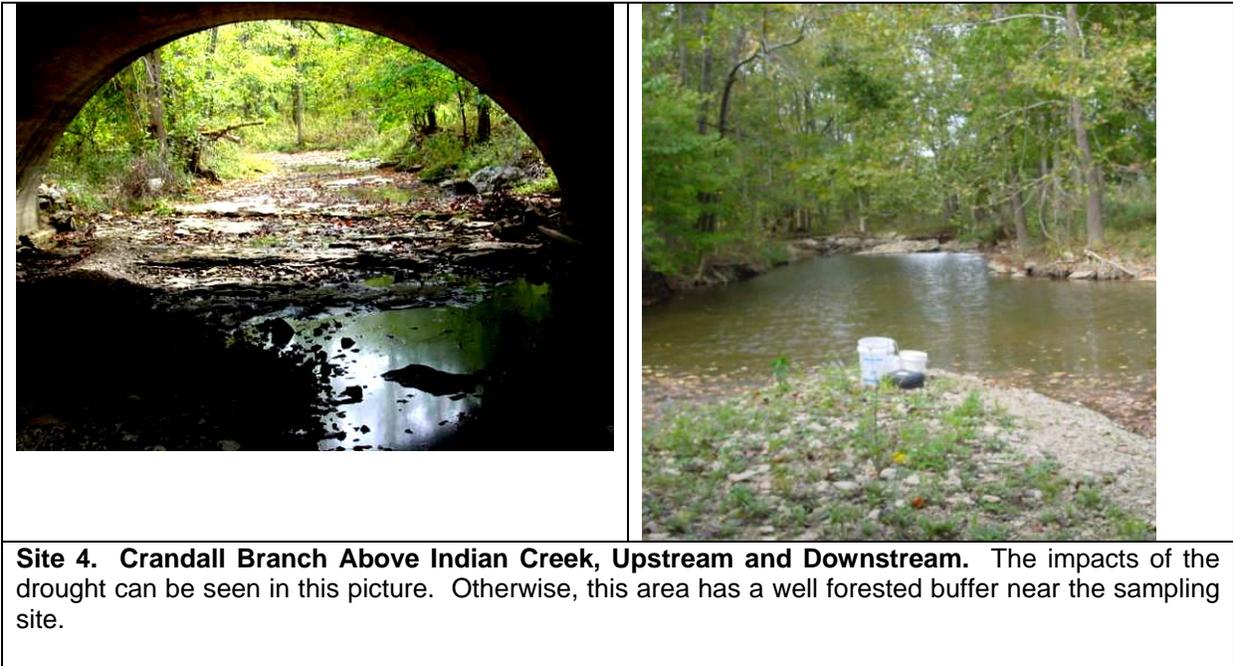
Site 4. Crandall Branch Above Indian Creek, Upstream and Downstream. The impacts of the drought can be seen in this picture. Otherwise, this area has a well forested buffer near the sampling site.

Strategies - Low Priority	Evaluate septic systems as a potential source of bacterial pollution using methods such as dye and smoke testing, fecal coliform / fecal strep ratios, optical brighteners.

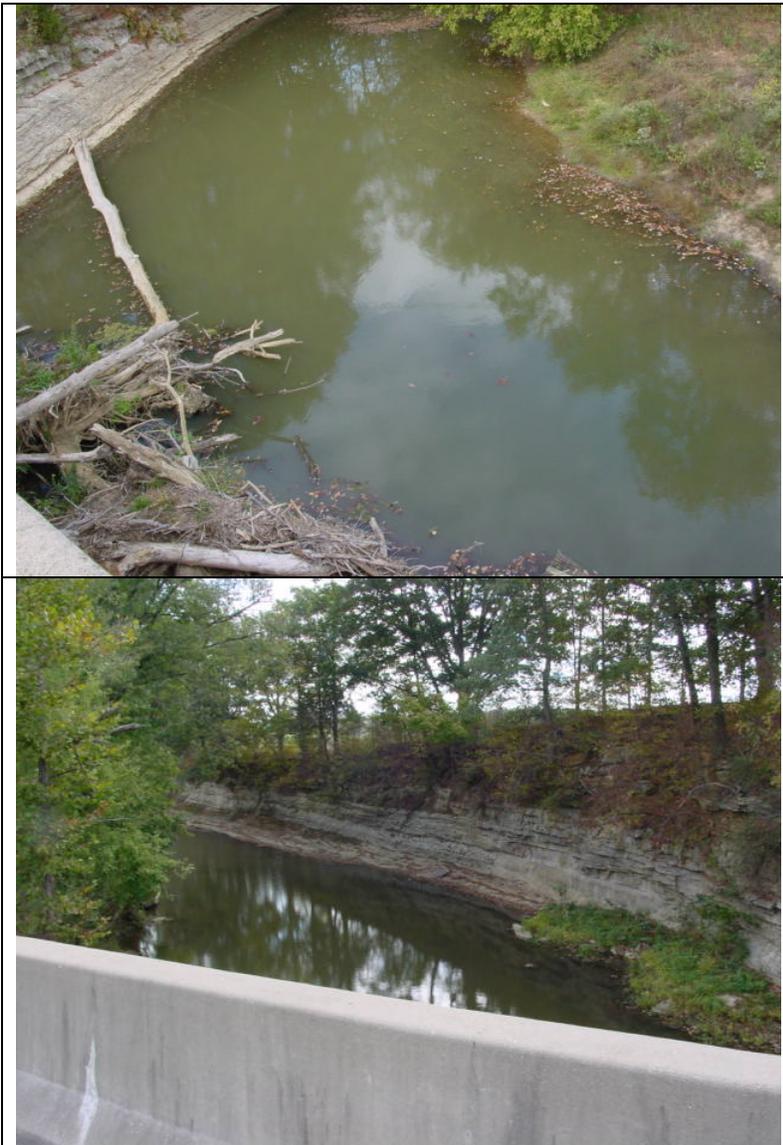
Item	Description
Monitoring Site	005
Location	Indian Creek above SR355 Bridge, IDEM Site OBS090-0004
Site Selection Rationale	303(d) Segment – Recreation
Bacteria Result	GeoMean: 268.8; Maximum: 410 Estimated Existing Load: 1.1 E+14 CFU/year
Interpretation	Recreational Use Impaired
Cause of Impairment	Elevated e. coli
Load Reduction Estimate	Load Reduction Estimate: 5.7 E+13 CFU/year 53.4%
Pollution Source(s)	BIT results indicate crop, pasture and cattle as potential sources of bacteria in Watershed 15; Septic systems were ranked lower than other Indian Creek subwatersheds in the BIT analysis; WWTP Compliance, discharges into the well developed karst system from septic systems and/or agricultural sources could contribute to impairments; bacterial regrowth?
Strategies - High Priority	Improve WWTP Compliance at Lanesville Welcome Center
Strategies - Medium Priority	Encourage agricultural BMPs such as cattle exclusion/ alternative water supplies, manure management plans

Site 5 Indian Creek above SR355 Bridge Looking Upstream and Downstream. This site has a relatively well vegetated riparian area, but there is evidence of some areas needing tree plantings. This area is highly influenced by karst and water was very still during the drought. This hot, dry condition promotes regrowth of bacteria.

Strategies - Low Priority	If septic system failures are reported, investigate with dye and smoke testing and repair or replace as needed

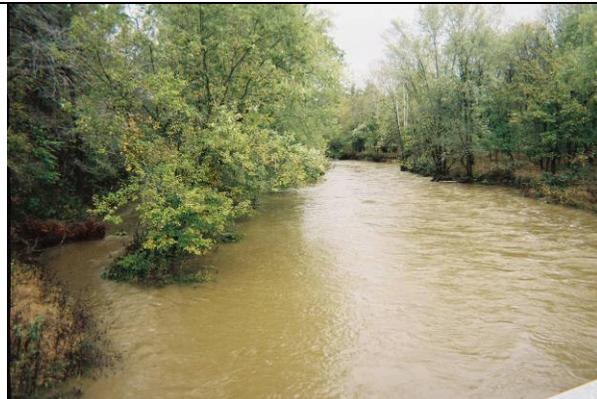
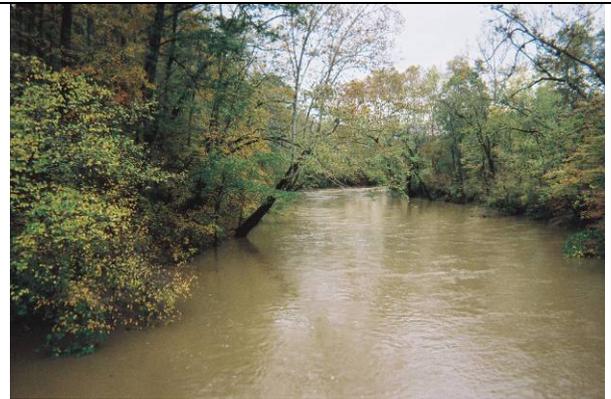
Site 007: Indian Creek at Mathis Road Bridge

Site 008: Indian Creek above Rocky Hollow Road Bridge (IDEM Site OBS100-0001)

These monitoring sites are located in an agricultural / undeveloped part of the watershed. This area is heavily influenced by karst and other than the mainstem Indian Creek, there is relatively little surface water in this area. The photographs show a well developed and stable riparian buffer in this area. The sediment load from upstream sources in these high flow photographs is clearly visible.

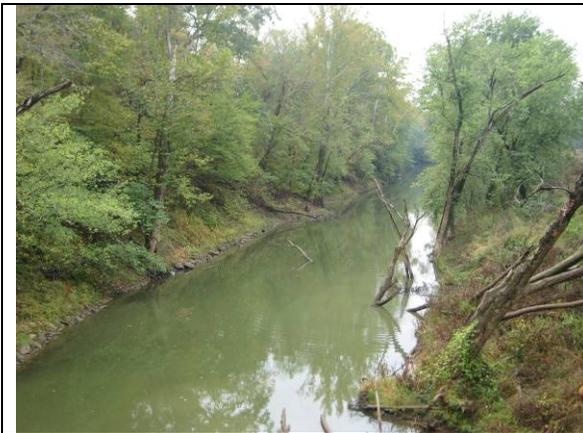
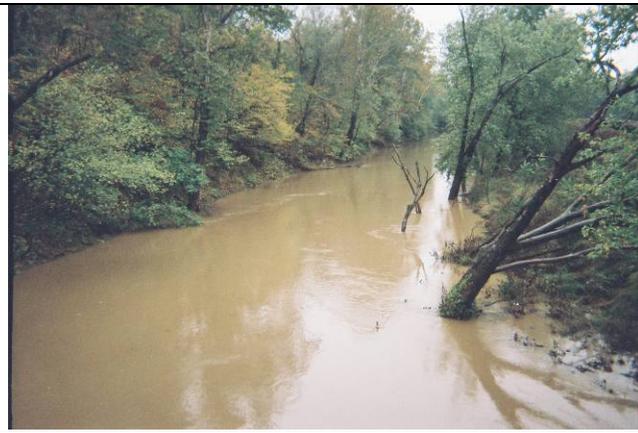
Site 009 under base flow conditions.

Site 009 under elevated flow conditions.

During four (4) sample events, flows were 0 feet/ second and during three (3) sample events, flows were reversed and ranged from -0.5 ft/s to -0.72 ft/s. These very low and reverse flows indicate the important influence of the Ohio River and it's backwater in this area.

This monitoring site is located in an agricultural / undeveloped part of the watershed. This area is heavily influenced by karst and other than the mainstem Indian Creek, there is relatively little surface water in this area. The photographs show a well developed and stable riparian buffer in this area. The sediment load from upstream sources in the elevated flow condition photograph is clearly visible.

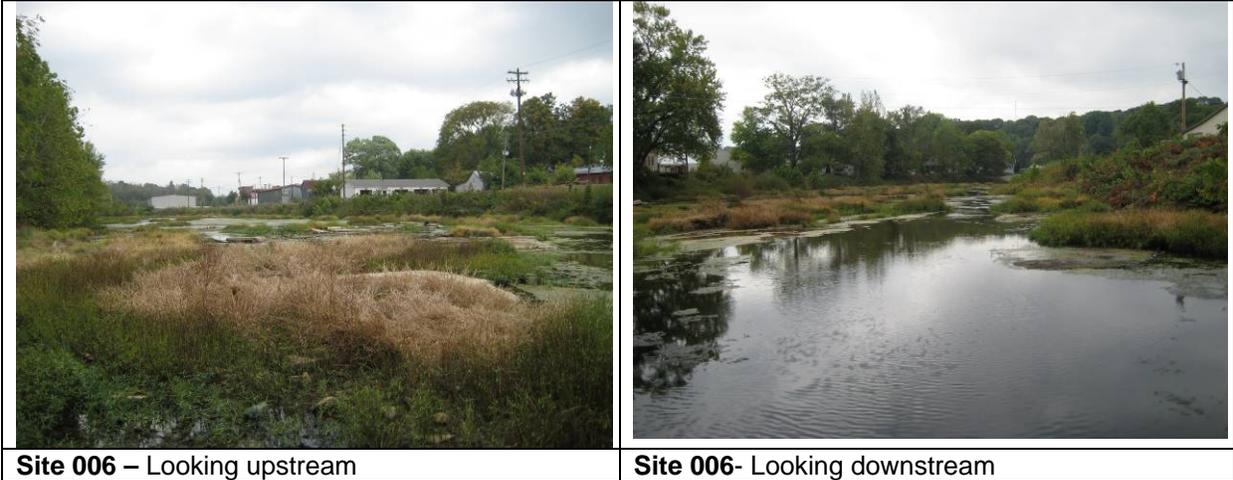
Site 006 – Looking upstream

Site 006- Looking downstream

While recreational criteria for bacteria were met, this location has poor habitat. Sedimentation is occurring and elevated nutrients may be contributing to algal proliferation seen in the downstream photograph.

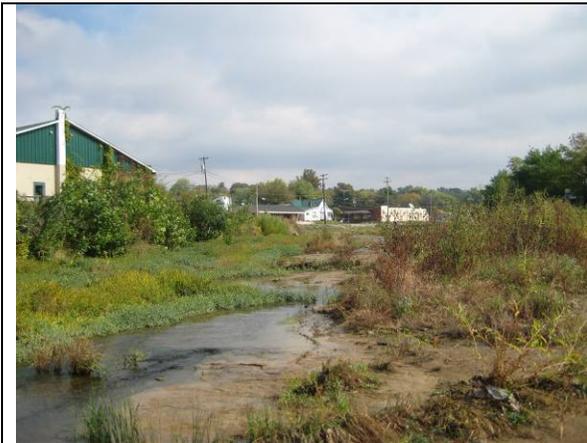
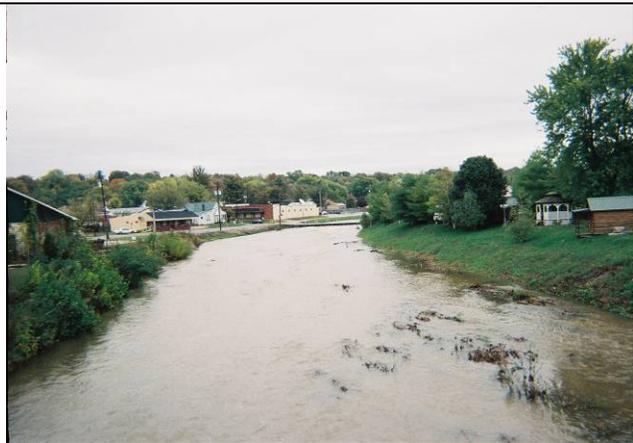
Site 010 – Low flow condition

Site 010- Elevated flow condition

The poor quality habitat is documented in the low flow condition photograph and potential for flooding is seen in the elevated flow photograph.

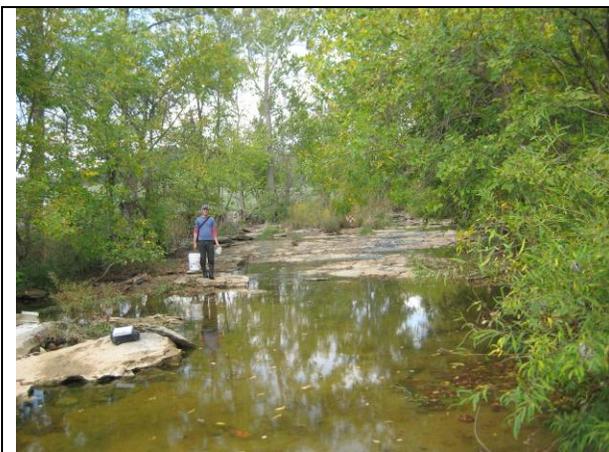
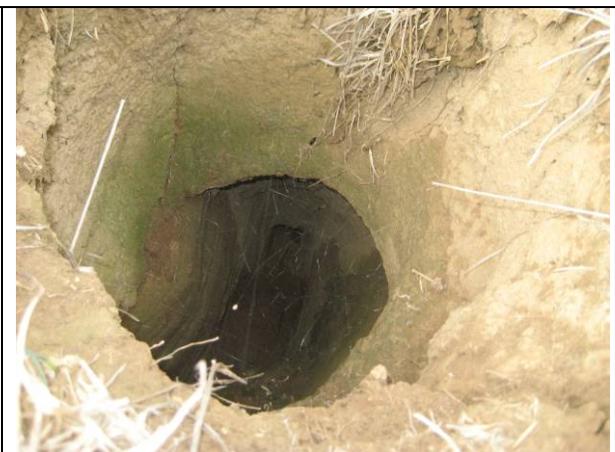
Site 11 – Biological sampling under low flow conditions

Site 11 – nearby sinkhole

Site 11 on Little Indian Creek near Lanesville had good quality habitat that should be maintained. The influence of karst and its ability to transport water through underground channels is depicted in the sinkhole photograph.
