## REMEDIATION WORK PLAN

The Butler Company  
325 South Broadway Street  
Butler, DeKalb County, Indiana 46721  
*BFD #4170705*

July 2020

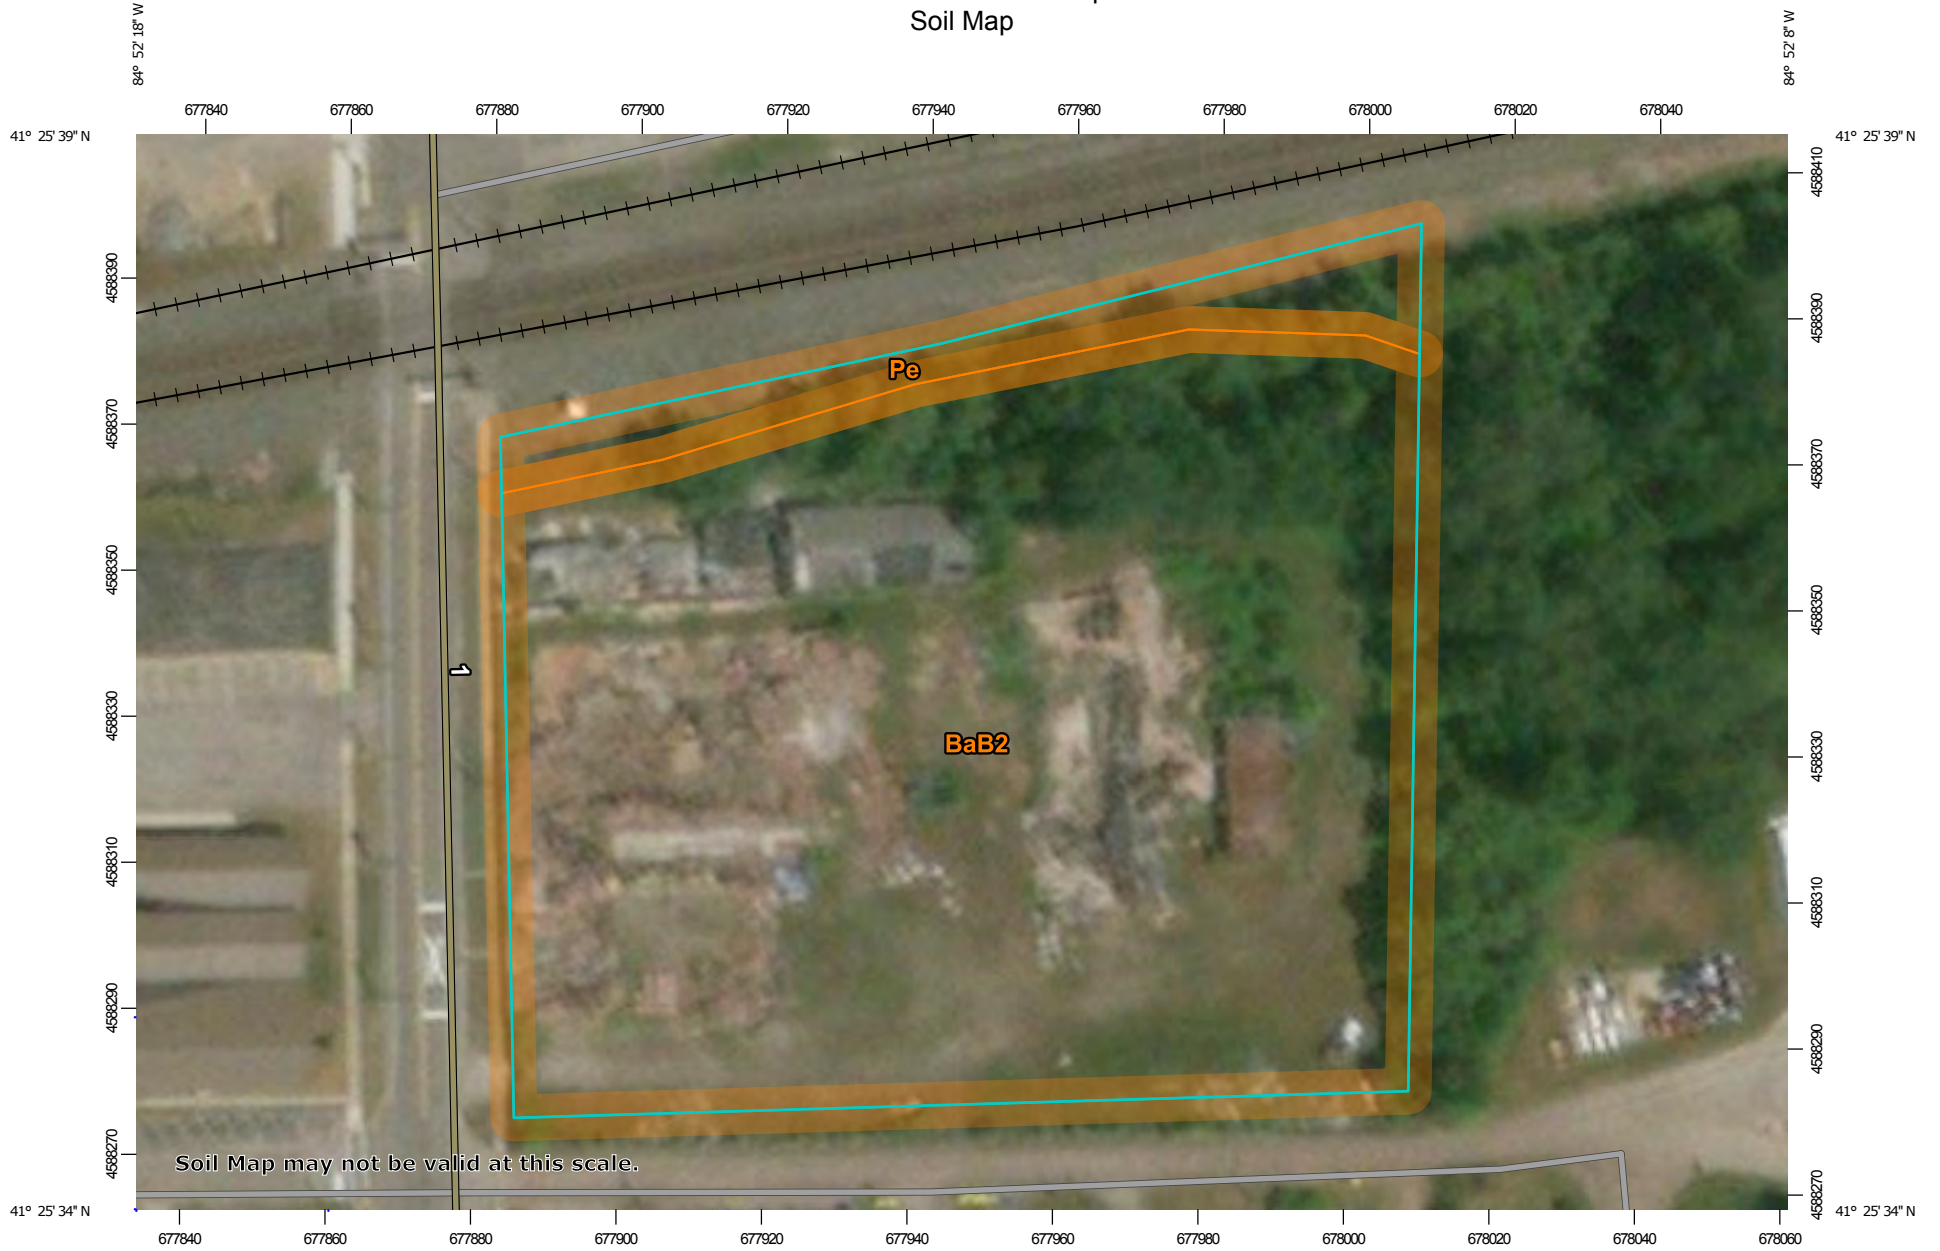
# Custom Soil Resource Report Soil Map

The soil map section includes the soil map for the defined area of interest, a list of soil map units on the map and extent of each map unit, and cartographic symbols displayed on the map. Also presented are various metadata about data used to produce the map, and a description of each soil map unit.

Map Scale: 1:1,040 if printed on A landscape (11" x 8.5") sheet.

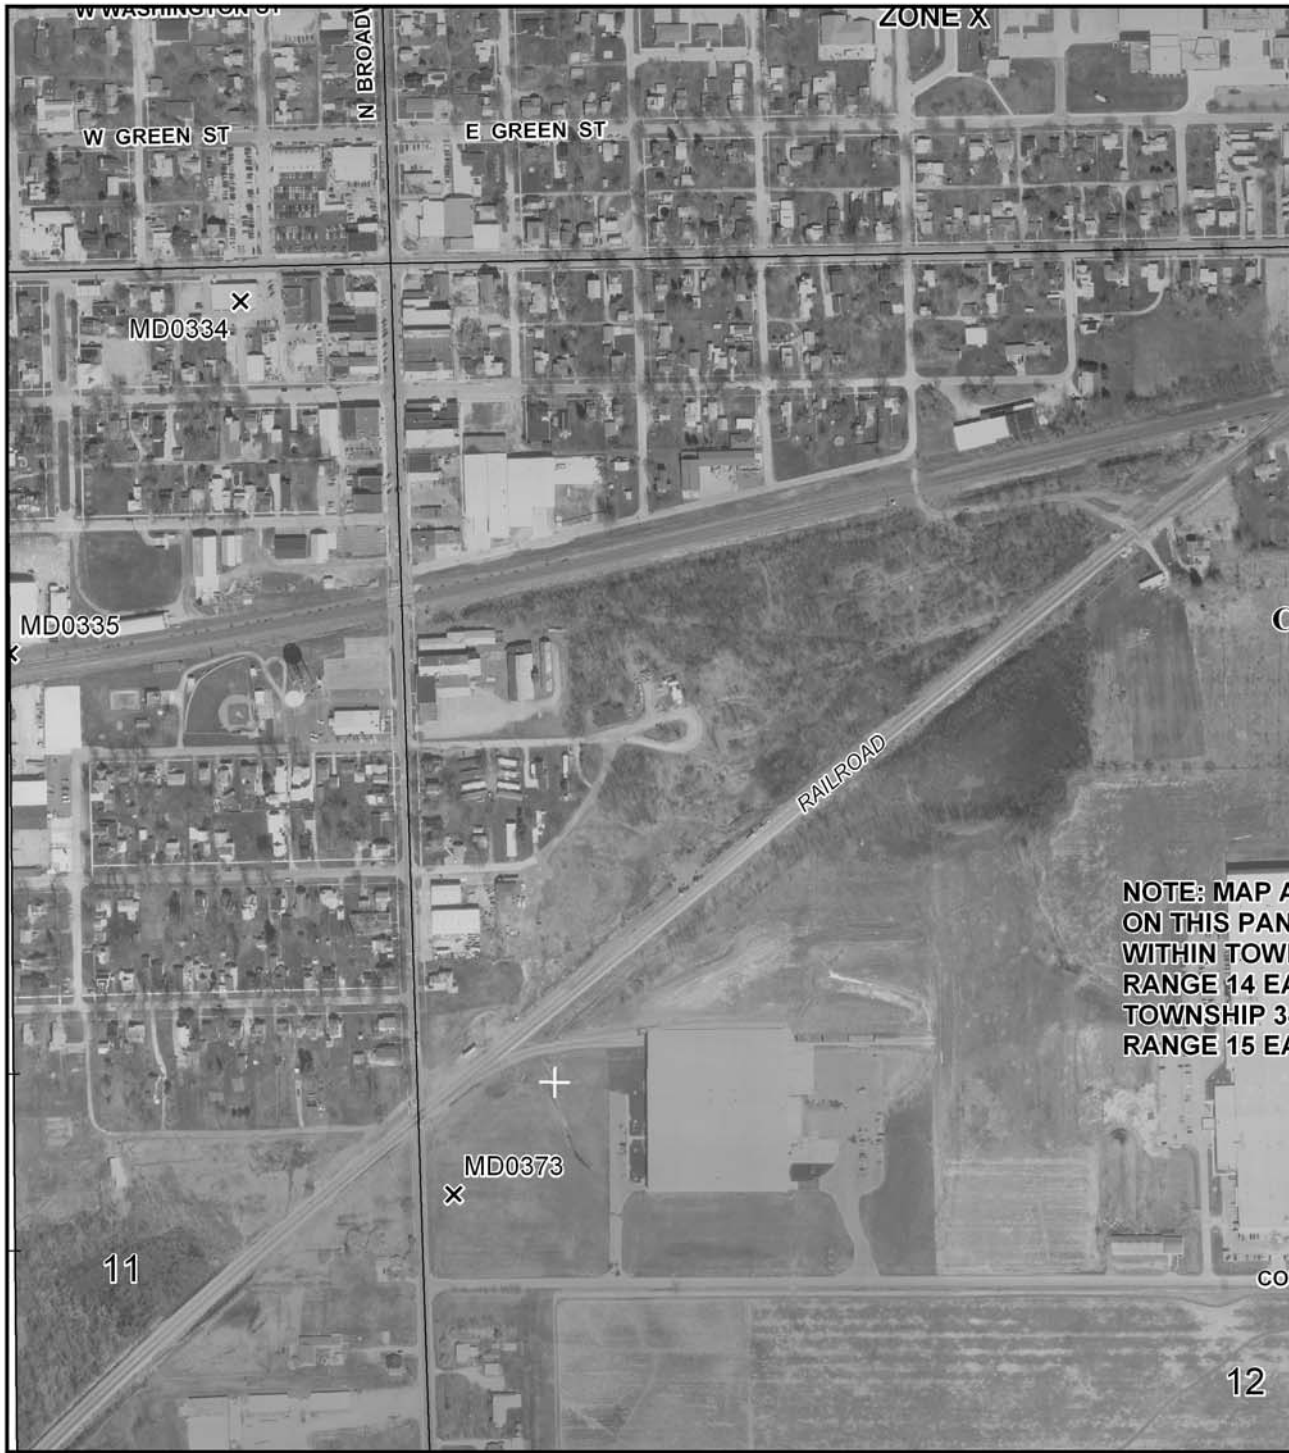
MAP SCALE 1" = 500'

Review of a FEMA Flood Insurance Rate Map (FIRM) indicates the site is located in Zone X, an area of minimal flood hazard. A copy of the FIRM is presented in Appendix E.
