NEW I-69 INTERCHANGE AT 106TH STREET

Federal Highway Administration and Indiana Department of Transportation

ENVIRONMENTAL ASSESSMENT

Des. No. 1298035

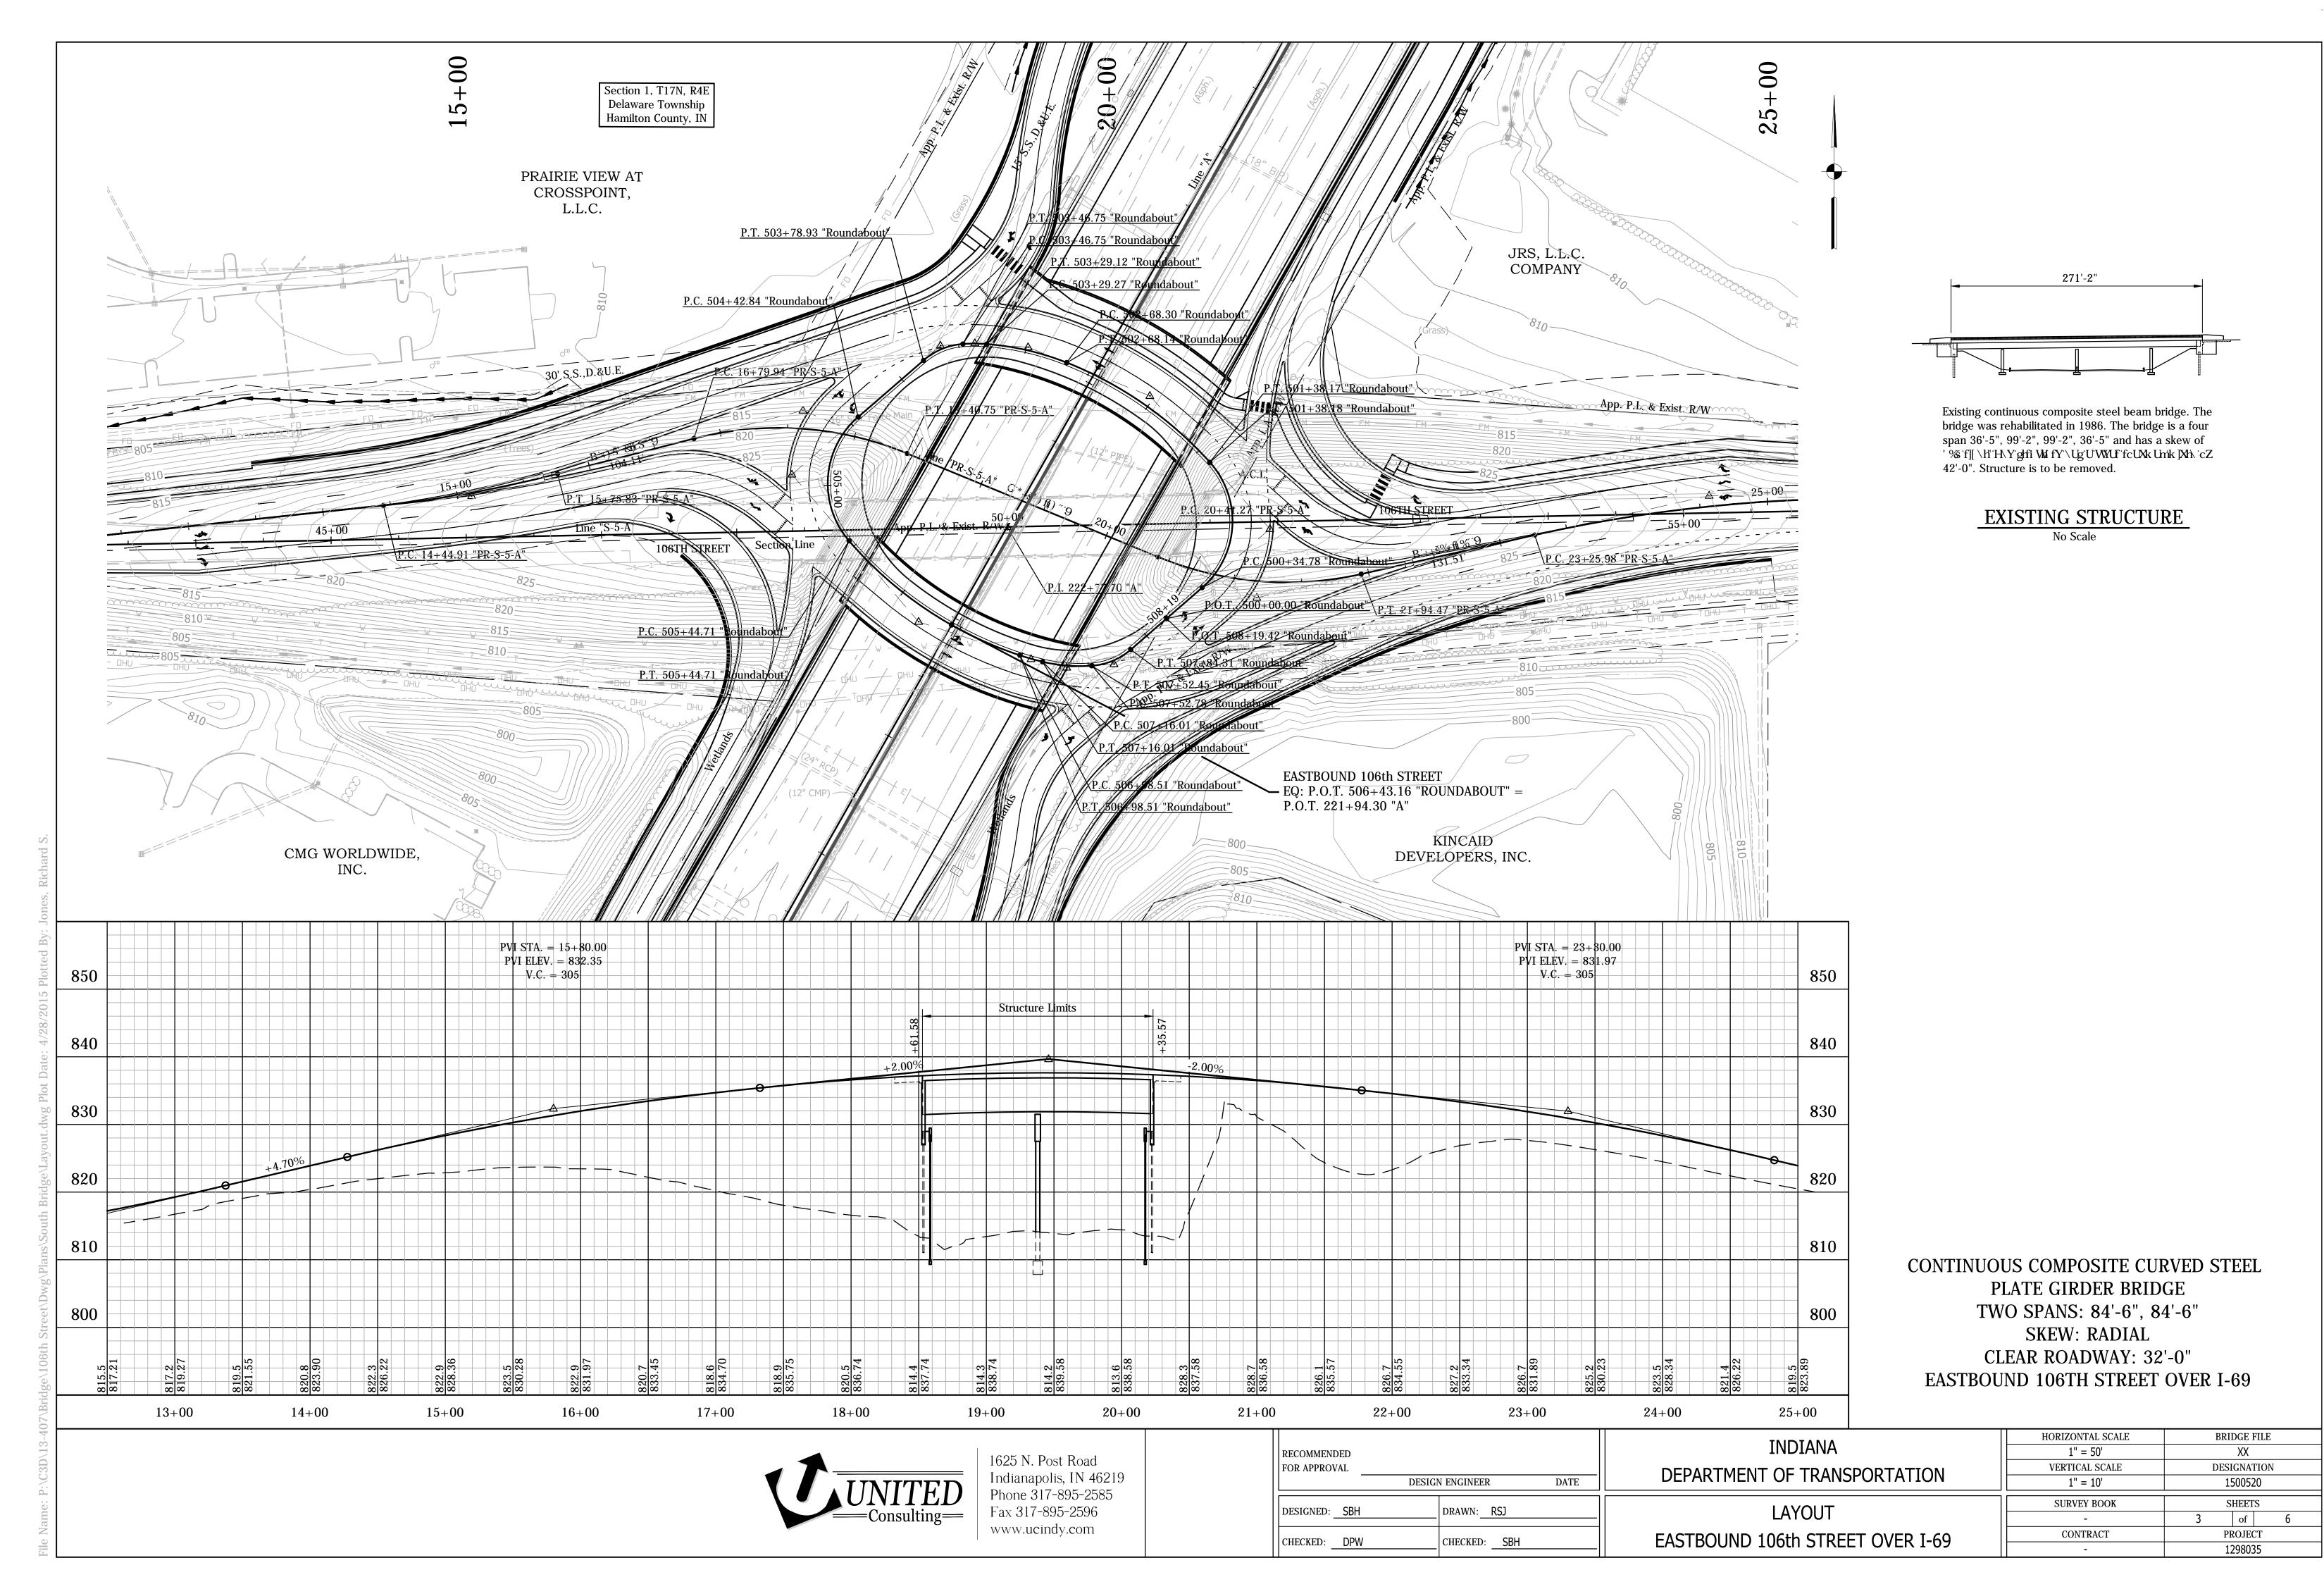
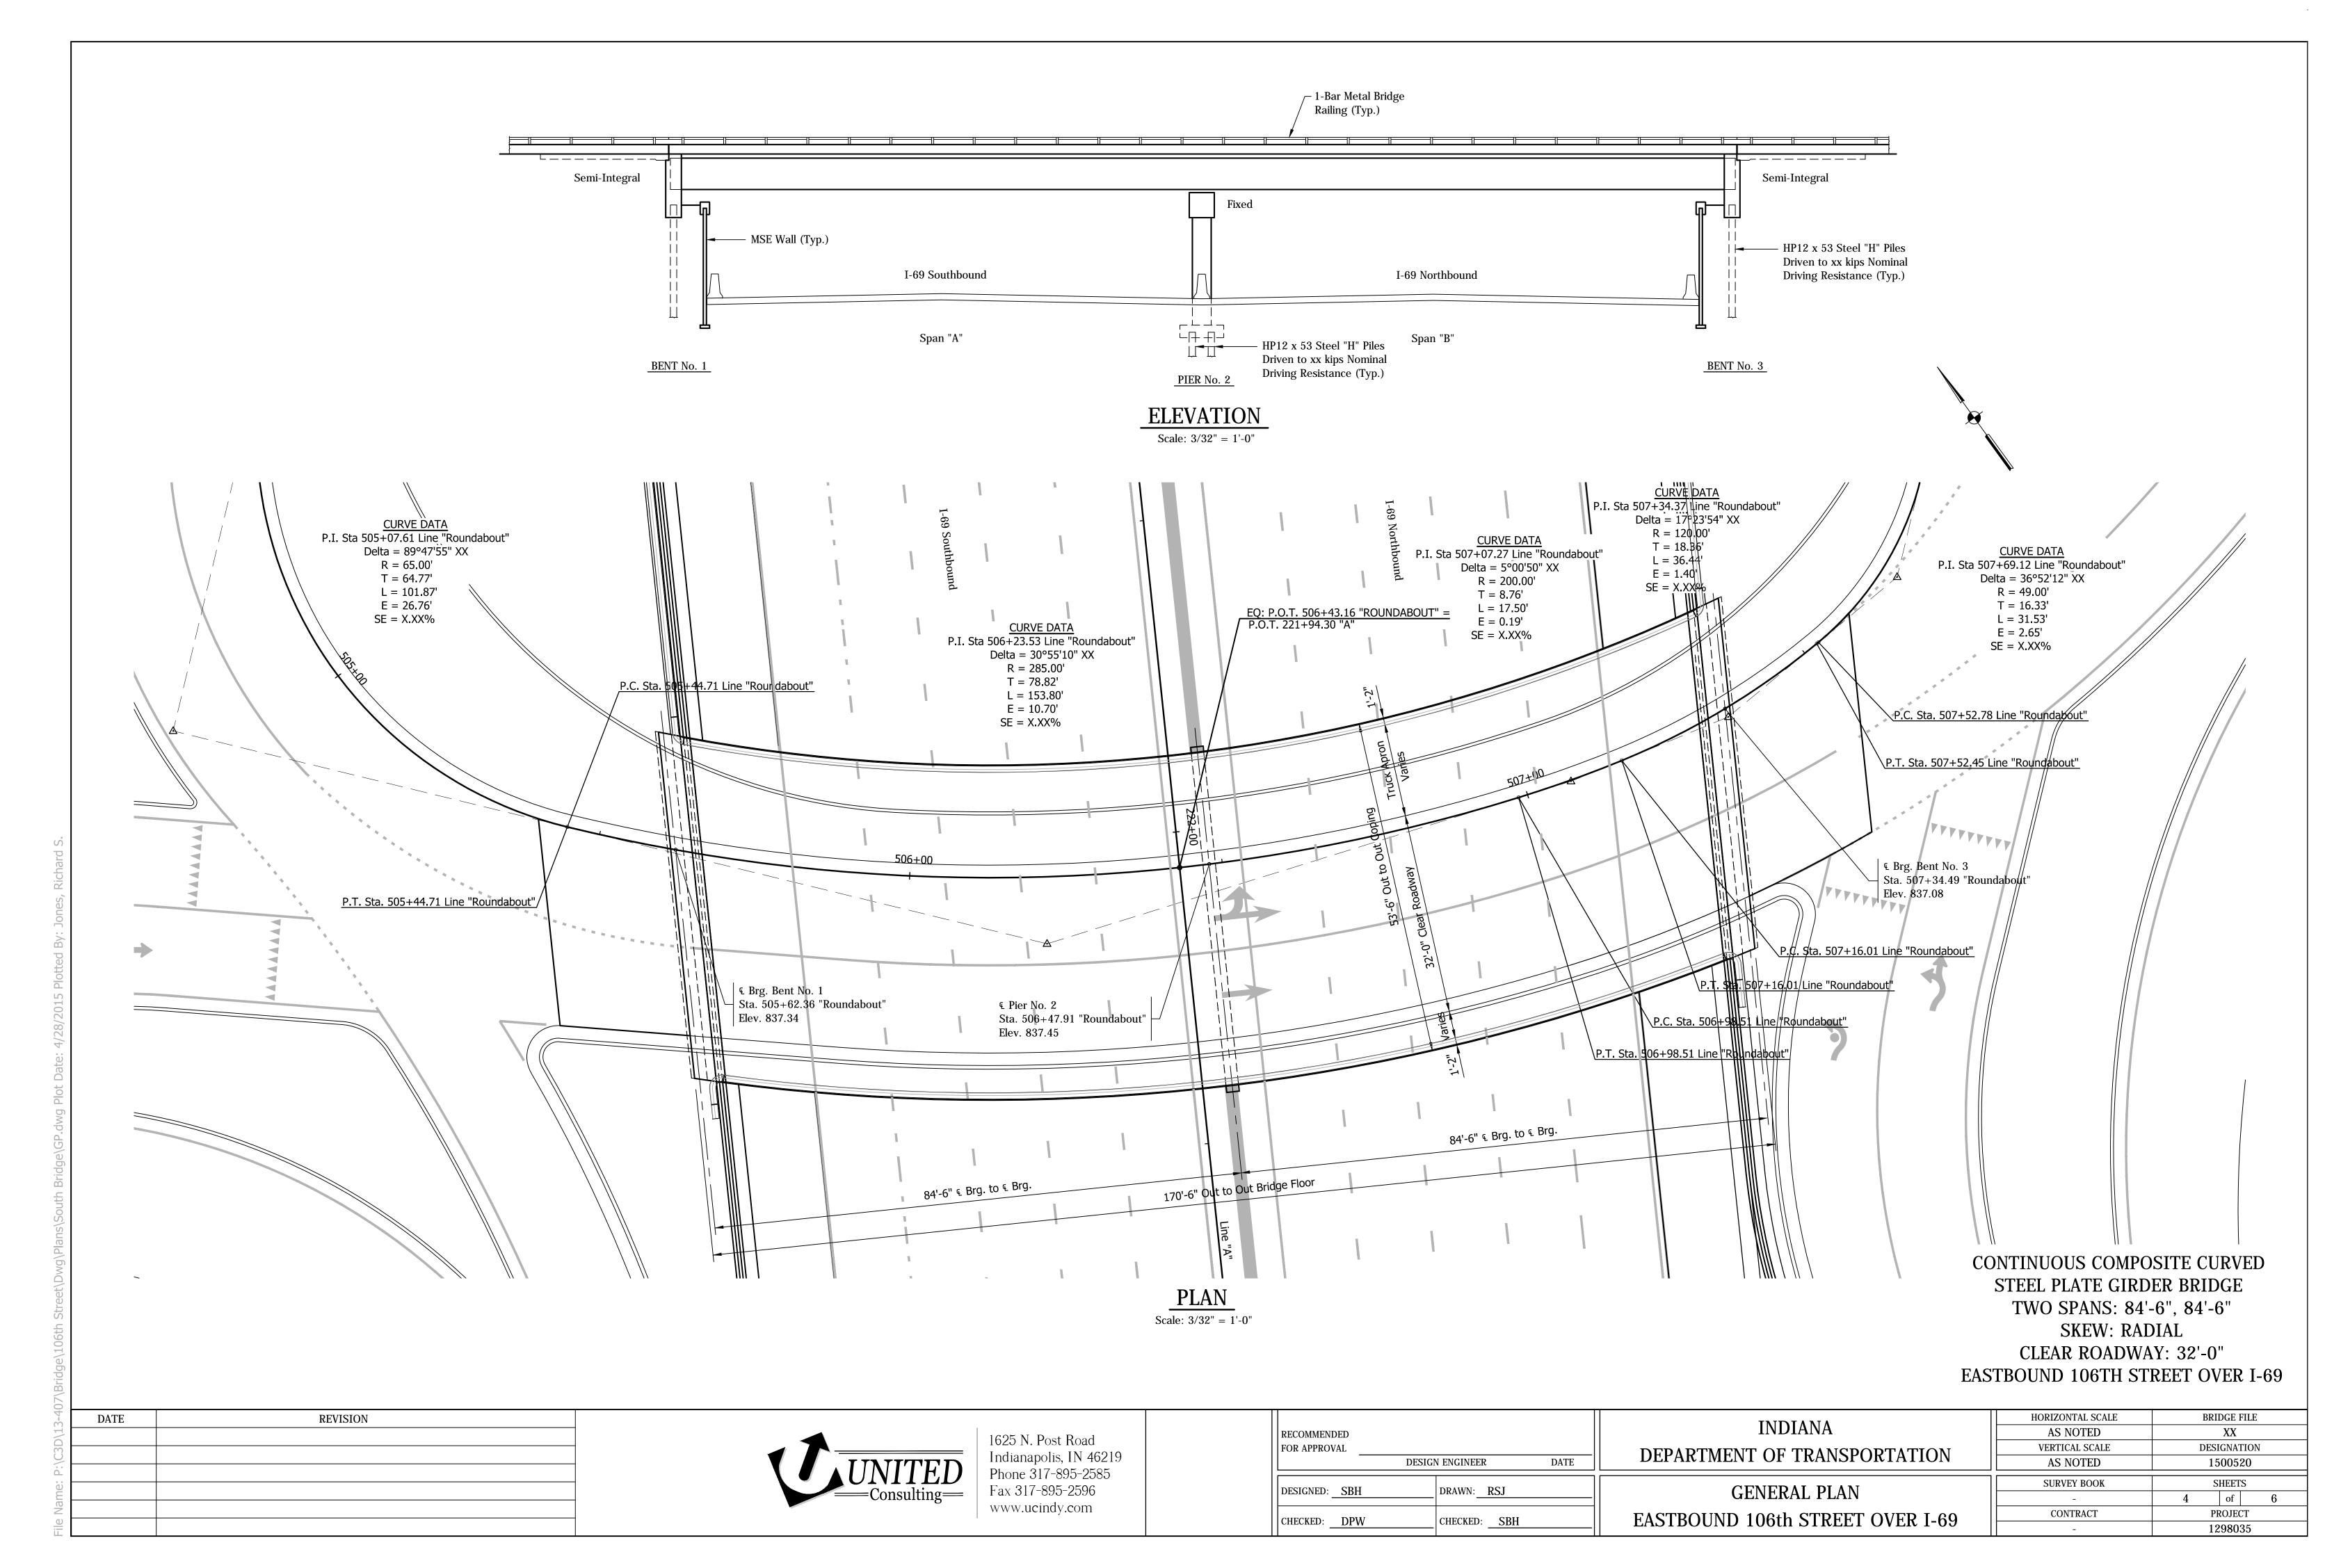
TYPICAL SECTION Scale: 3/8" = 1'-0"

> The exterior girder has been checked for strength, deflection, and overturning using the construction loads shown below. Cantilever overhang brackets were assumed for support of the deck overhang past the edge of the exterior girder. The finishing machine was assumed to be supported 6 in. past the outside of the vertical coping form. The top overhang brackets were assumed to be located 6 in. past the edge of the vertical coping form. The bottom overhang brackets were assumed to be braced against the intersection of the girder bottom flange and web.

Actual loads plus 35 psf allowance for future wearing surfaces and additional 15 psf for permanent metal forms.

Floor slab designed with a 7.5 inch structural depth and a 0.5 in integral wearing surface.

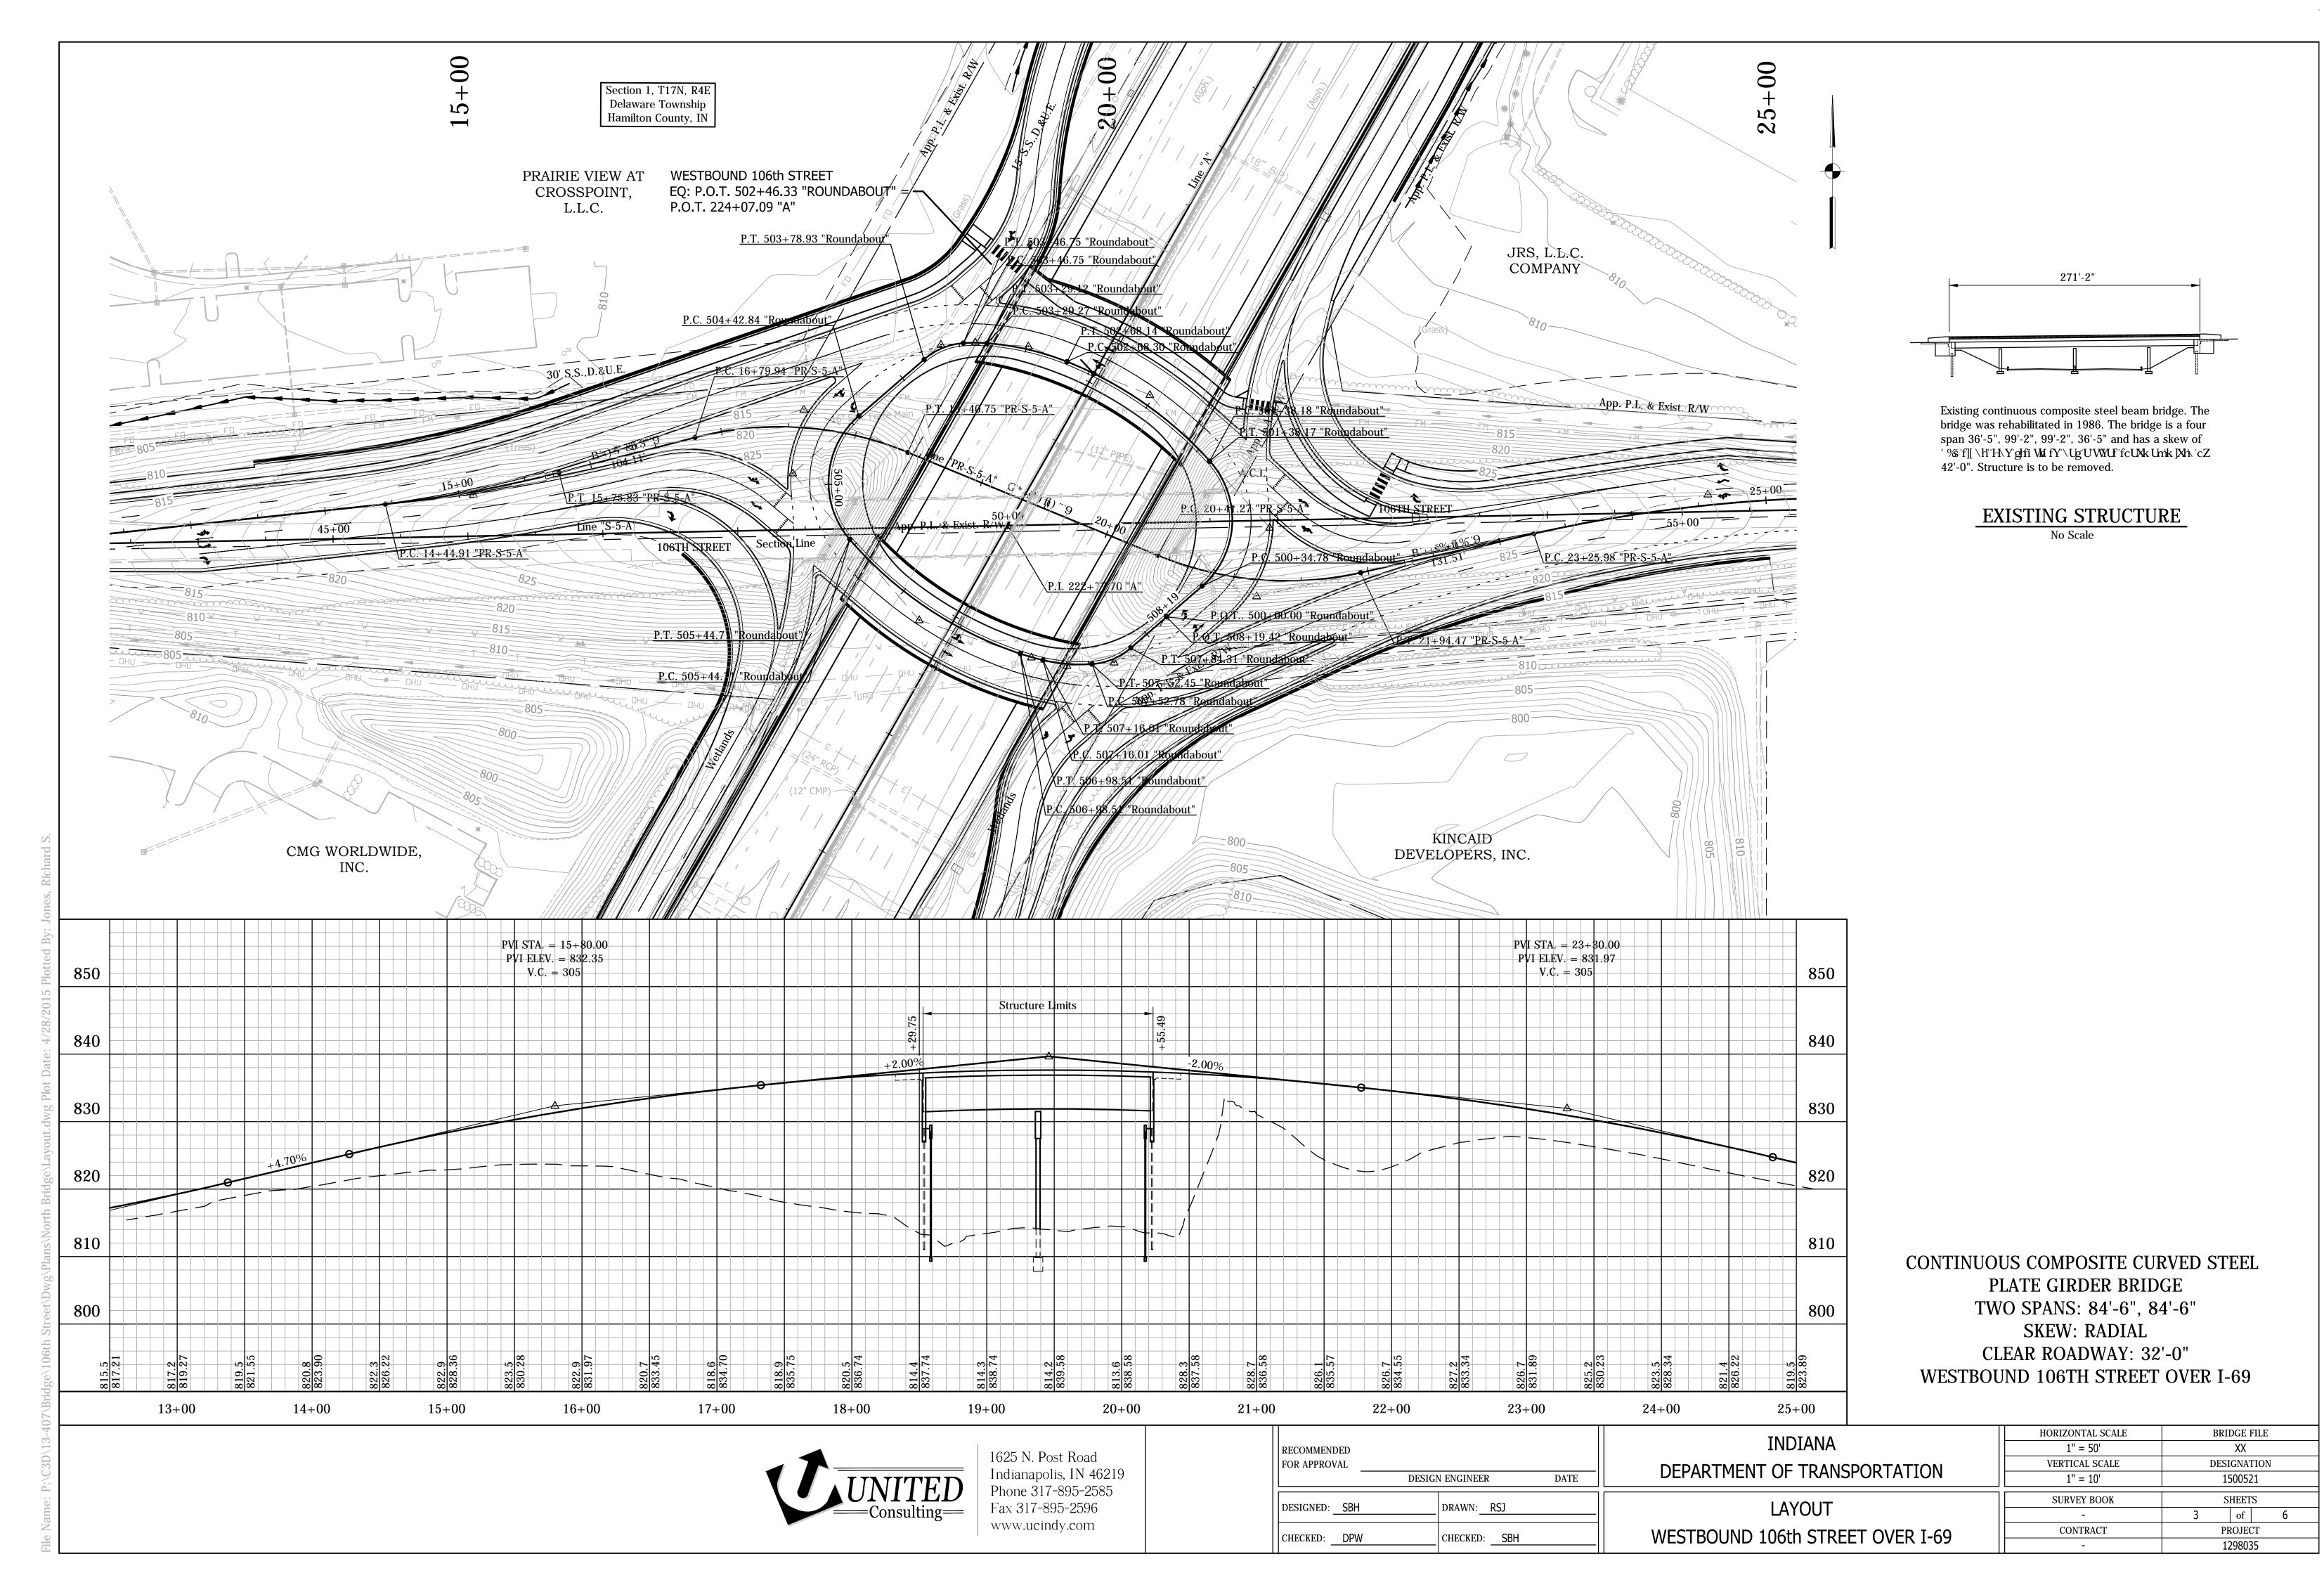
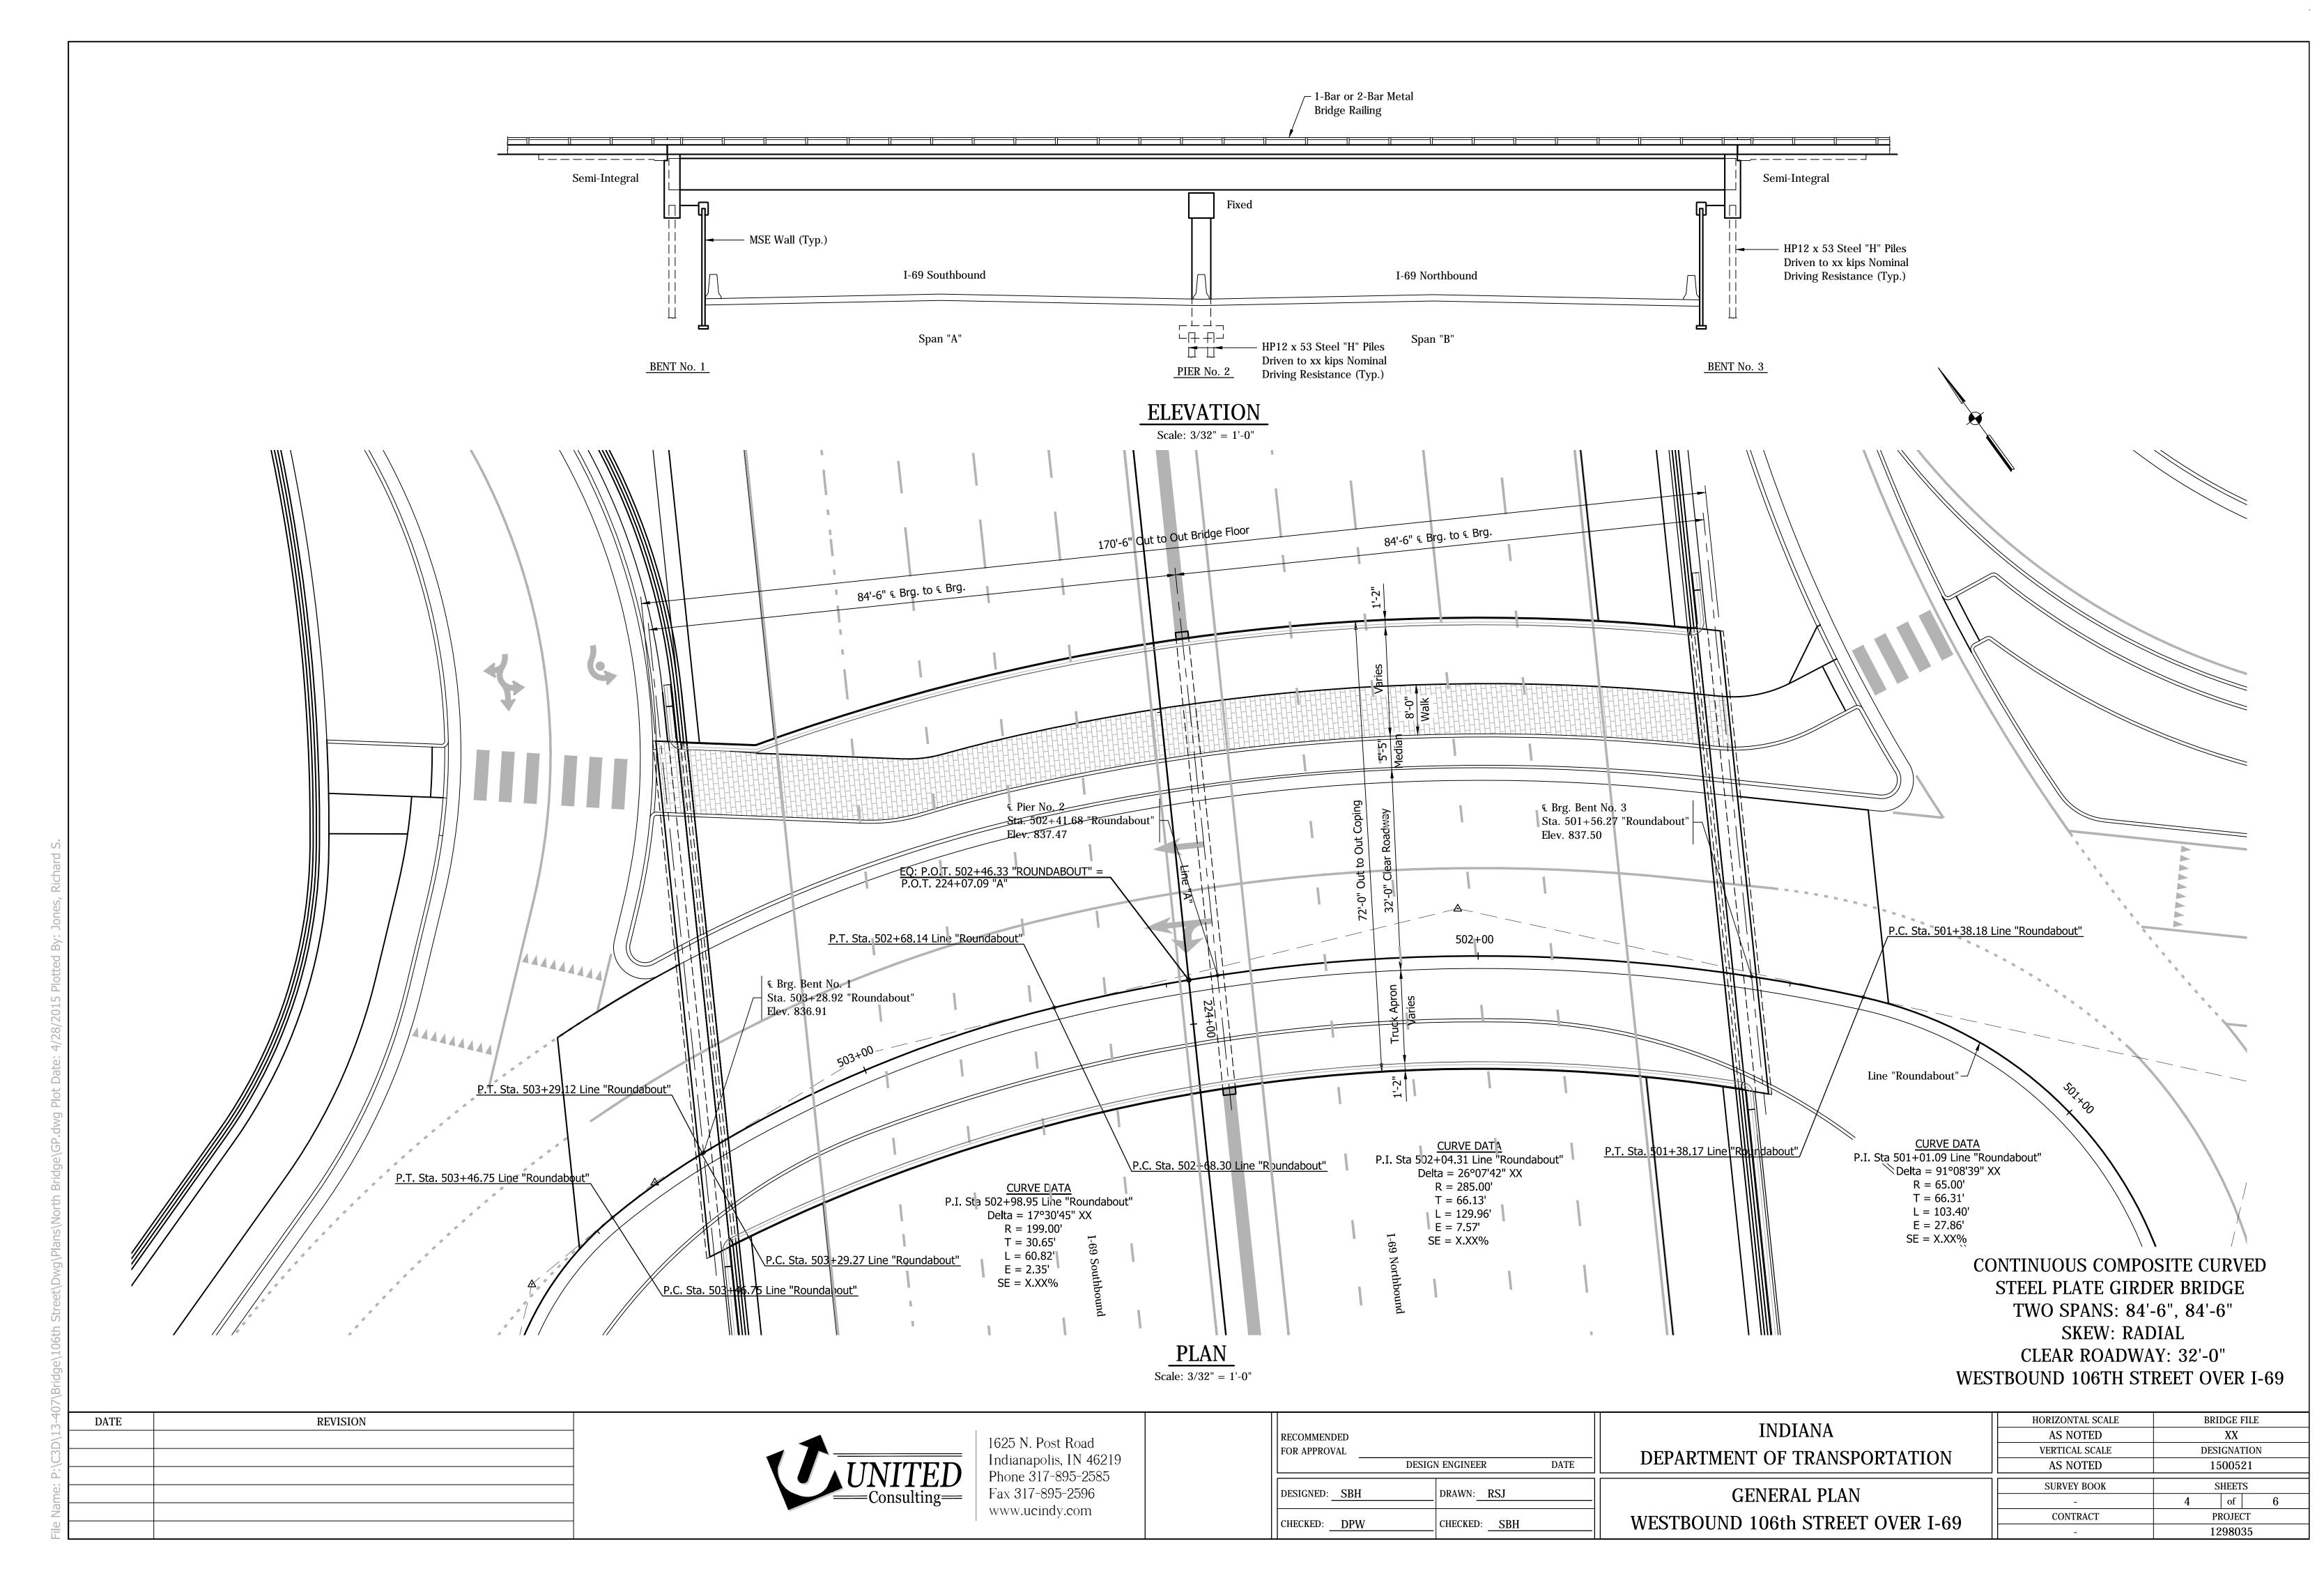
TYPICAL SECTION Scale: 3/8" = 1'-0"

CONSTRUCTION LOADING

Reinforcing steel covering shall be 2 1/2" in top and 1" min. in bottom of floor slabs, and 2" in all other parts, unless noted.

Actual loads plus 35 psf allowance for future wearing surfaces and additional 15 psf for permanent metal forms.

Floor slab designed with a 7.5 inch structural depth and a 0.5 in integral wearing surface.

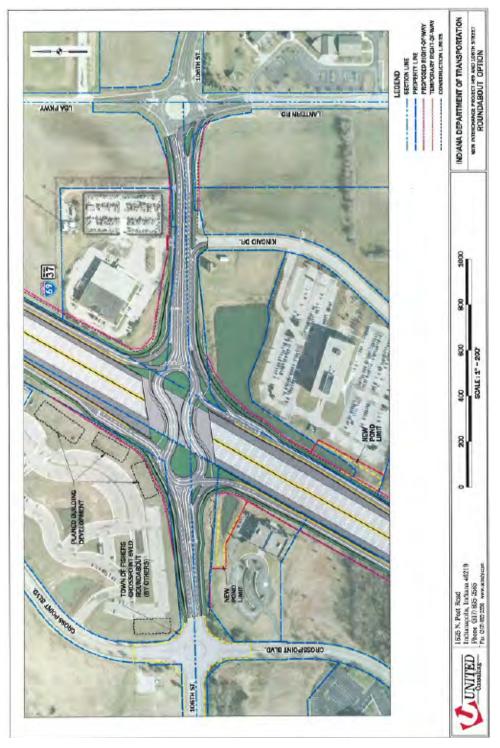
Project plans with roundabout interchange option at Kincaid Dr and E 106th St Image courtesy of United Consulting

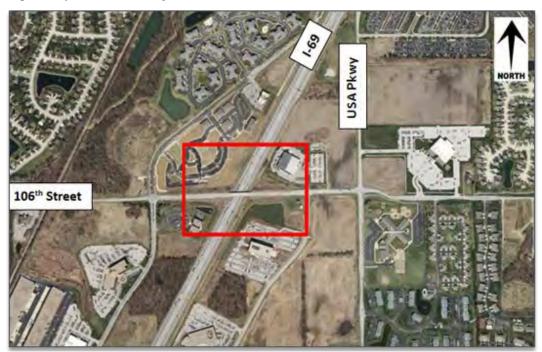
Figure 1-2 | Aerial View of Project Area

Figure 1-2 provides an aerial view of the immediate project at 106th Street and I-69.

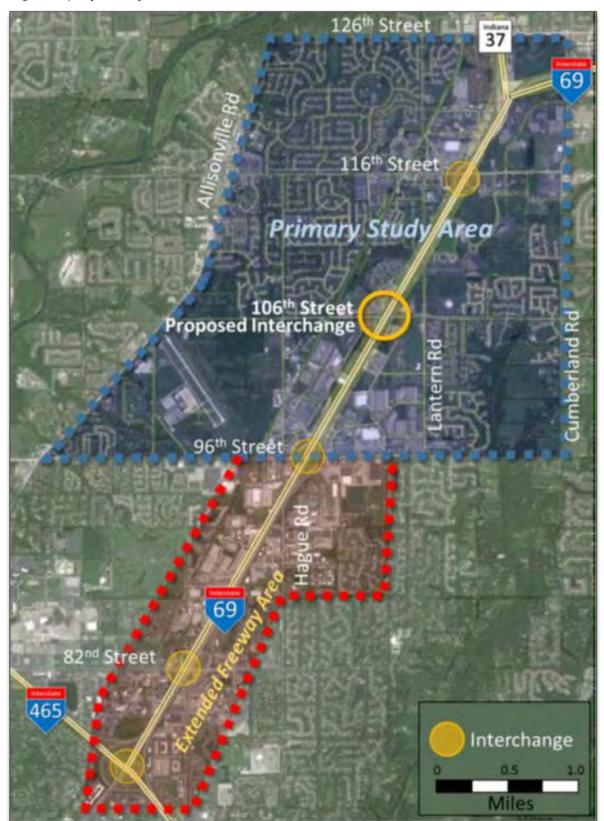
Figure 1-4 | Project Study Area

The study area for the project was agreed upon during a November 7, 2013 coordination meeting between INDOT and FHWA (Figure 1-4). The study area in the immediate vicinity of the proposed 106th Street interchange is bounded by 96th Street to the south, Allisonville Road to the west, 126th Street to the north, and Cumberland Road to the east. This provides adequate coverage to perform detailed capacity analysis for 1) the 106th Street interchange, 2) one interchange to each side of 106th Street (96th Street and 116th Street), and 3) one adjacent signalized intersection or roundabout to each side of the three previously mentioned interchange locations.

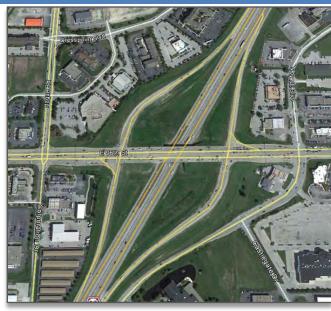
96th Street Interchange

- Located south of the proposed 106th Street interchange
- Standard diamond interchange
- Fully developed
- High traffic volumes particularly in PM peak

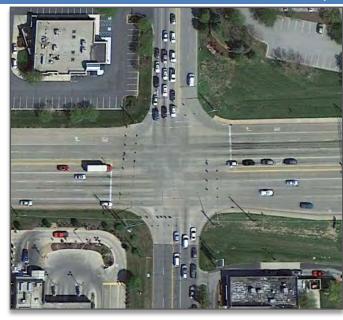
96th Street & Corporation Drive

- Located West of the I-69 96th St. Interchange.
- 3 Thru lanes East and West, with 1 left and one right turn each.
- 2 Thru lanes north and south, 1 left turn and 1 right turn each.

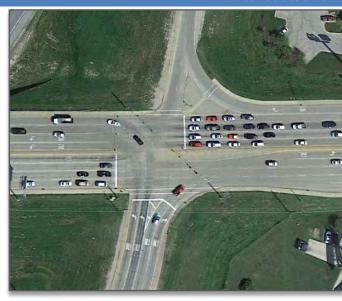
96th Street & I-69 NB Ramp

- Located on the East side of the interchange
- NB off ramp has 2 left and 2 right turn lanes
- NB on ramp has 2 lanes that merge into 1
- EB has 3 thru lanes, 1 left turn lane
- West bound has 2 thru and 2 left lanes

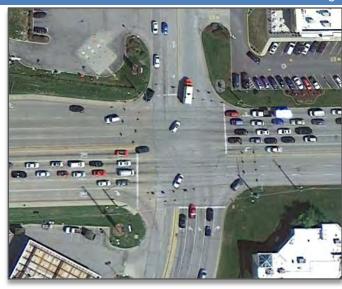
96th St & Hague Rd

- Located on the East side of the interchange
- EB has 1 left, 3 thru and 1 right turn lane
- WB has 1 left, 3 thru and 1 thru/right turn lane
- NB has 3 left, 1 thru and 1 right turn lane
- SB has 1 right, 1 thru and 1 left turn lane

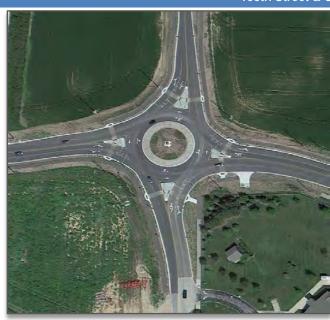
106th Street & USA Pkwy

- Located east of I-69
- Recently constructed two-lane roundabout
- Two-lanes entering and exiting
- Transitions to one-lane each direction beyond roundabout

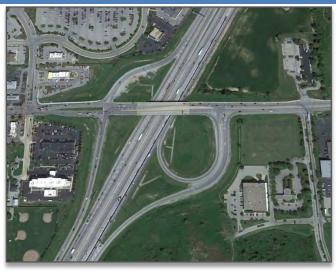
116th Street Interchange

- Located north of the proposed 106th Street interchange
- Jug handle interchange
- Originally built in a rural area now suburban
- Built up to the west
- High traffic volumes particularly in PM peak

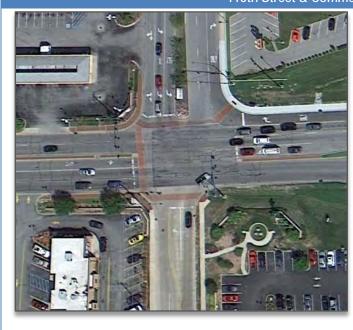
116th Street & Commercial Drive

- Located on the West side of the interchange
- EB has 1 left and 2 thru lanes
- WB has 1 left, 2 thru and 1 right turn lane
- NB has 1 left and 1 shared thru / right turn lane
- SB has 2 left and 1 shared thru / right turn

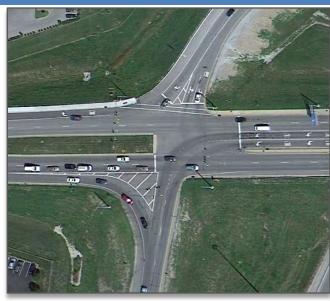
116th Street & SB Ramp

- Located on the West side of the interchange
- SB off ramp has 1 left,1 left/thru, and 1 right turn lane
- SB on ramp has 2 lanes that merge into 1
- EB has 2 thru lanes and 1 right turn lane
- WB has 2 thru and 2 left lanes
- Sidewalk along north side

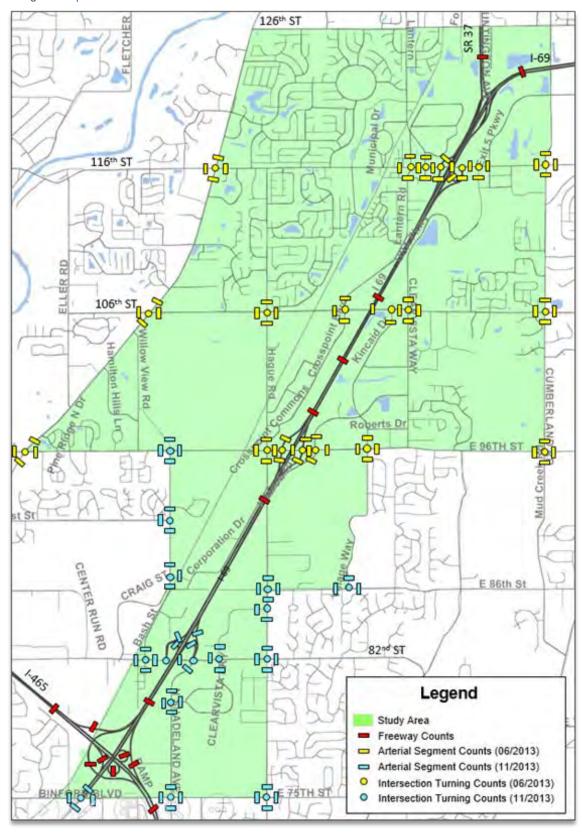
Figure 2-2 | Traffic Count Location

The travel demand model is a tool for determining the project's traffic data and was calibrated to the real world to make sure that the results are realistic. Traffic turning movement counts were taken at various intersections throughout the study area as shown in Figure 2-2. These counts were used to calibrate the model. Speed data associated with these counts were used as a secondary measure of effectiveness in the calibration effort. Traffic data and associated speed data for mainline freeway segments were provided by the INDOT Traffic Management Center (TMC). Metrics for how well the model performs are included in the IJ Study (Appendix G).

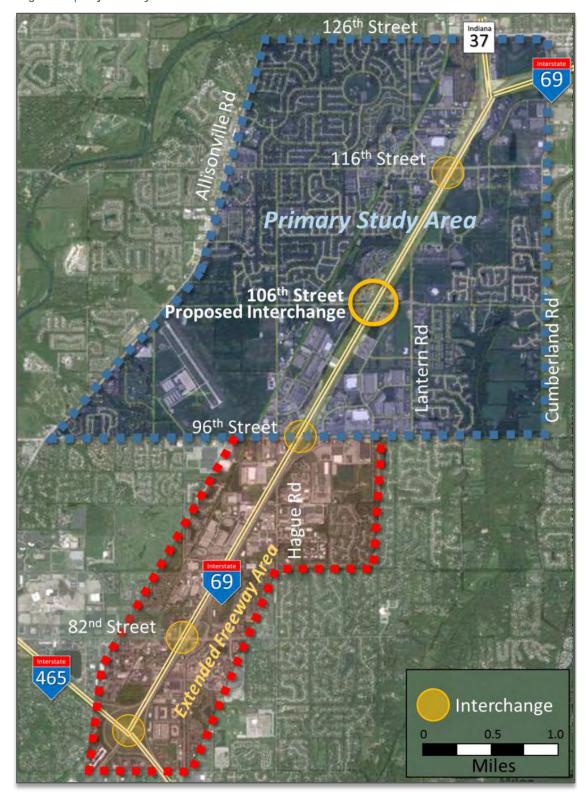
Figure 4-1 | Project Study Area

The information summarized in Table 4-6 was generated from the microsimulation for the entire study area bordered by I-465, Allisonville Road, 126th Street, and Cumberland Road (Figure 4-1). Methodology for this analysis is contained in the previously provided Frame Work Document. The analysis illustrates that the construction of a new interchange at 106th Street will reduce the overall vehicle hours travelled and overall delay experienced within the study area for years 2015, 2020, and 2035.

The IJ Study is required to analyze base year (2015) and future years (2020 & 2035), pre- and post-construction traffic operations for all of the interchange alternatives being considered. The IJ Study requires analysis of the entire study area (Figure 4-1), with a primary focus on one existing interchange upstream and downstream (96th Street and 116th Street), as well as analysis of one signalized intersection and/or roundabout to the east and west of each of the three interchange locations at 96th Street, 106th Street, and 116th Street. The pre- and post-construction operations of the adjacent interchanges and adjacent signalized intersections and/or roundabouts to the east and west perform in similar fashion, regardless of the interchange type selected for the 106th Street interchange.
