NEW I-69 INTERCHANGE AT 106TH STREET

Federal Highway Administration and Indiana Department of Transportation

ENVIRONMENTAL ASSESSMENT

Des. No. 1298035

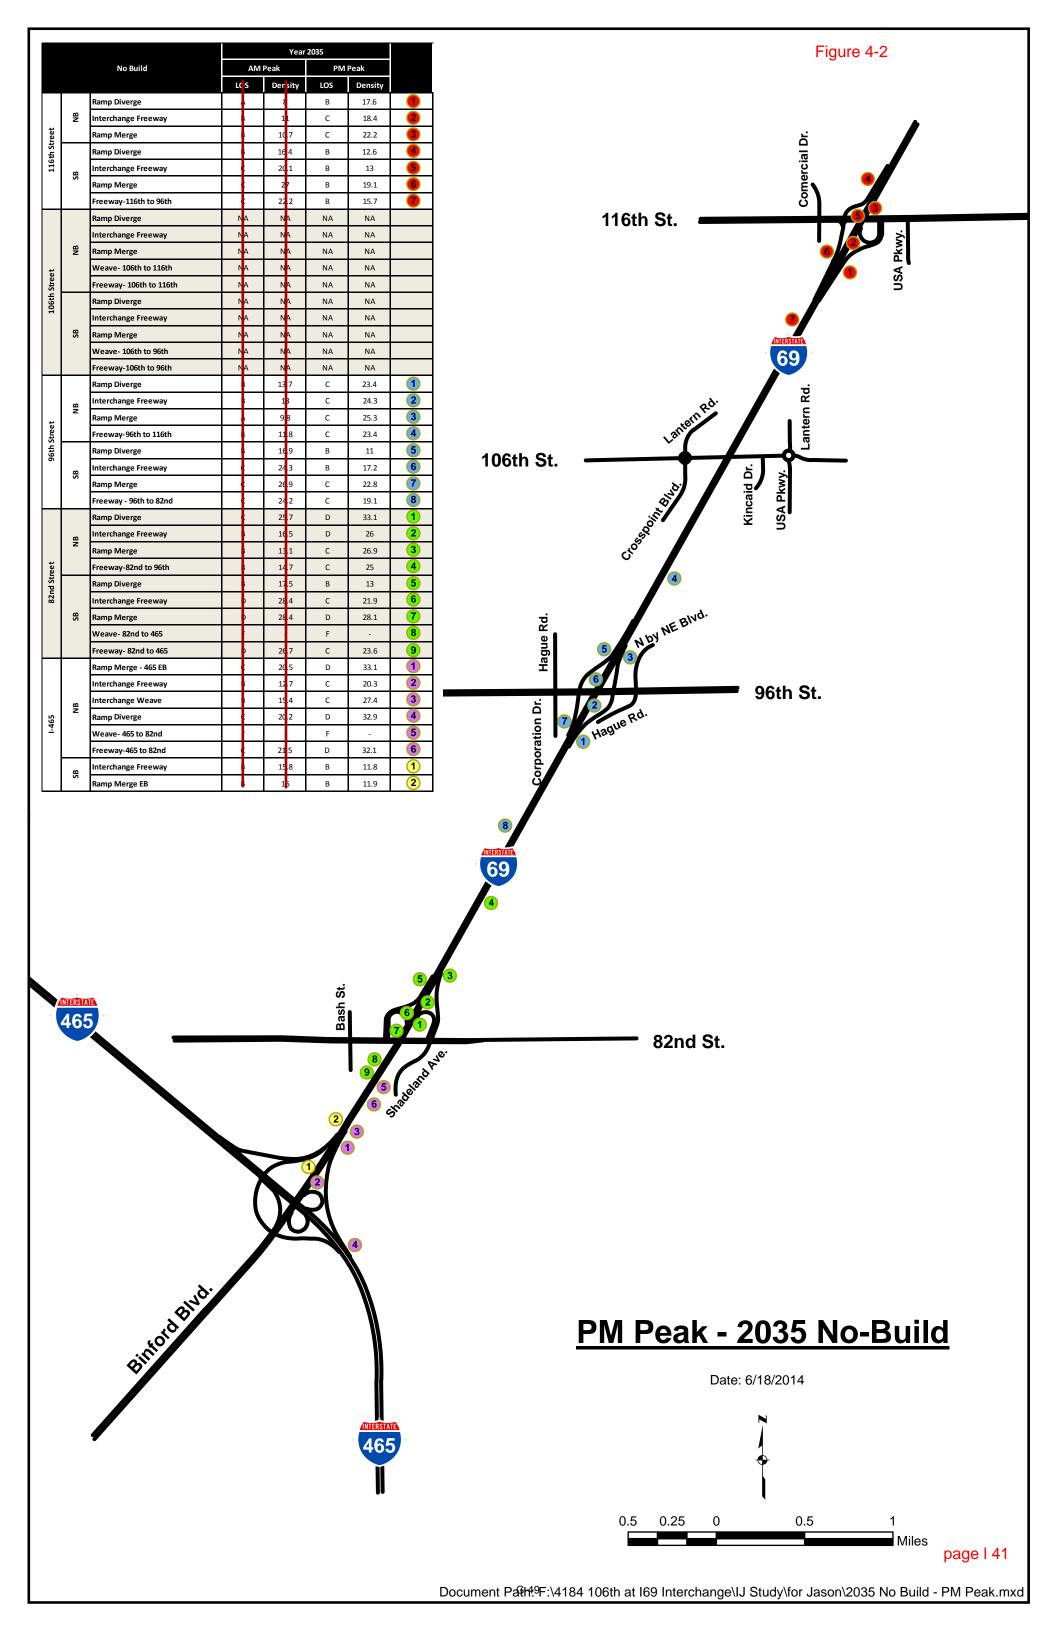
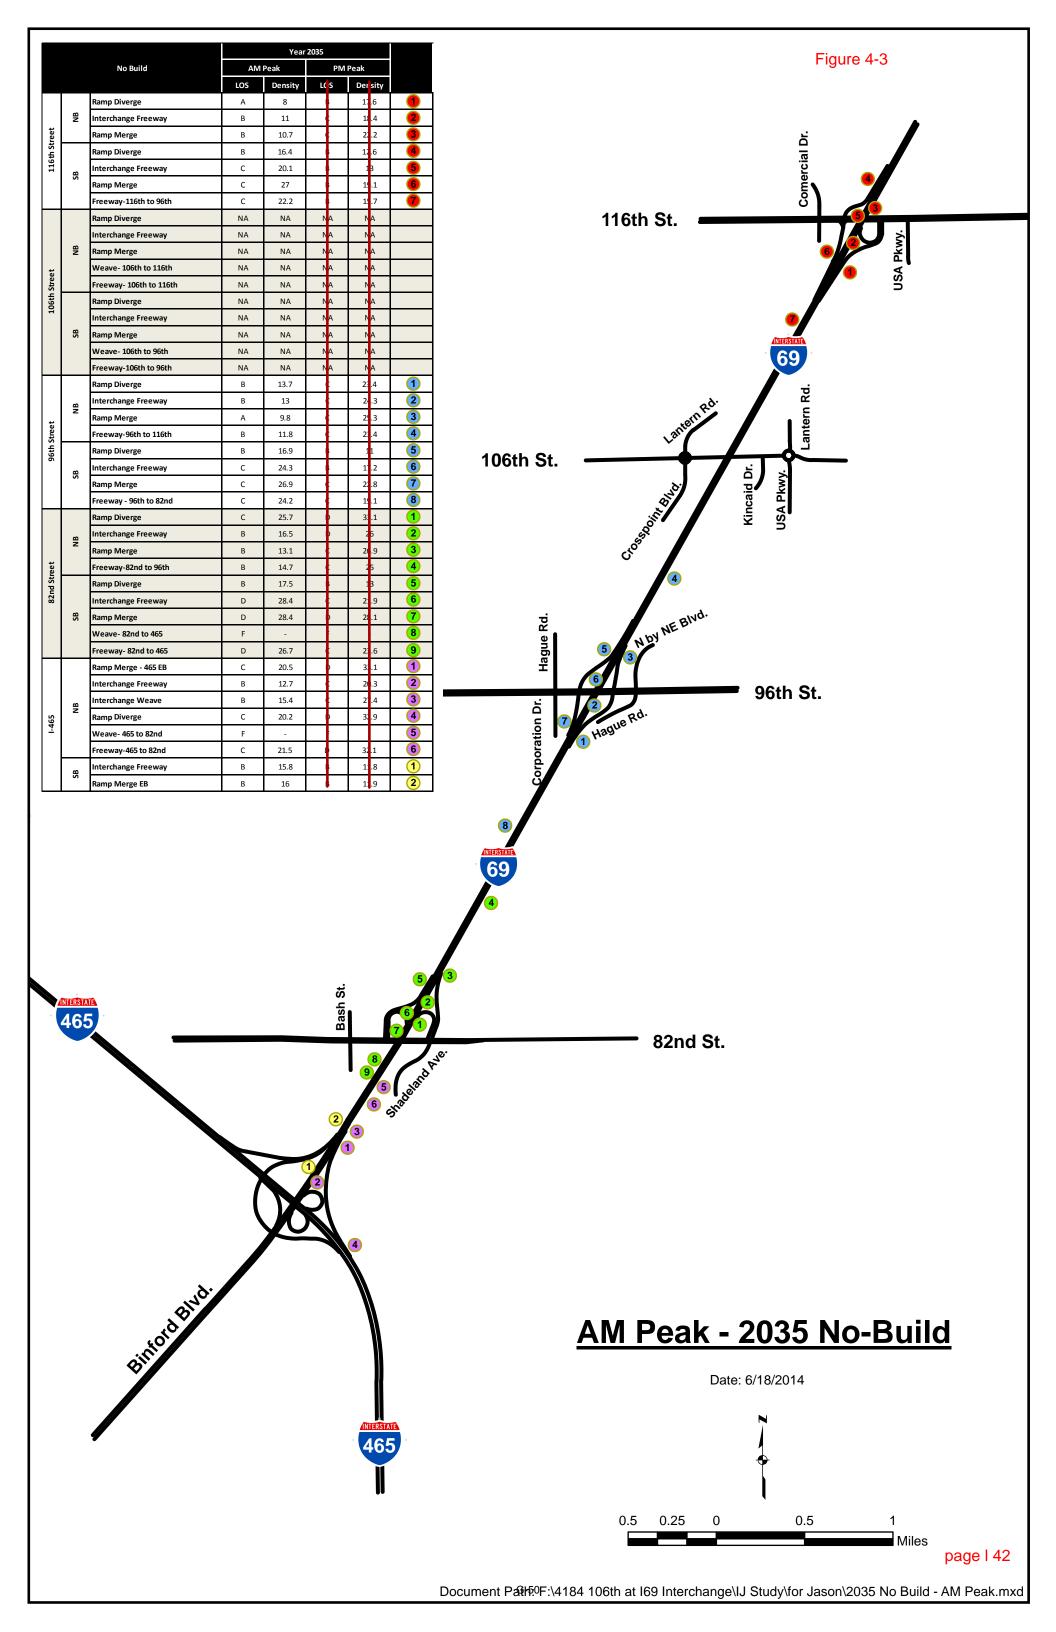
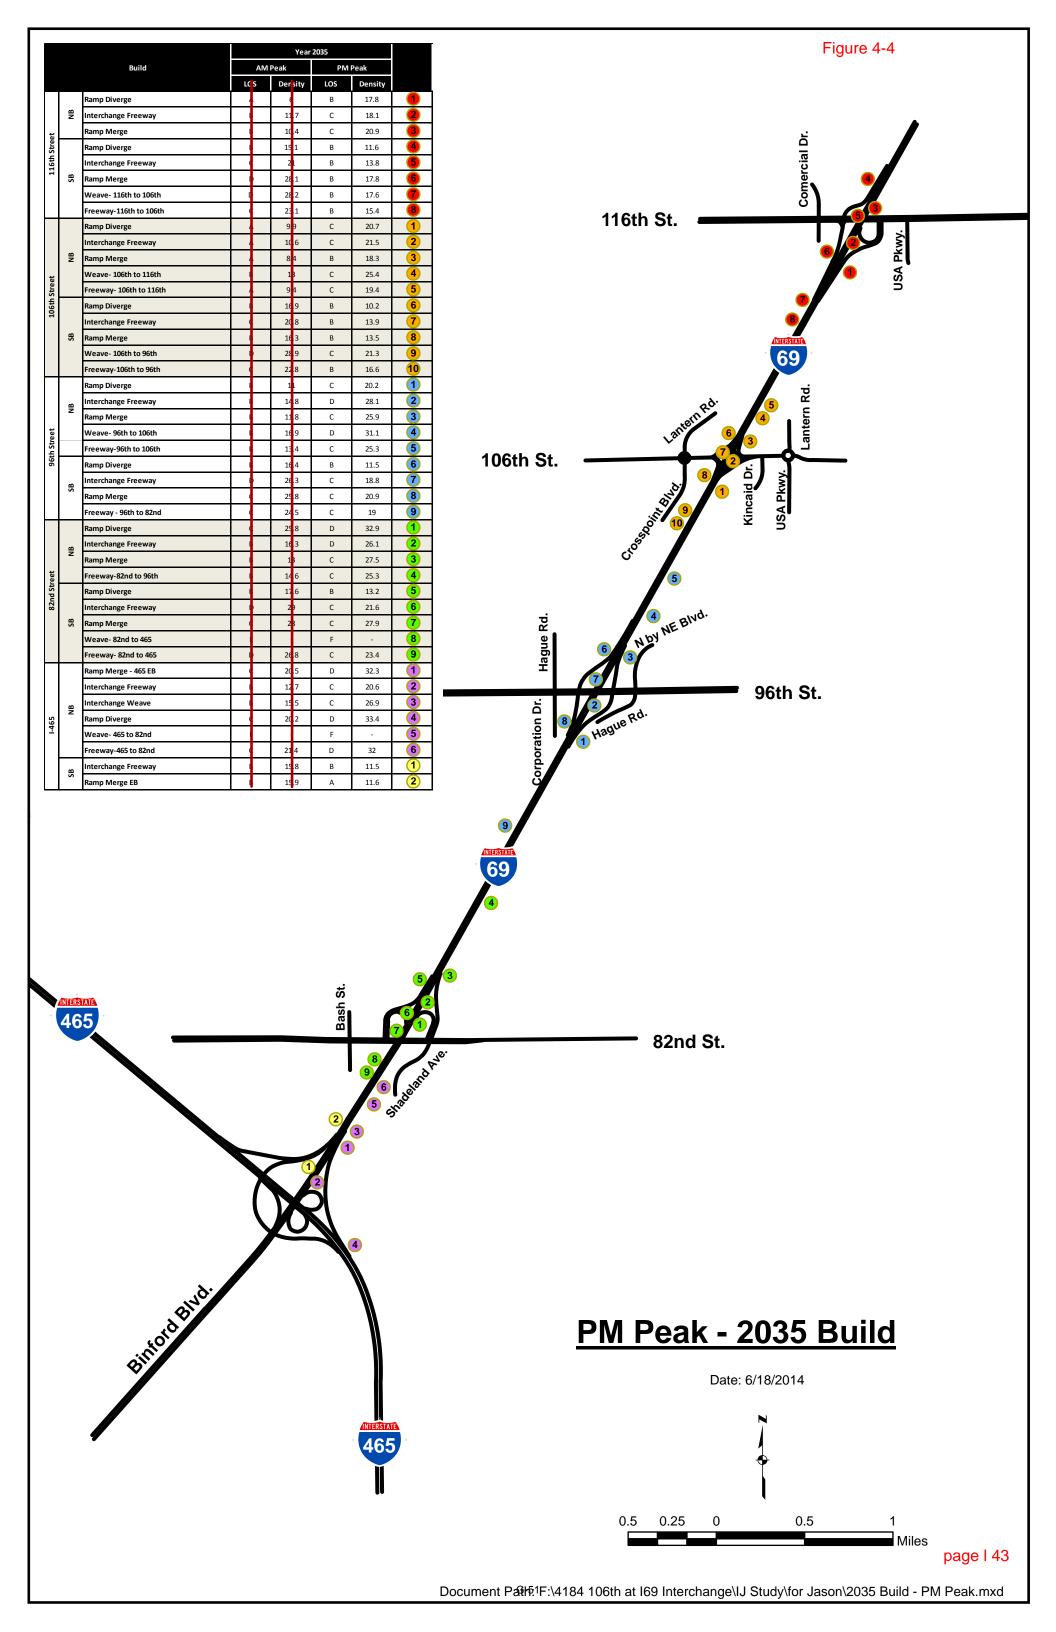
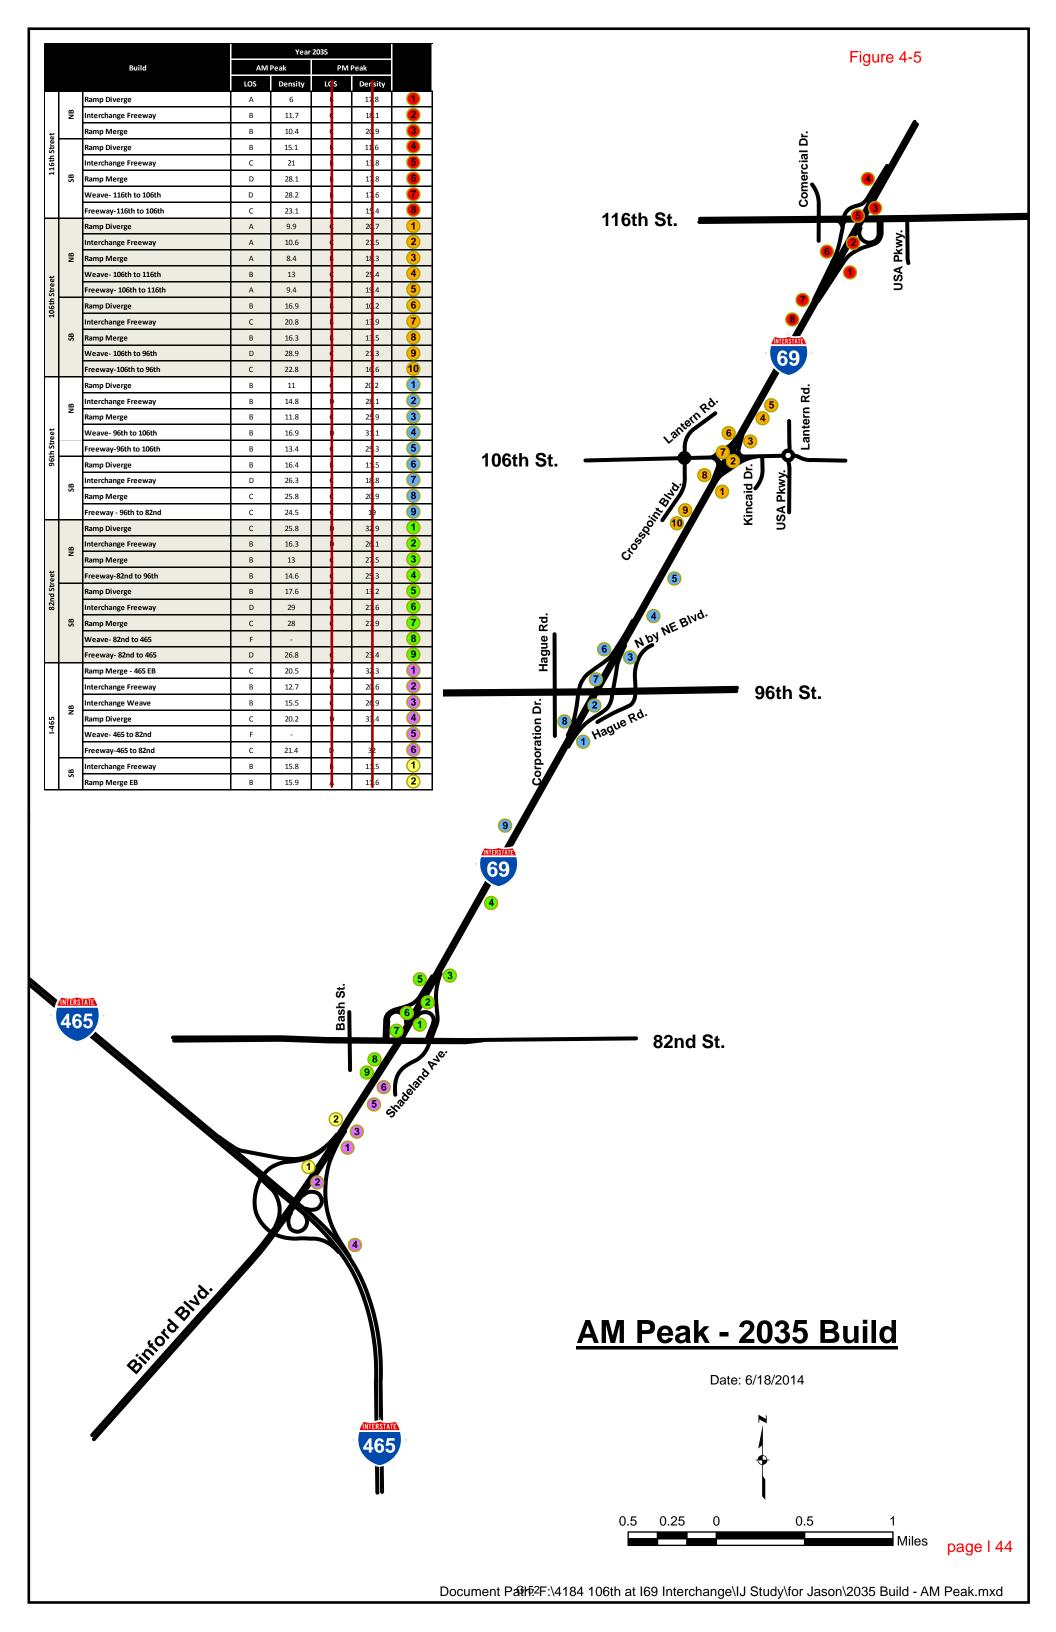
Figure 4-2, 3, 4, & 5 displays these results graphically.

The 106th Street interchange Build alternative will have a significant, positive impact on the traffic operations of the 96th Street and 116th Street interchanges and corridors. It will result in a better LOS classification for many of the intersections, and a reduction in delay for all intersections, most drastically along 116th Street. The 96th Street and 116th Street corridors currently experience operational challenges, which are only expected to get worse with time, due to anticipate traffic growth. The 106th Street Build alternative helps to alleviate some of these operational issues at the adjacent interchanges.

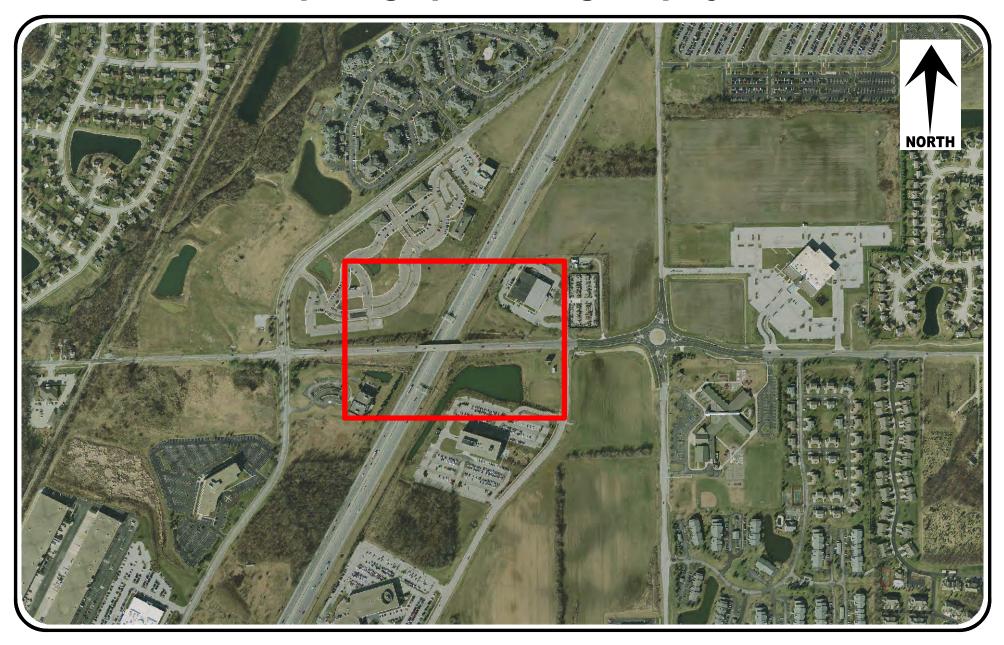
Aerial Photo, Project Location, and Water Resources

A 2012 aerial photograph showing the project location.

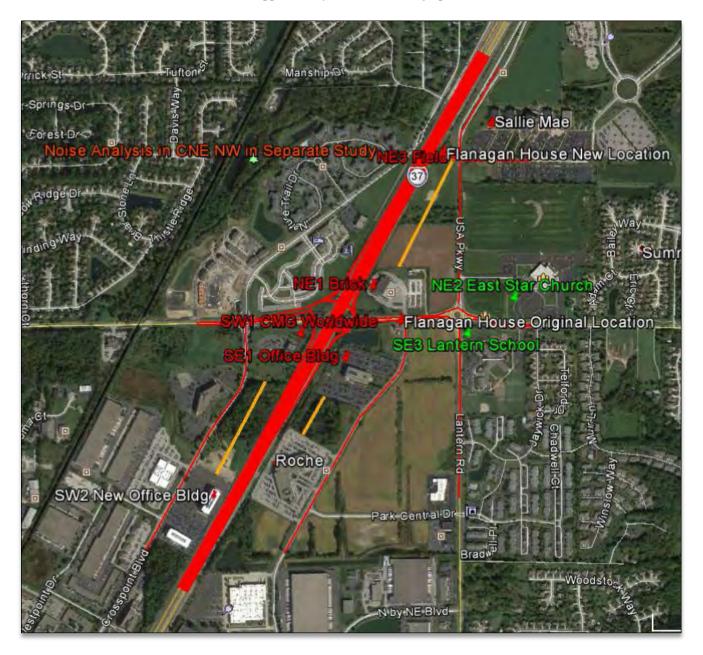
Figure 1
Project and Receivers - I-69 at 106th Street

This Noise Study Report accompanies an Environmental Assessment for the new interchange of 106th Street in Fishers, Hamilton County with I-69 (Des. No. 1298035) (**Figure 1**). The purpose of this project is to add an exit in Fishers, Ind., to improve access there, while relieving traffic demand on the interchanges to the south and north. The northwest quadrant of the proposed interchange has been analyzed separately in the *Draft I-69 Expansion Design Projects Traffic Noise Impact Analysis* (October 2014, Des. #s 1383332, 1383336).

Build Alternative – This alternative adds an interchange at 106th street with a large roundabout over I-69, to which the I-69 ramps connect (**Figure 2**). All locations within 500 feet of the project were represented in TNM2.5 (**Figure 1**). Output indicates the project would result in noise levels ranging from 60 to 77 dBA, with noise abatement criteria exceeded at the Roche office building at the south project limit on the

Noise measurements were made in conformance with FHWA's guidance at six locations (**Figure 1**, **Appendix B**, and **Table 2**) on October 23, 2013. As noted on the Noise Data Sheets in Appendix B, a Rion NL-31 sound level meter was used with an exchange rate of 3, set on slow response, and A-weighting. A Norsonic Noise Calibrator 1251 emitting 114 dBA was used to calibrate the meter before and after the measurements (calibration certificates follow the Noise Data Sheets). The setup height was five feet on a tripod with the tripod set away from reflective surfaces. All measurements and traffic counts were 15 minutes in duration. Leq(1h) and Lmax were recorded at each site.

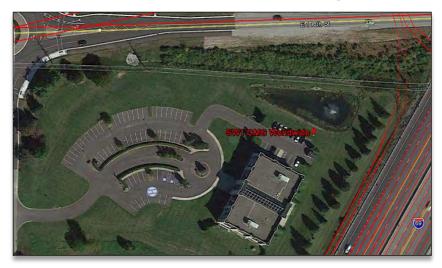
Figure 3
SW1 at CMG Worldwide Office Building

SW1 CMG Worldwide – This office building appeared largely vacant at the time of the noise measurement. The measurement was taken in the northeast corner of the parking lot of the building at a point close to I-69 where there could be outside activity (**Figure 3**). A fountain with a spray that reached more than 20 feet high operates continuously in the detention area between the parking lot and 106th Street. It causes a low level of background gray noise. A planted berm along the property border with I-69 affords some mitigation of noise from I-69, as does the berm supporting 106th Street, such that the recorded noise level was only 67 dBA.

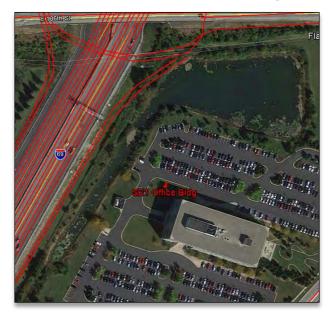
Figure 4
SE1 at CMG Worldwide Office Building

SE1 Office Building – The measurement at this site was in a grassy area at the rear of the building where there is an entrance from the parking area (**Figure 4**). There is water detention between the building and I-69 that wraps around to the north side of the parking lot, between the lot and 106th Street. The noise measurement found the existing noise level to be 67 dBA.

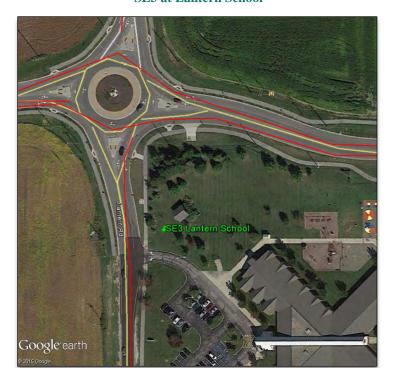
Figure 5 SE3 at Lantern School

SE3 Lantern School - The Lantern Elementary School is one of two sensitive receivers measured. It is on the southeast corner of 106th Street and Lantern Drive, which meet in a roundabout. The measurement site was near a gazebo-type structure that may experience some school use during designated activity. It represented the area of potential activity closest to the east project limit. Improvements to 106th Street extend east to the roundabout shown in Figure 5. The noise measurement at this site was only 59 dBA, well below the established NAC for schools of 67 dBA.

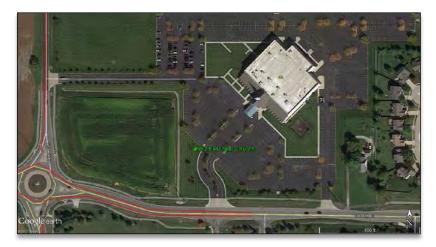
Figure 8
NE3 Field Awaiting Development

NE3 Field This last measurement site is located in an area subject to development (Figure 8). Indeed, during the course of the study, the Flanagan House has been relocated to this site, though it does not yet show on aerial photography. The Sallie Mae office complex is to the east across USA Parkway. levels in this undeveloped area will vary, but the location chosen representative had measurement of 71 dBA.

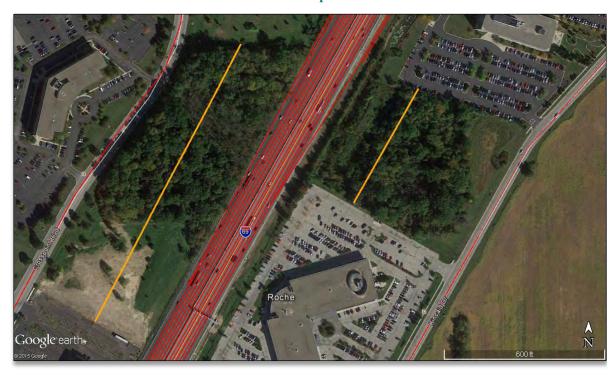
Figure 9
71 dBA Noise Contour in Undeveloped Land South of 106th Street

Noise contours are provided for the undeveloped areas along either side of I-69. The 71 dBA contour line falls at approximately 200 feet from the right-of-way fence at the point at which the new interchange ramps meet the surrounding grade. That is generally the position of undeveloped land both south and north of 106th Street. **Figure 9** shows the area south of 106th Street and **Figure 10** shows the area to the north.
