Monitoring Results for State Forest Properties • 1996-2023

Indiana Forestry Best Management Practices

By: Jennifer Sobecki & Duane McCoy

Indiana State Forest BMP Report

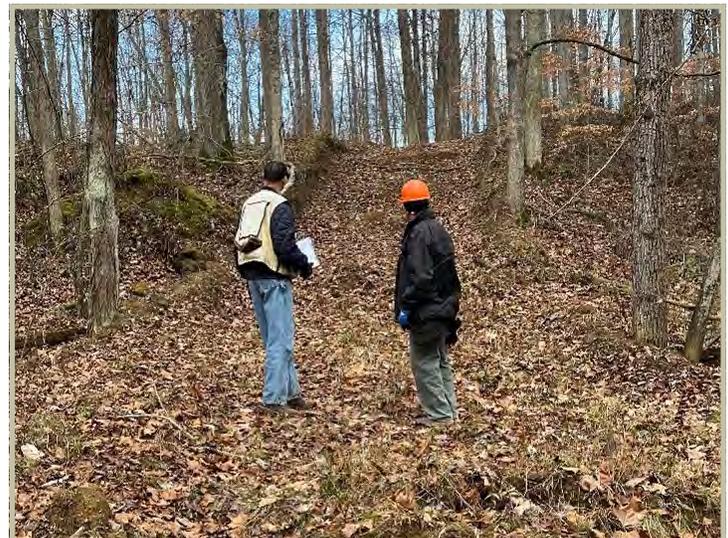
Indiana DNR Forestry BMP teams have at least one calibration training per year to discuss forestry BMP application and effectiveness on a recently harvested site. Photo taken on private property by Jennifer Sobecki, DNR.

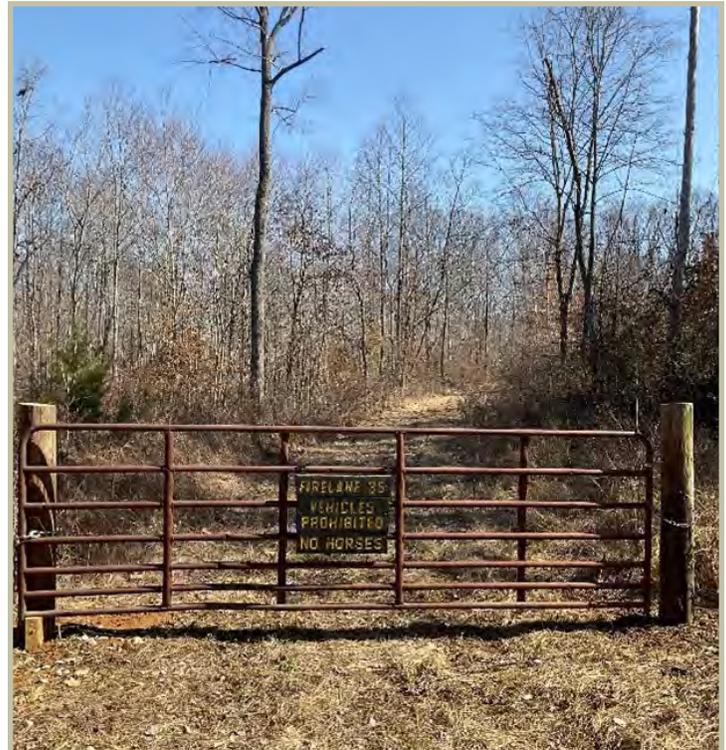
Restricting access to a harvest can be accomplished with a simple cable gate, limiting trespass that could cause significant damage to the soil and water resources on the site. Photo by Duane McCoy, DNR.

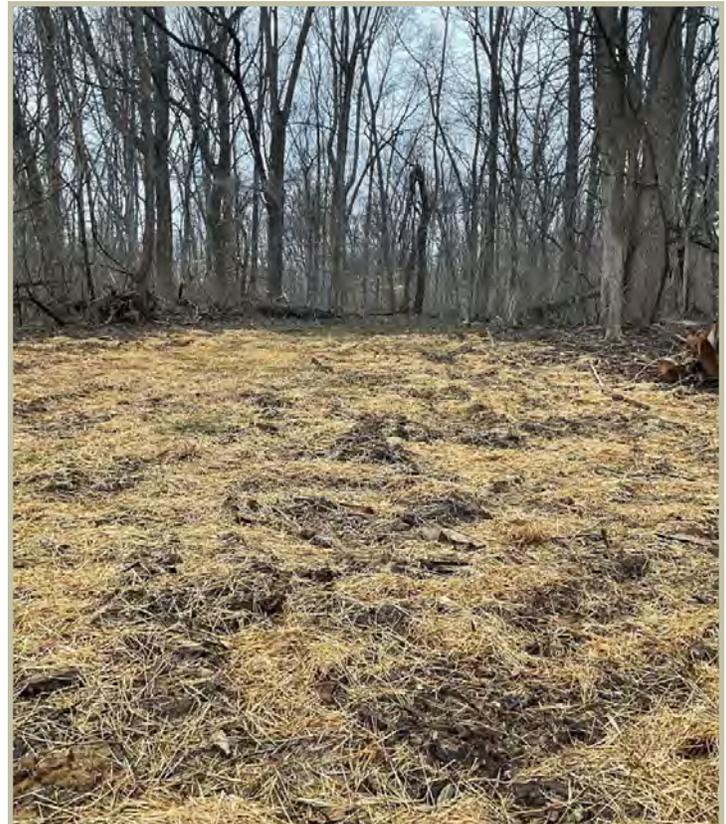
Seeding and strawing a landing after a harvest helps to quickly establish new plant growth while providing protection to the soil surface. This reduces erosion and increases water infiltration. Photo taken in state forest. Photo by Duane McCoy, DNR

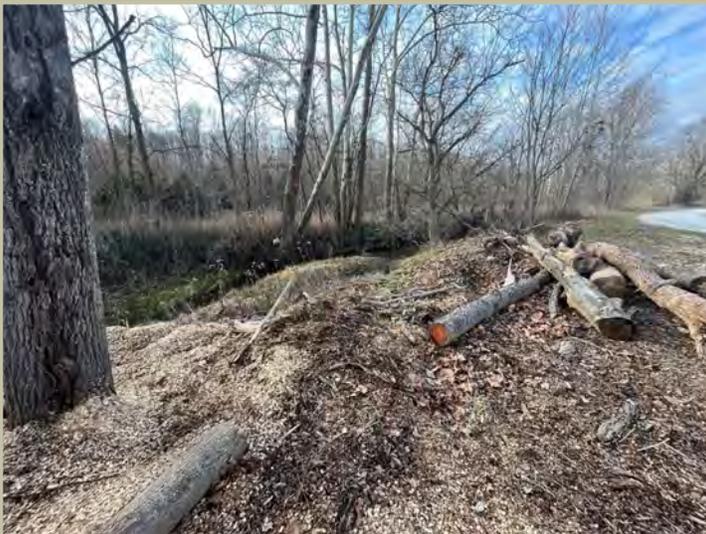
Log landings should generally be avoided near a stream. This landing used debris to filter water before it flowed into the stream so while this site scored low on application, it was still effective at protecting the water resources onsite. Photo taken on private property by Jennifer Sobecki, DNR.

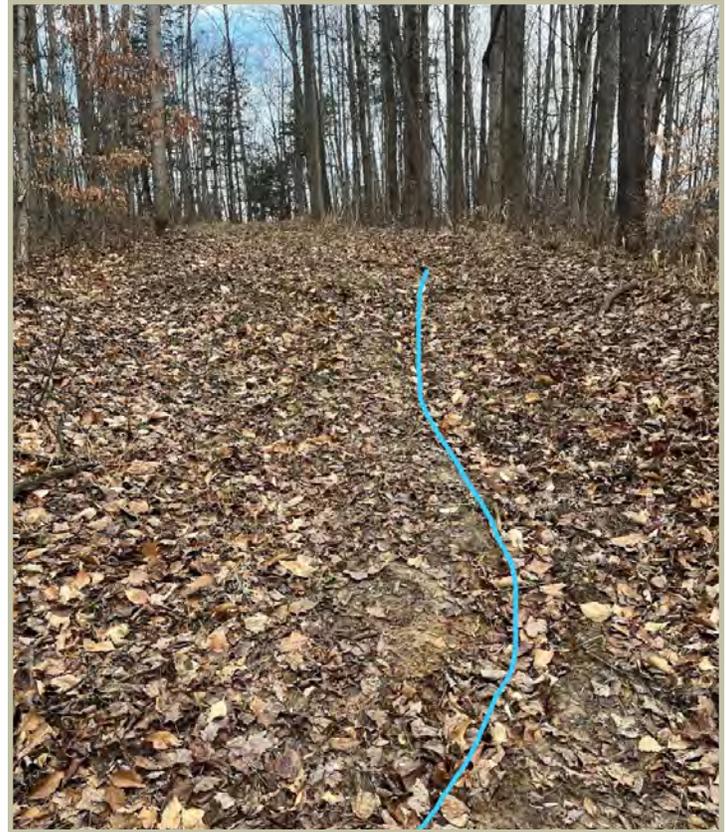
Despite leaf cover and some revegetation, the lack of diversions on this trail are leading to deepening gully erosion. Photo taken on private property by Duane McCoy, DNR.

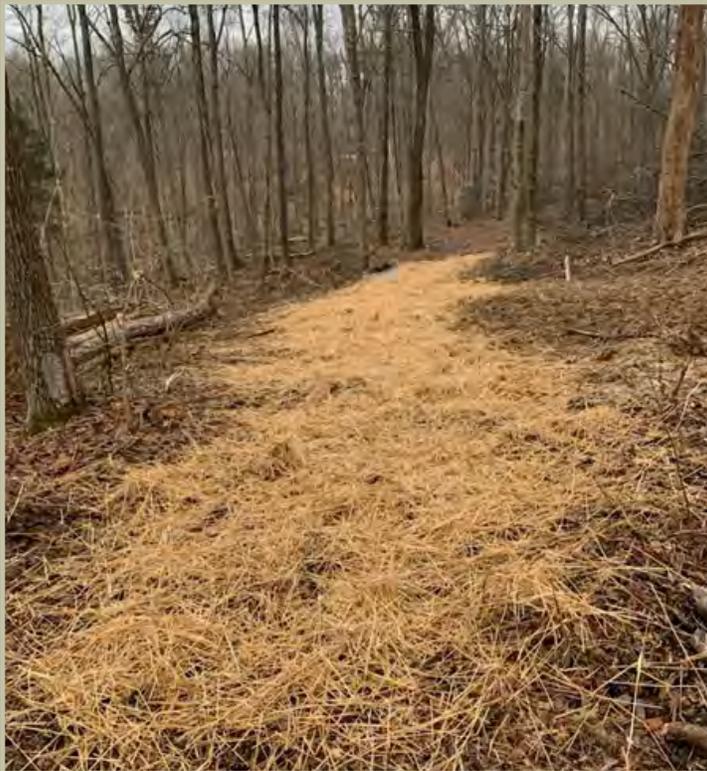
This skid trail was mulched with straw after a harvest on state forest land. Photo by Duane McCoy, DNR

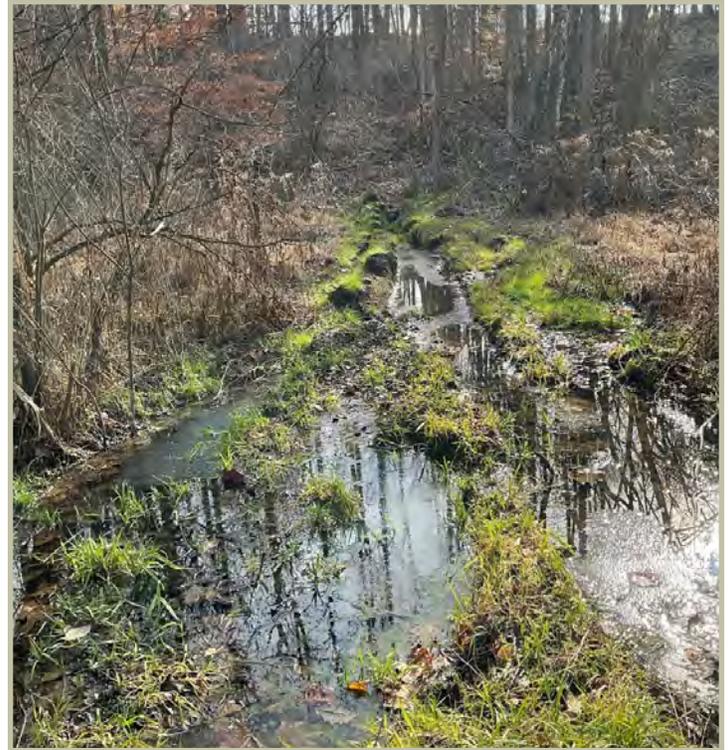
Skid did not avoid this poorly drained area. Photo taken on private property by Duane McCoy, DNR.

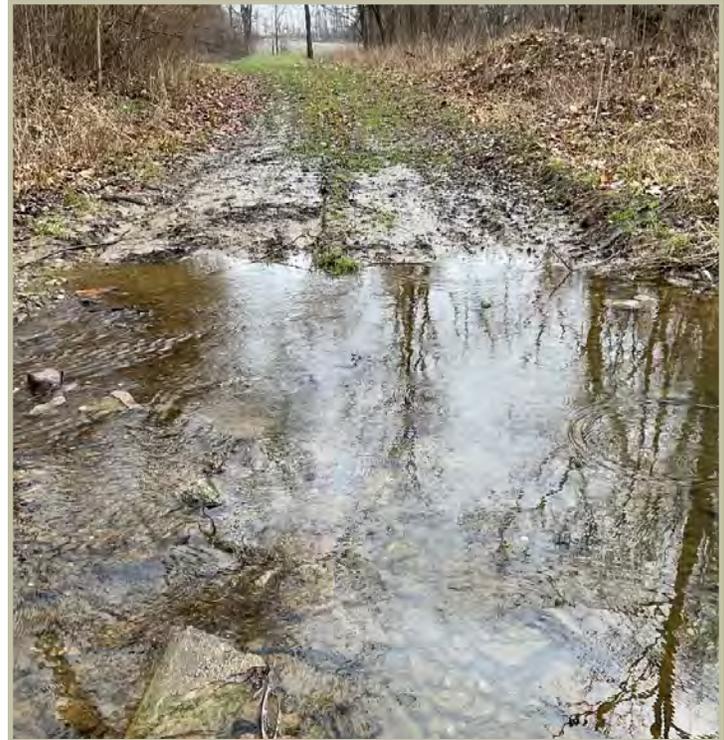
This low ford crossing is well done, with the exception that water should have been diverted prior to crossing. Photo taken on private property by Duane McCoy, DNR.

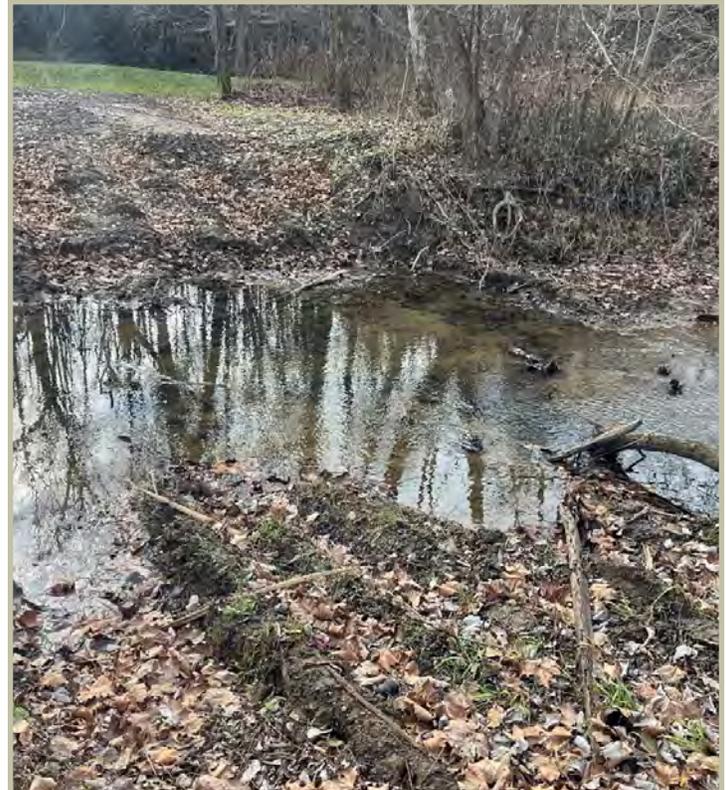
While it appears some sort of bridge or mat was used to cross this stream, it was not smoothed or stabilized after closeout, which will cause erosion for years to come. Taken on private property by Jennifer Sobecki, DNR.

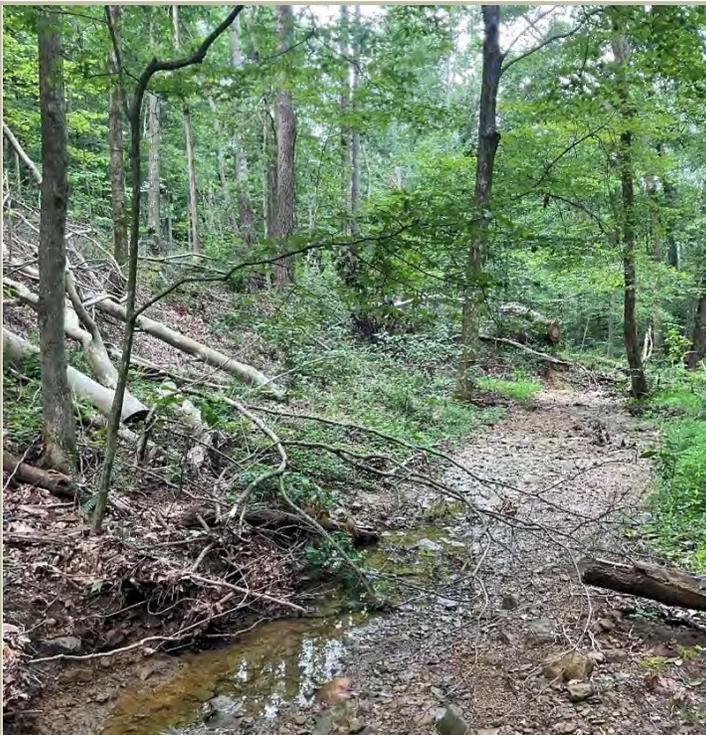
Tops have been removed from the stream in two different areas along this stream on state forest lands. Photo by Duane McCoy, DNR

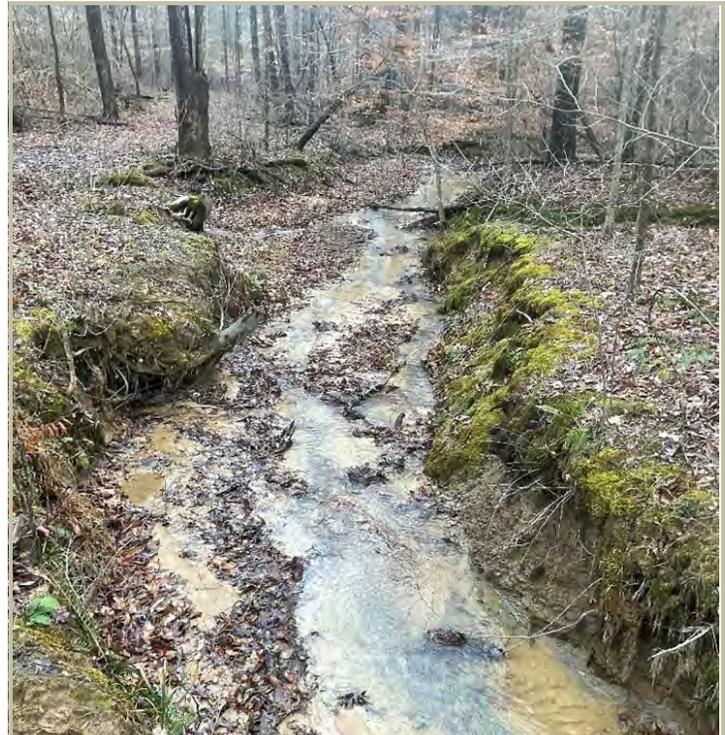
A small stream clogged with sediment due to large area of bared soils near the stream and runoff from that area flowing directly into the stream. Photo taken on private property by Duane McCoy, DNR

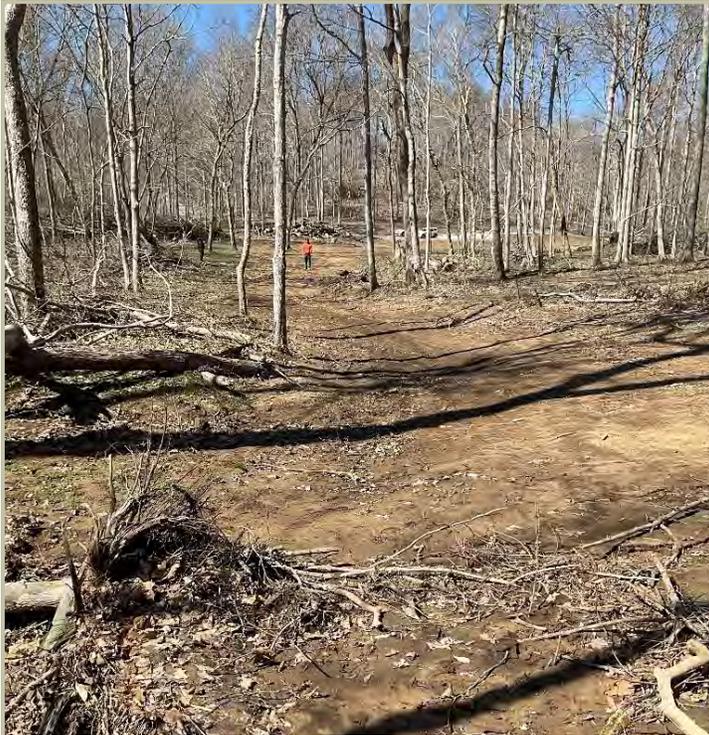
This trail in the RMZ was scoured by overflow from the creek resulting in erosion and sediment deposition. Photo taken on private property by Duane McCoy, DNR.
