Comprehensive Indiana Forestry Best Management Practices

1996-2021

By: Jennifer Sobecki & Duane McCoy

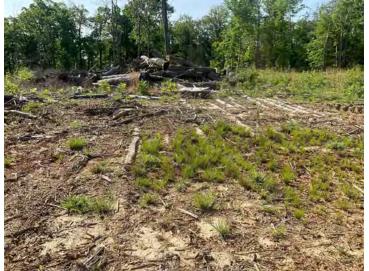
In this pine clearing, the smaller pine trees that were not marketable were used to stabilize the log landing area, as pine plantings can be quite wet. This allowed the landing to be stable even during wetter periods.

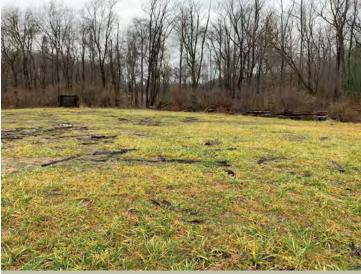
A grassy field used as a log landing. Using existing grassed areas for log landing reduces damage to soil, runoff, and sedimentation to bodies of water and speeds recovery of the area.

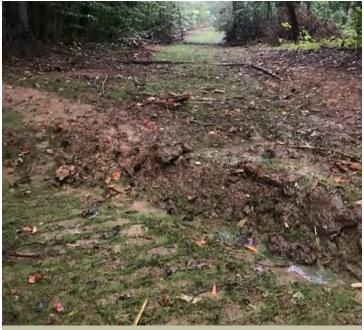
This skid trail has been closed out properly, with waterbars diverting flow off the trail and seeded to expedite growth of vegetation that will stabilize the soil.

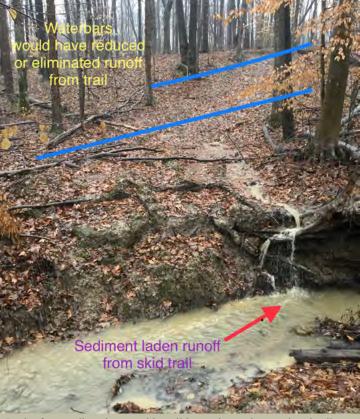
Lack of water diversions on this trail is causing active erosion, leading to sediment-laden runoff reaching the stream.

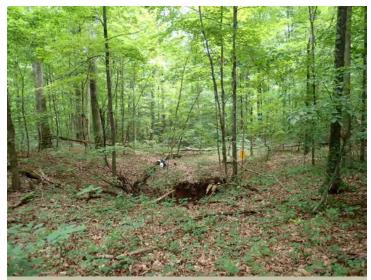
Sinkholes generally lead directly to a water source, thus the area around them is an RMZ. See the 2022 Forestry Field Guide.

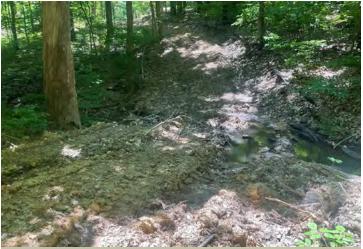
A skid trail was constructed with soil and pushed into this ephemeral channel blocking the flow, causing the water back up and to go over the trail, eroding the trail and causing sediment deposition in the channel. This will also lead to the eventual failure of this skid trail.

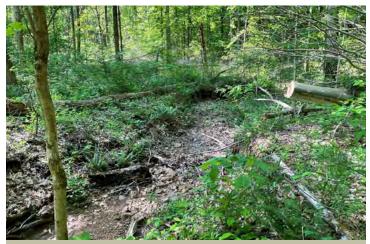
Harvest debris was cleaned out of this drainage.
