VUJC Land Stewardship Initiative

soil health...the root of everything

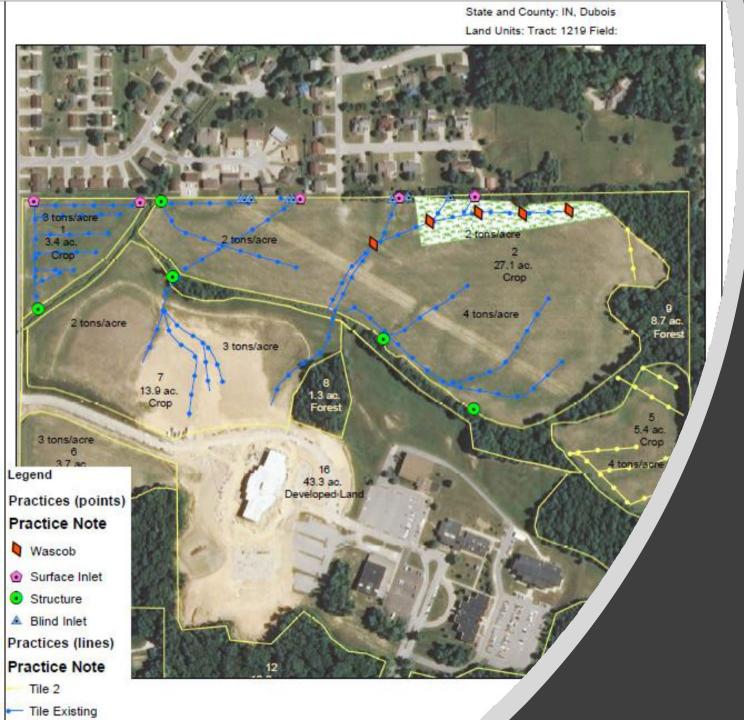
Planned improvements for the property. Many of these occurred in the early years of the Initiative. Recent Google Earth Image shows many of the improvements put in place on the farm throughout the years.

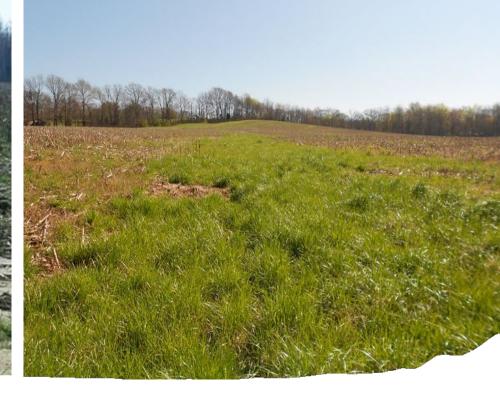
Turning erosion prone soil into a Grassed Waterway-2014

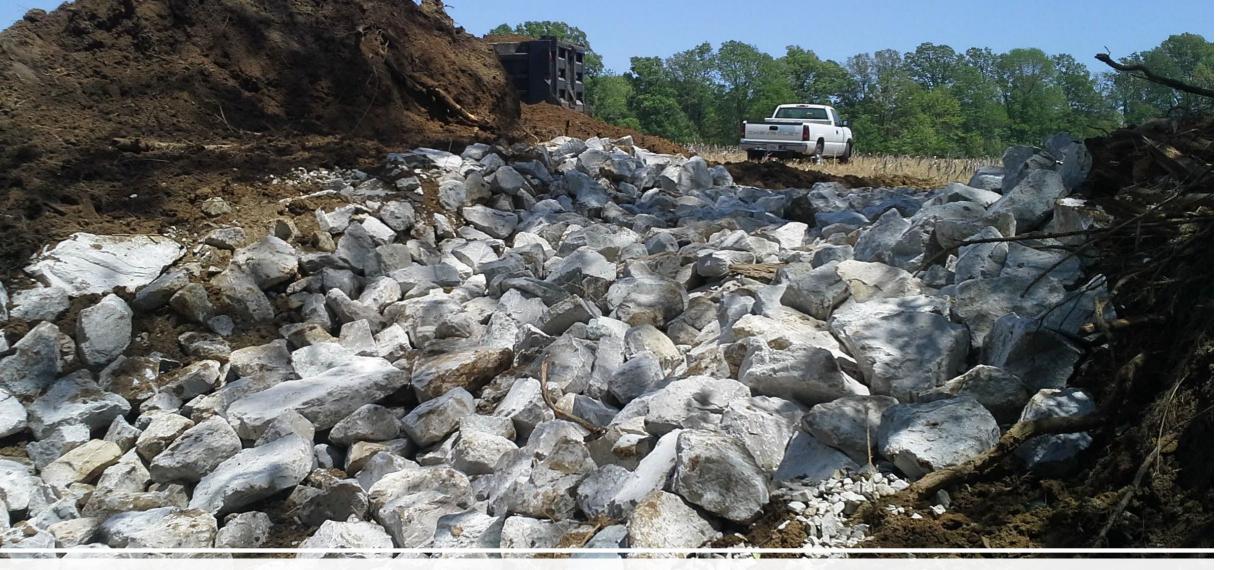
2014- Rock Chute installation at the end of Grassed Waterways

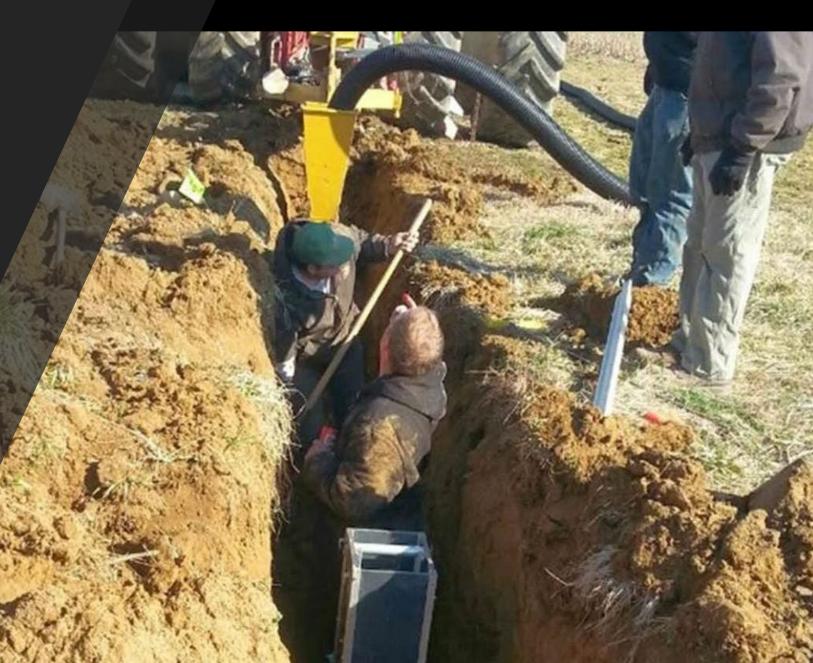
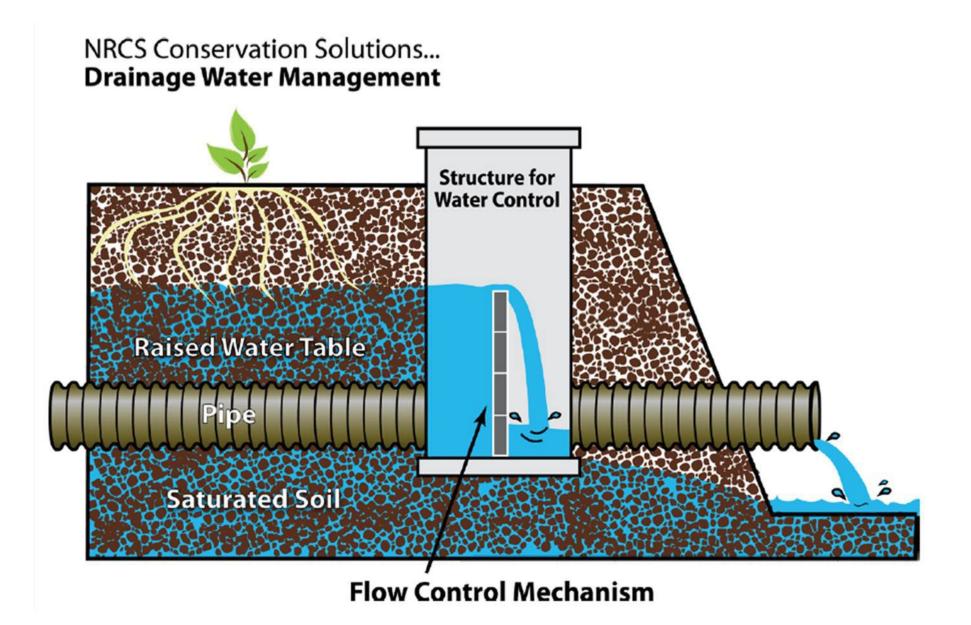
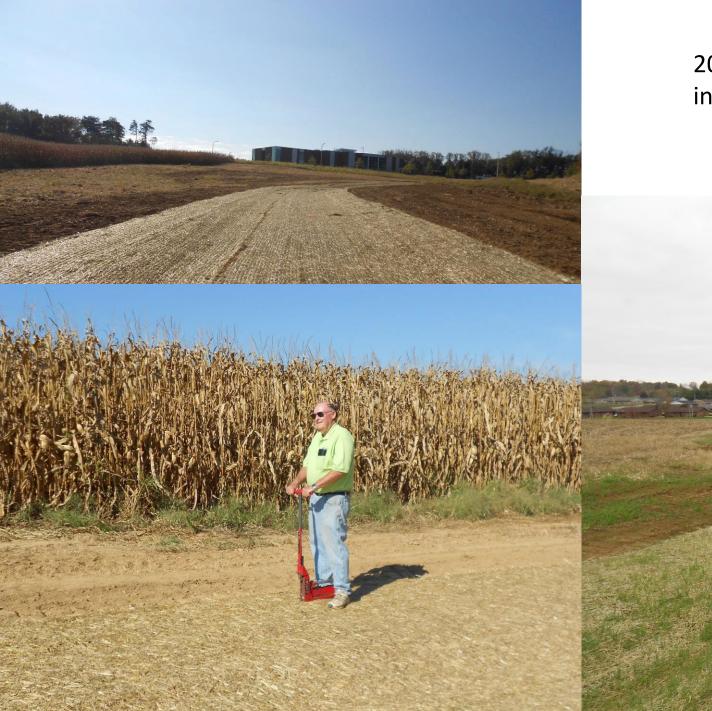
Installation of the Stop Log System in Field 1

2015- adding additional Grassed Waterways in more fields

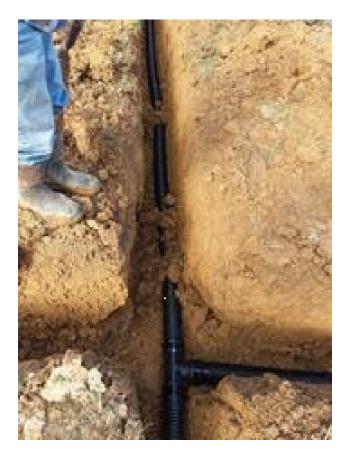
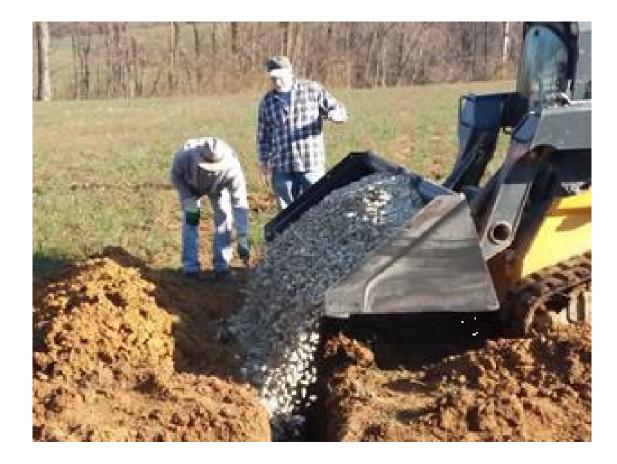
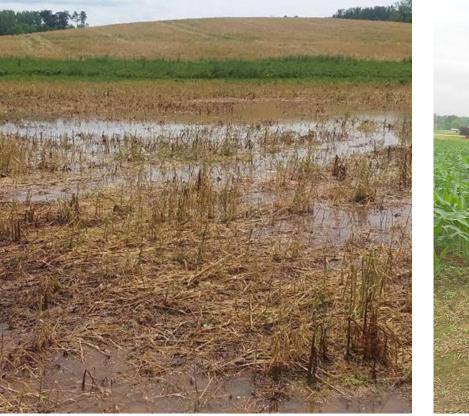
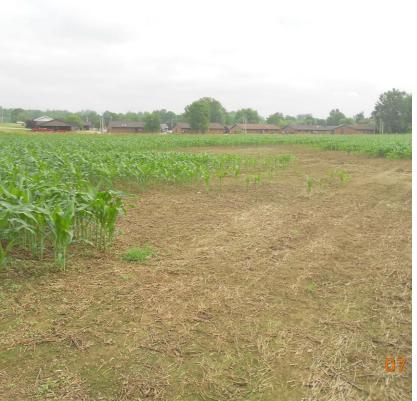
Installation of French Drains in Field 5 to address drainage issues - 2019

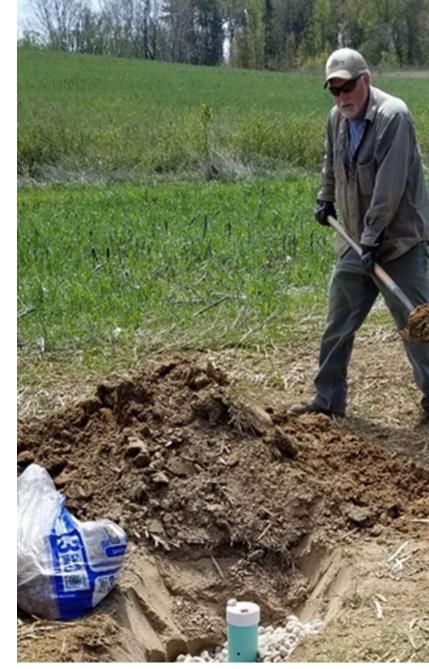
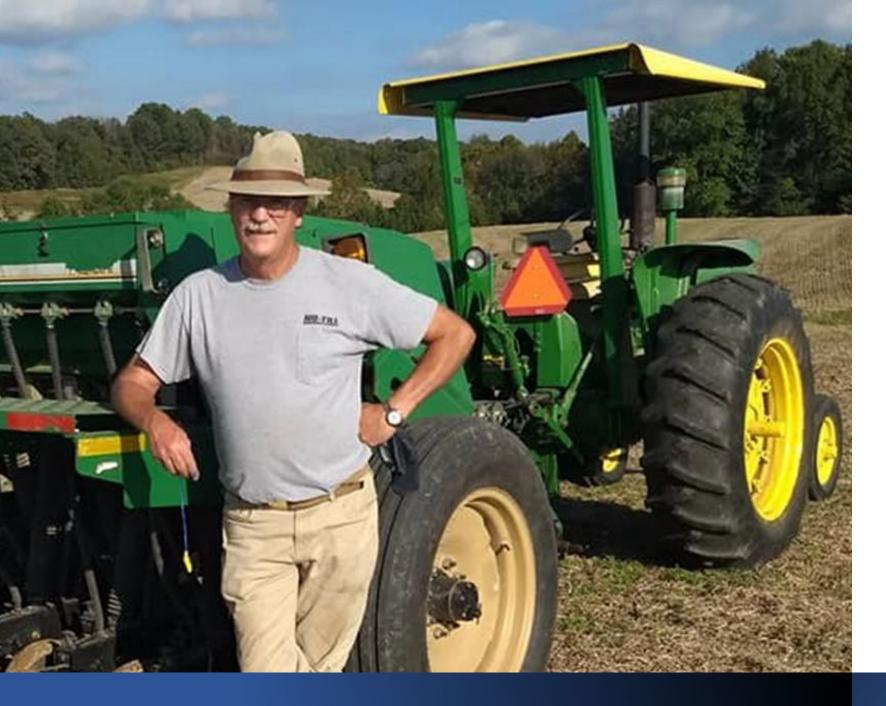
This lower lying area in Field 1 has been prone to holding a large pool of water after a significant rain reducing yields. In 2020 Bart Pitstick and Alan Smock installed a hidden drain to resolve the issue. The two men dug down several feet to the existing tile line in the field and added a junction and a vertical perforated pipe. A cap was placed on the top of the structure approximately one-foot underground. The hole was filled with gravel creating pore space and allowing water to infiltrate more easily. In May, a significant rain event tested the system and it passed with flying colors!

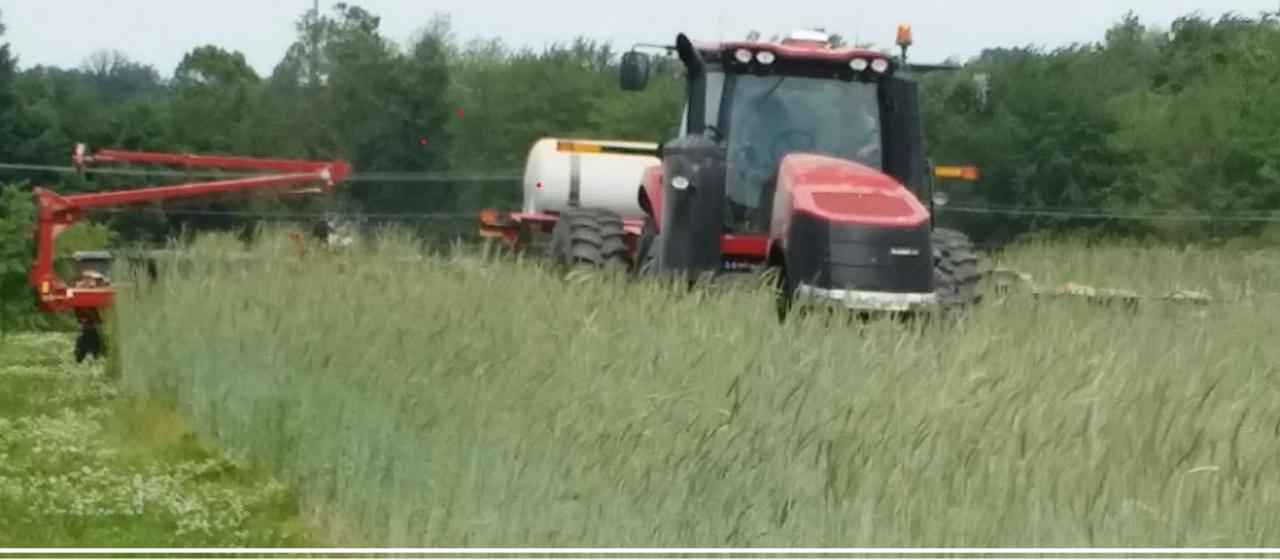
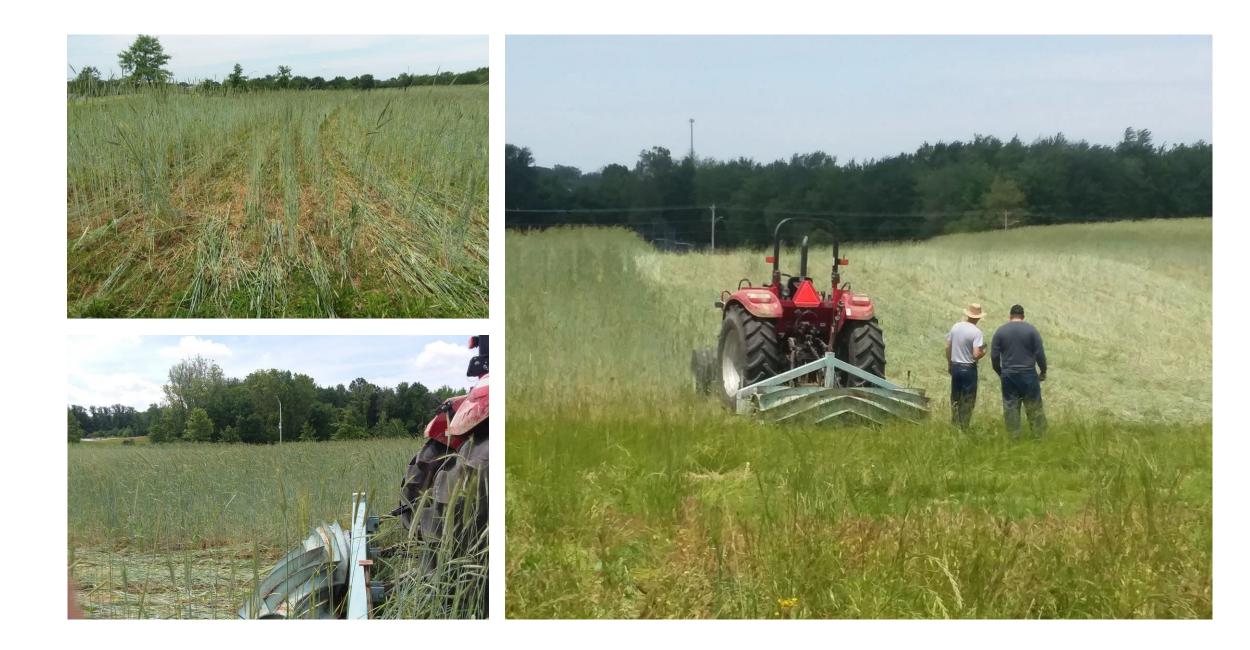
2019 – Planting green into standing cover crop of Cereal Rye. This was followed immediately by roller crimping.

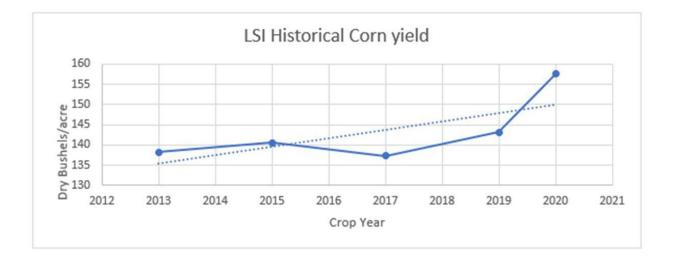
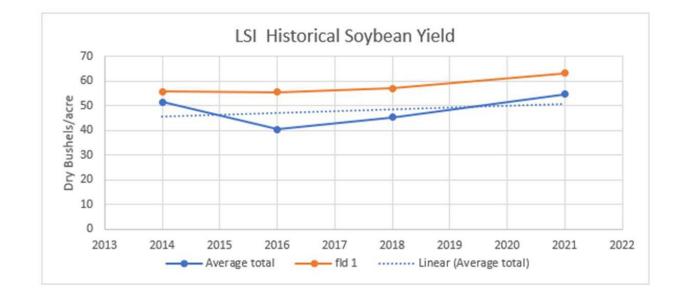
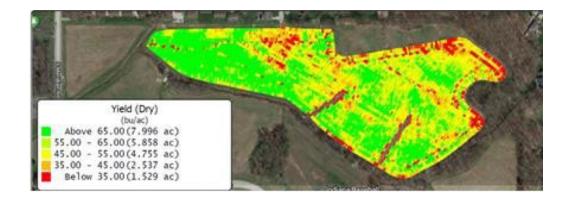
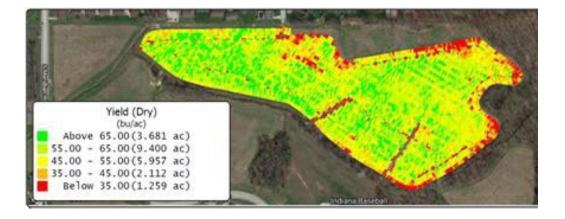
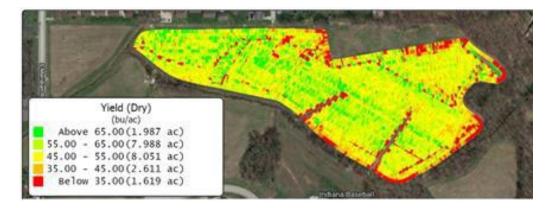
Increase in yield

Year:2018 Avg. Yield: 58.95 bu/ac

Year: 2016 Avg. Yield: 55.43 bu/ac And an increase in the overall functionality of the soil.

Year 2014 Avg. Yield 52.65 bu/ac

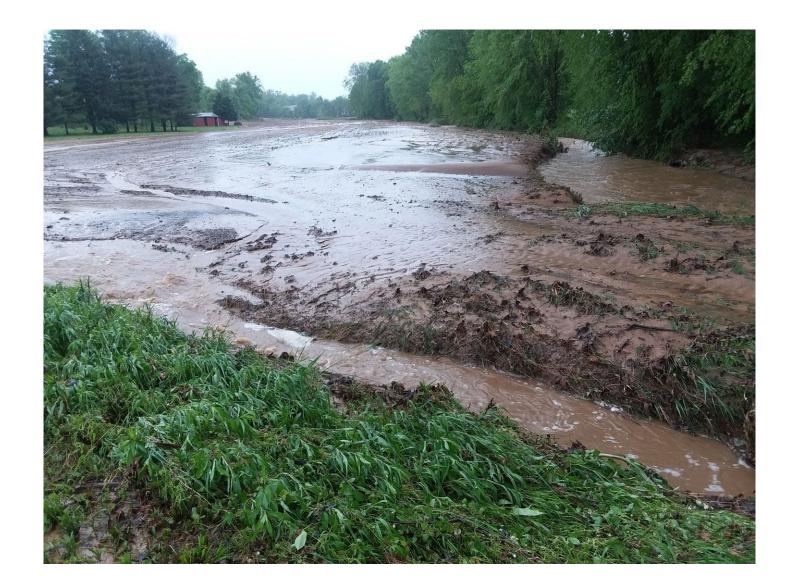
A neighboring conventionally tilled field up stream from LSI with soil being detached and transported down stream

Water from LSI fields running cleanly into a ditch before joining the muddied water in Jahn Creek.

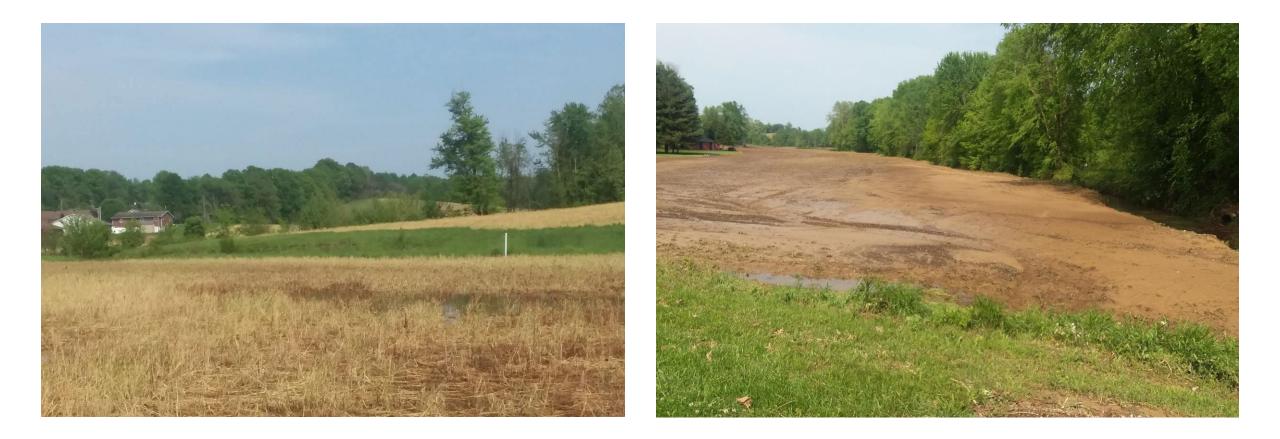
• A day or two later. The cover crops on the LSI fields have armored the surface and prevented soil erosion. The farm upstream will form a crust on top of the soil and will be tilled again before planting.

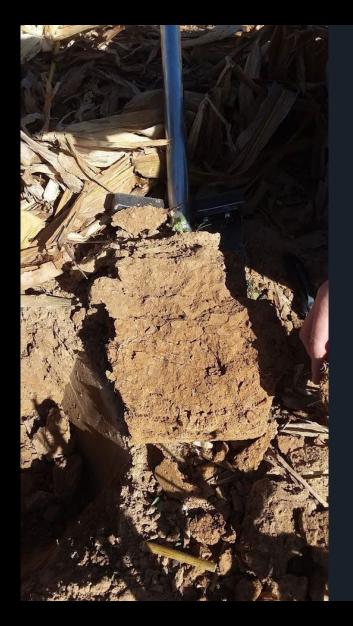
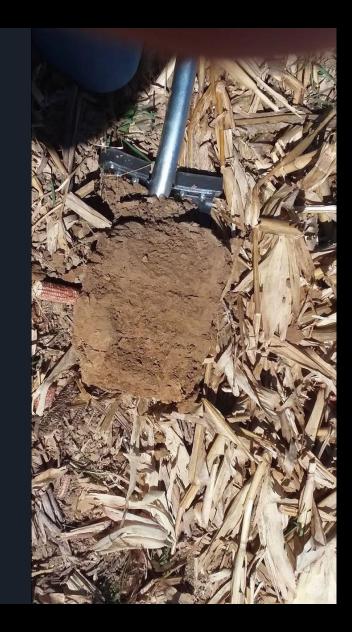
A comparison of the color due to increased OM in the no tilled cover cropped soil (right) and the conventionally tilled soil in the same field that has not seen the increase in organic matter (left).

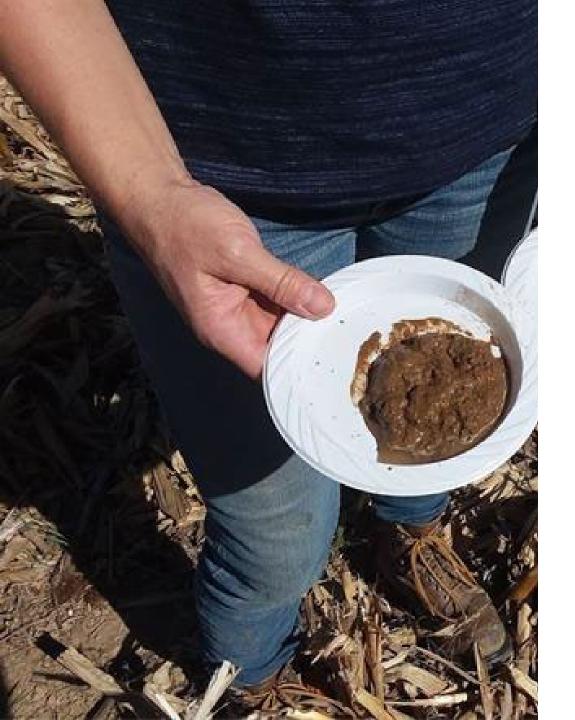
• Slump test using the same soil type from field 2 demonstrating aggregate stability in the NTCC sample (right) compared to the conventionally farmed sample on the left.

• Notice both the color and water holding capacity differences between the two samples.
