Waters Report

State Road 58 in Lawrence County, Indiana

Small Structure Project

Des. No. 2200992

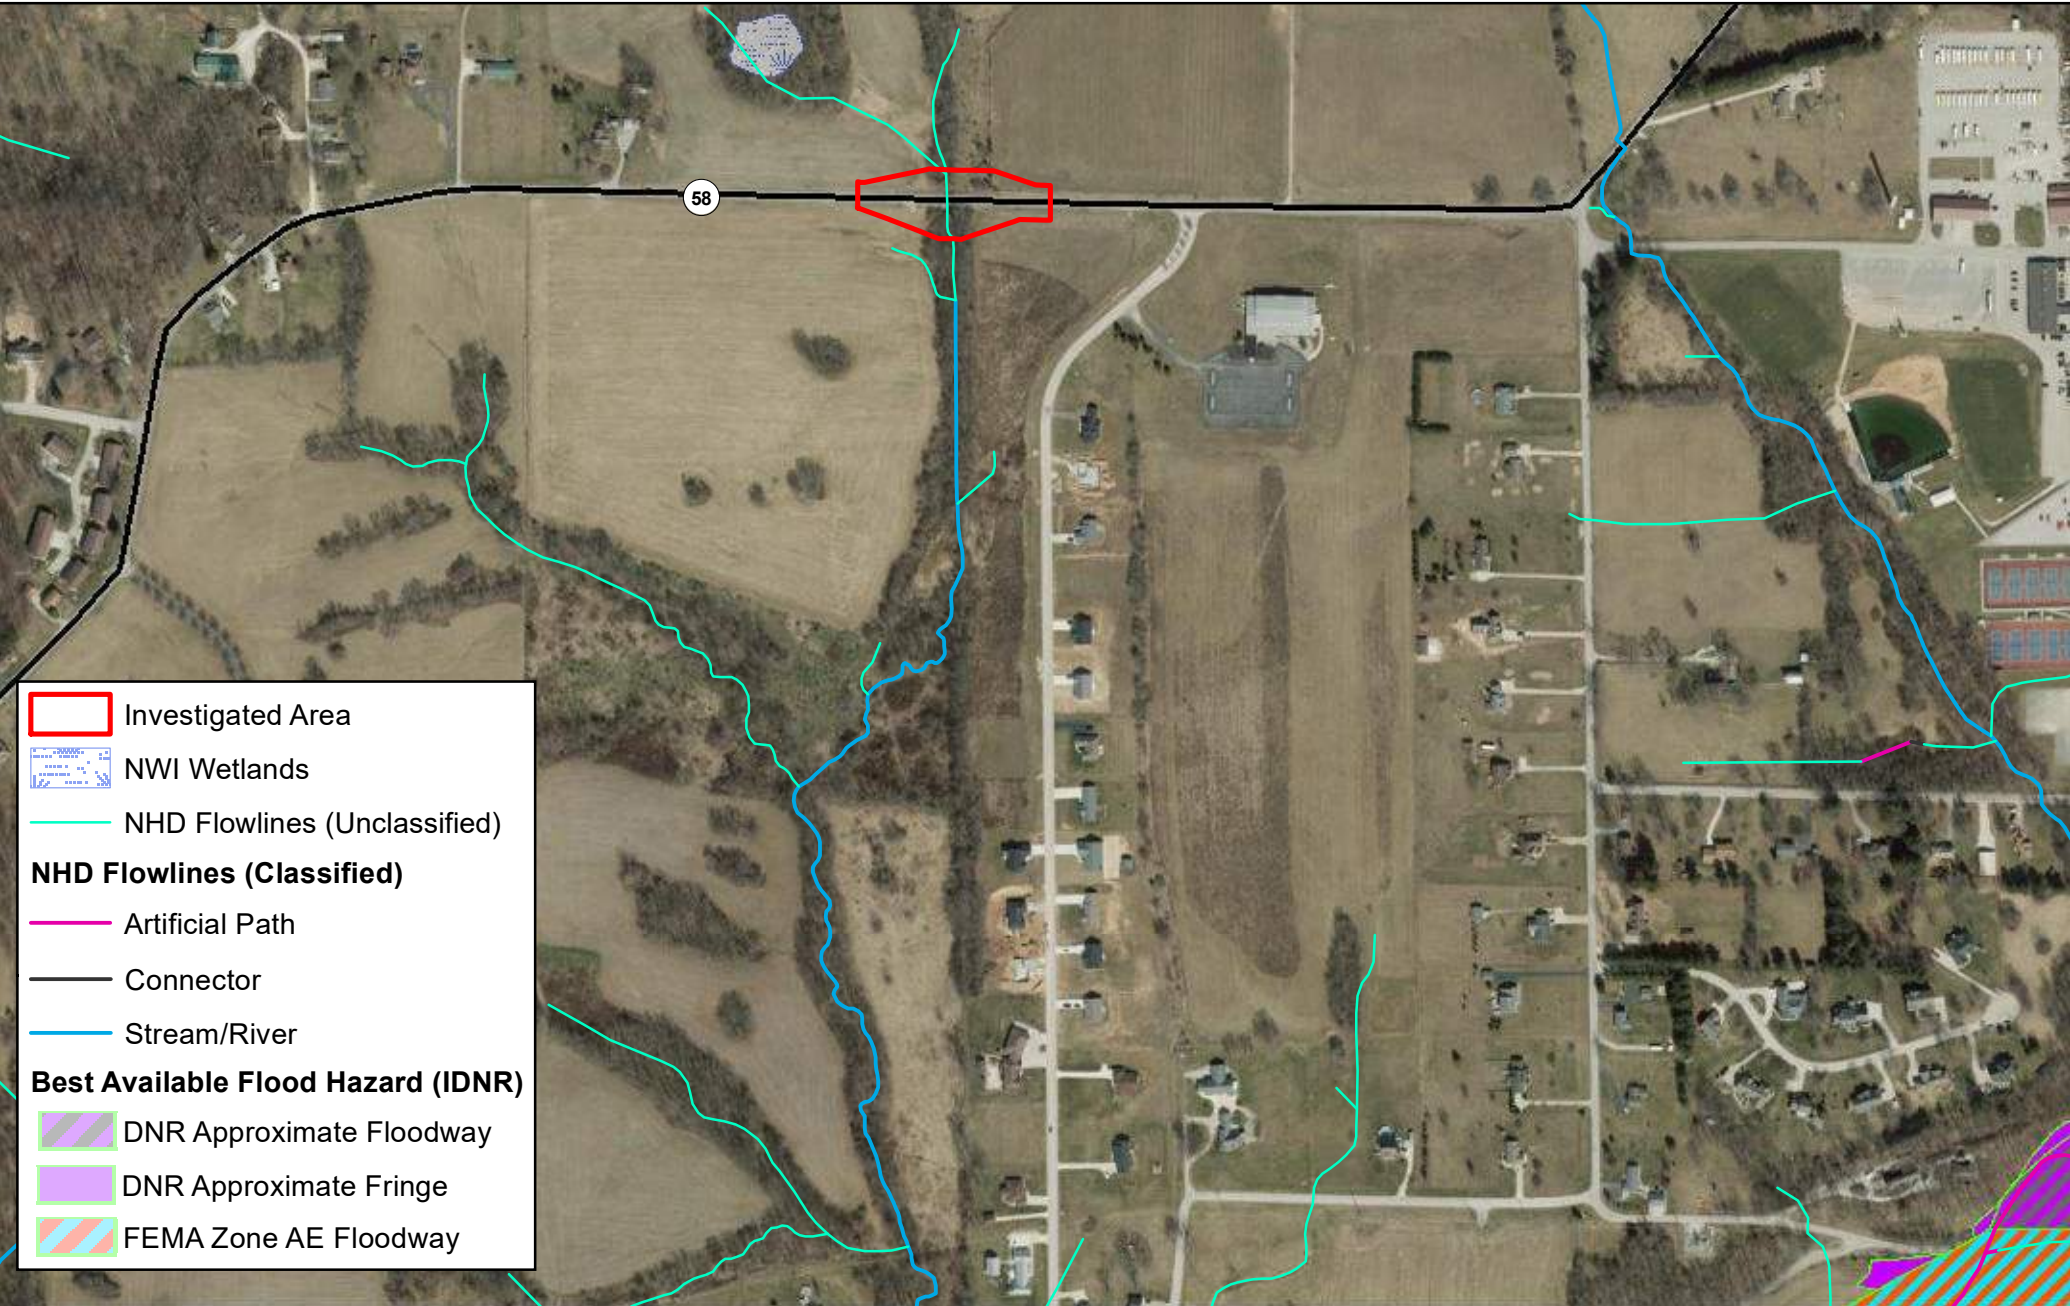
A review of the USGS topographic maps (Figure 2) shows no streams (solid blue lines) within the investigated area. The NWI wetlands and NHD flowlines can be seen on aerial photography (Figure 6); there are 2 unclassified flowlines within the investigated area. The IDNR Floodplain Map and National Flood Hazard Layer FIRMette (Figures 6 and 7) show no floodplains within the investigated area; the nearest floodplain is approximately 0.68 mile southeast of the investigated area.

Stream/River
- Best Available Flood Hazard (IDNR)**
-

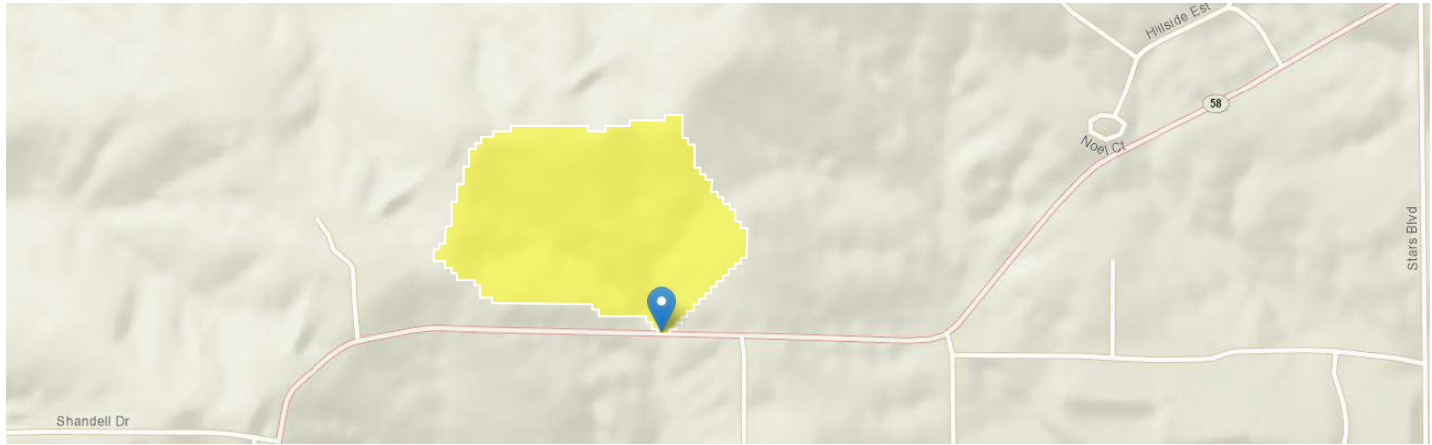
Des. No. 2200992; SR 58 Small Structure Project StreamStats Report (Figure 8)

Within the investigated area, the UNT to Leatherwood Creek flows south for approximately 201 feet and drains the surrounding agricultural uplands. The UNT to Leatherwood Creek does not appear on the USGS 7.5' Bartlettsville Quadrangle (1994; Figure 2) within the investigated area. Based on field observations, the UNT to Leatherwood Creek appears to be ephemeral. The UNT to Leatherwood Creek exhibits an OHWM. The OHWM was taken at two SAP's and is summarized in Table 2. The maximum OHWM of UNT to Leatherwood Creek is 8' wide by 0.5' deep. The USGS StreamStats website shows the upstream drainage area of UNT to Leatherwood Creek as 0.052 square mile at the project location (Figure 8).

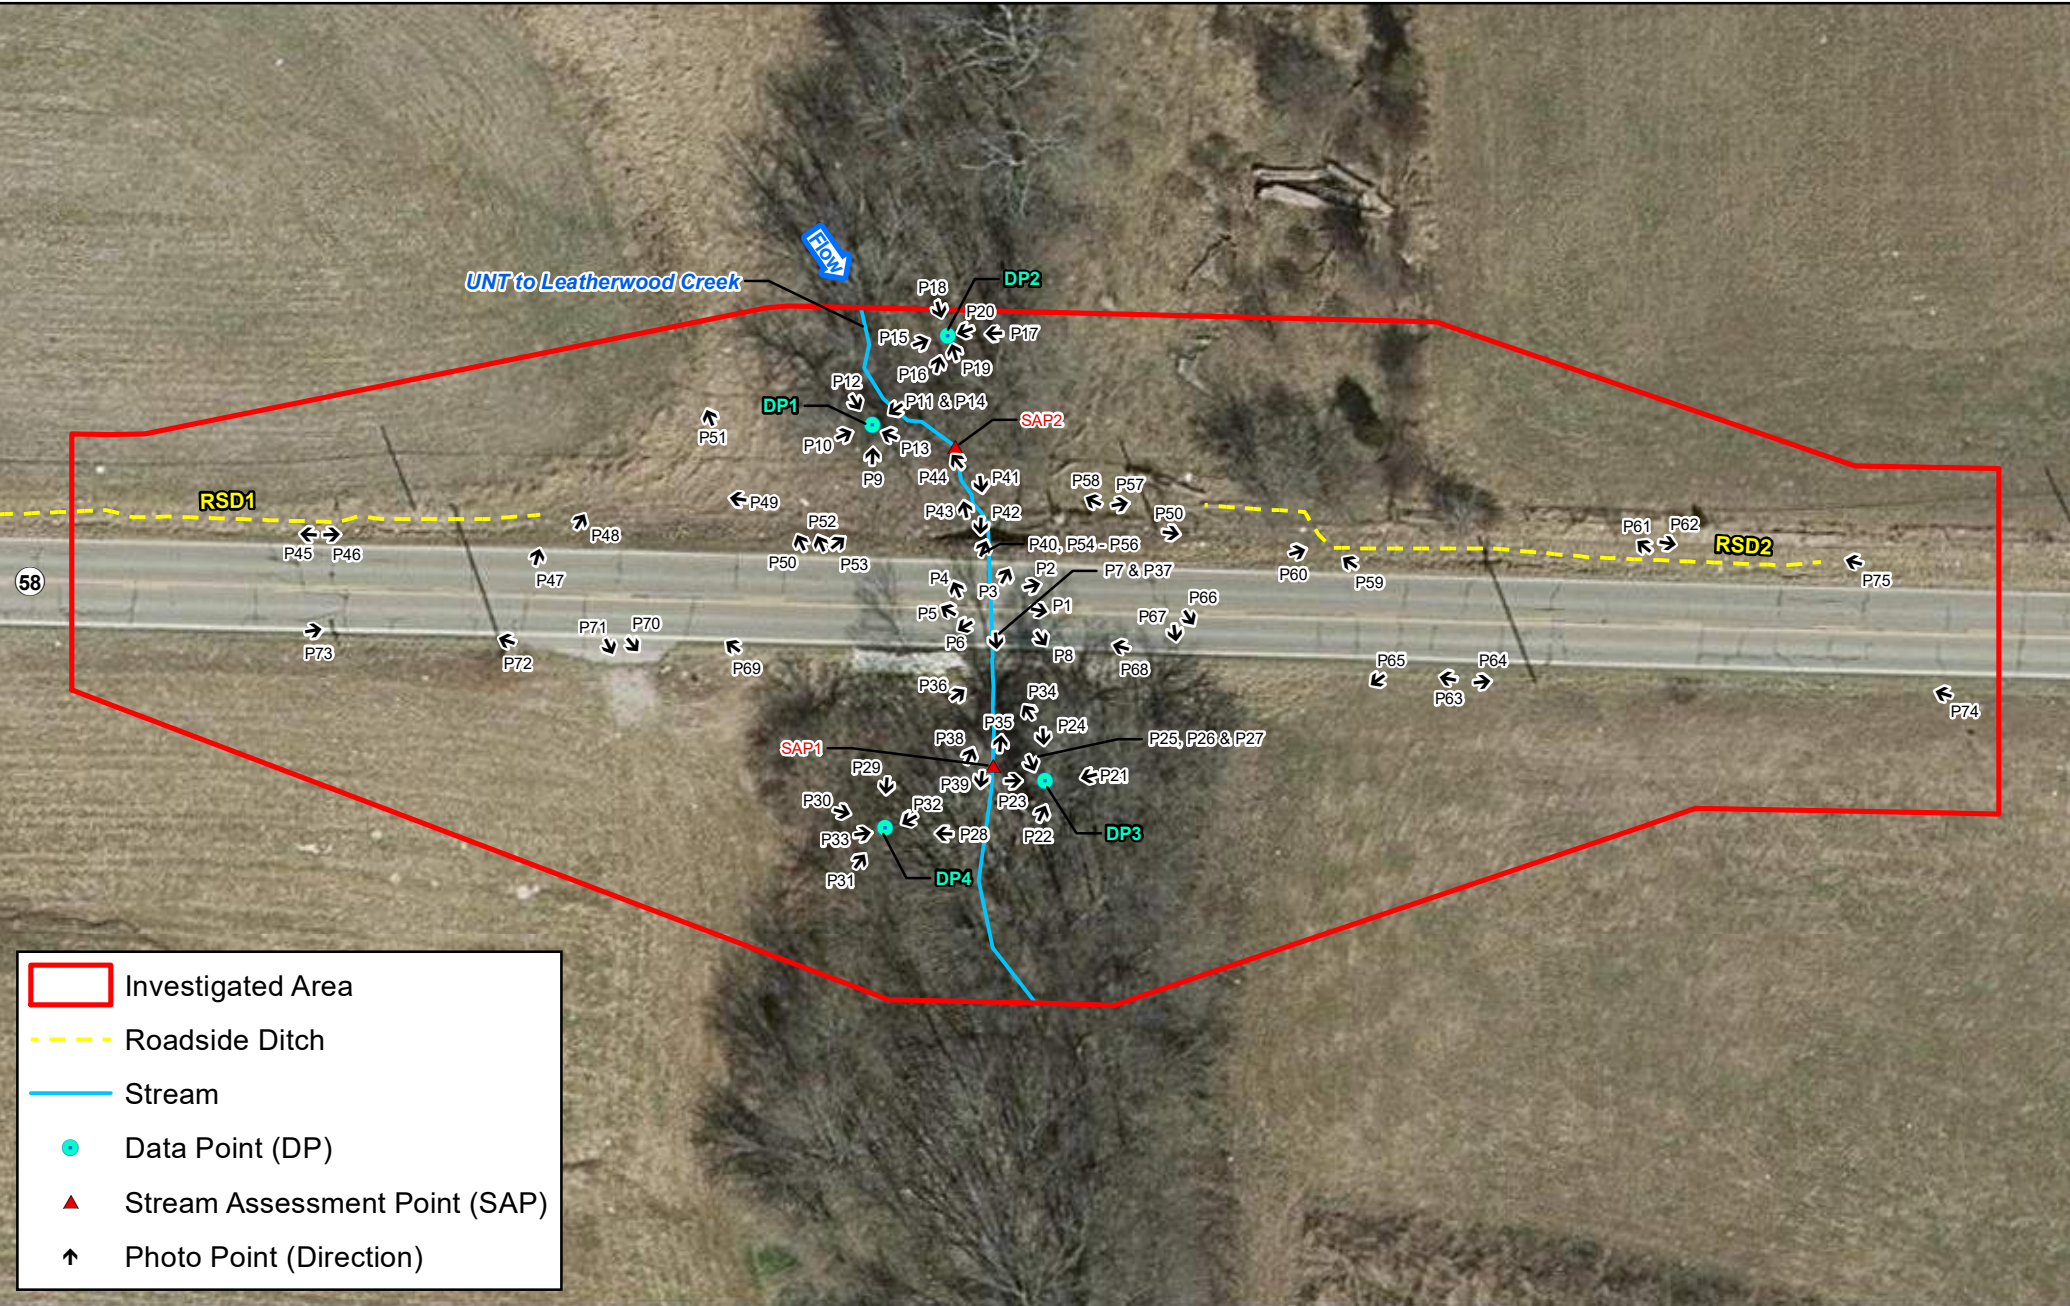
F-19

- Investigated Area
- Roadside Ditch
- Stream
- Data Point (DP)
- ▲ Stream Assessment Point (SAP)
- ↑ Photo Point (Direction)

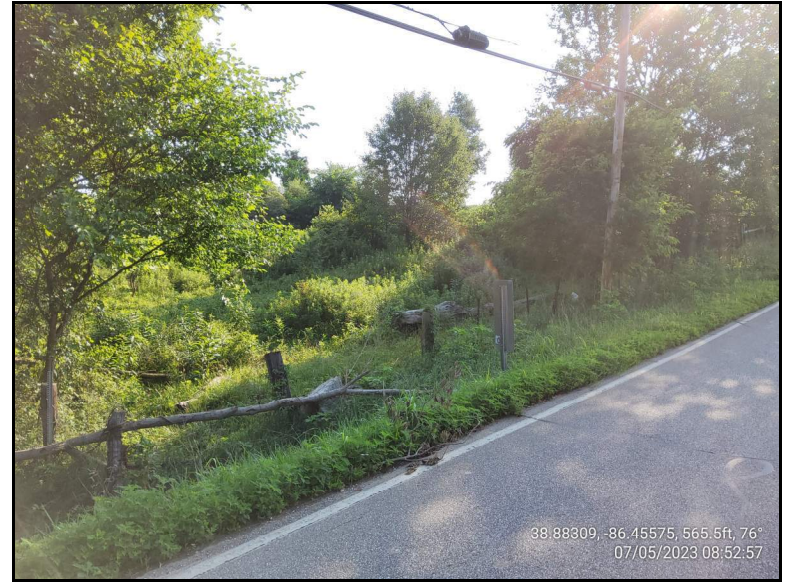
Photograph 2. Taken from SR 58 at center of the investigated area, facing east-northeast showing roadside vegetation north of SR 58.

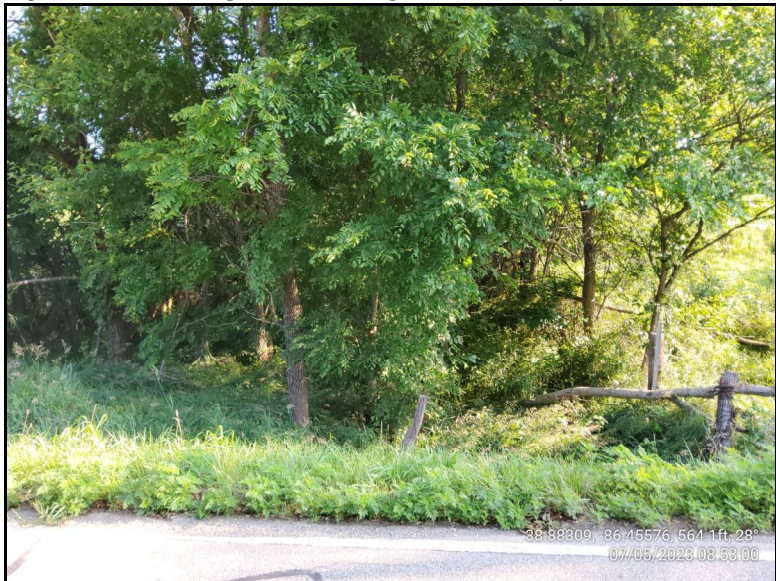
Photograph 3. Taken from SR 58 at center of the investigated area, facing northeast showing roadside vegetation north of SR 58 at the corrugated metal pipe (CMP) inlet.

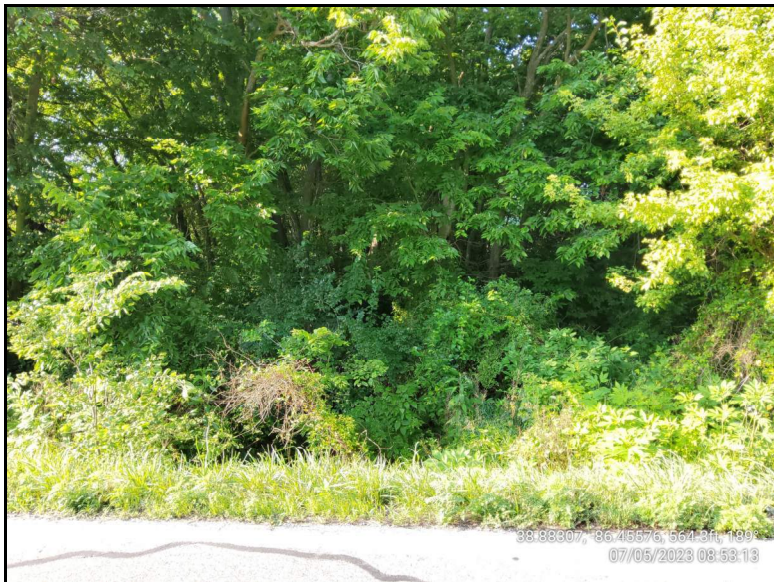
Photograph 7. Taken from SR 58 at center of the investigated area, facing south showing roadside vegetation south of SR 58 at CMP outlet.

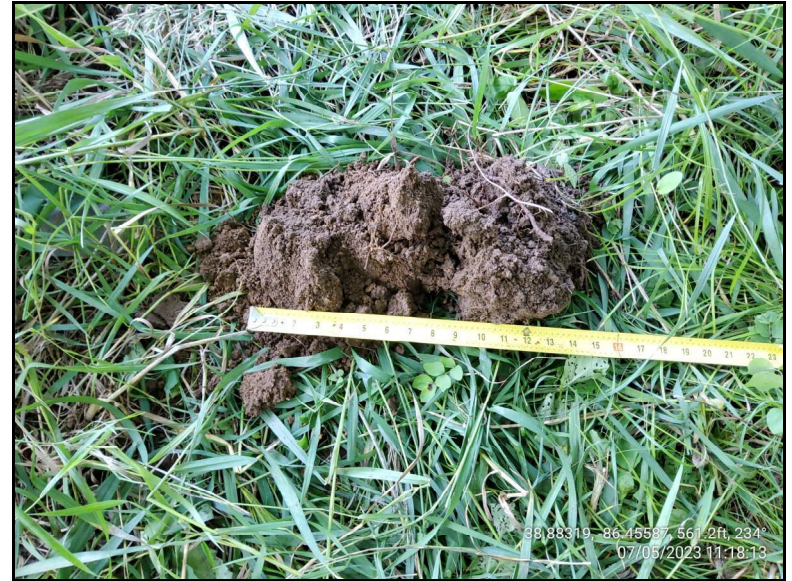
Photograph 14. DP1 soil profile. Soil is non-hydric.

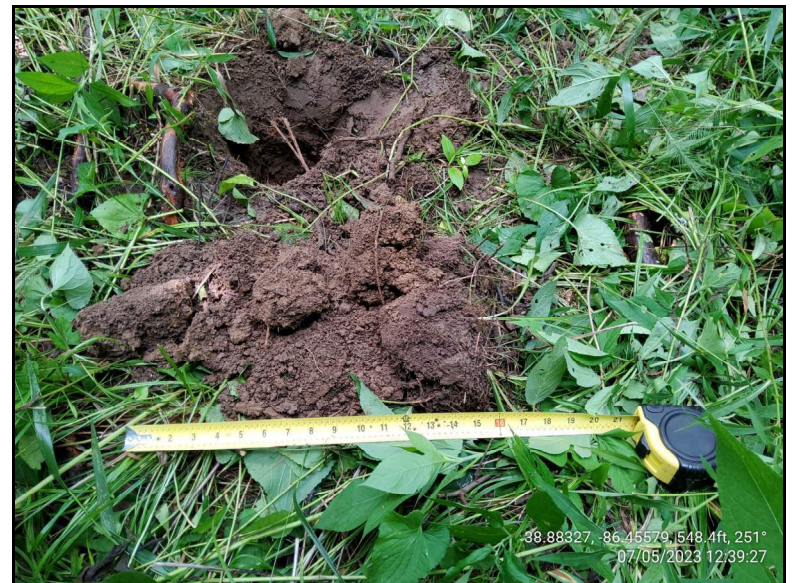
Photograph 20. DP2 soil profile. Soil is non-hydric.

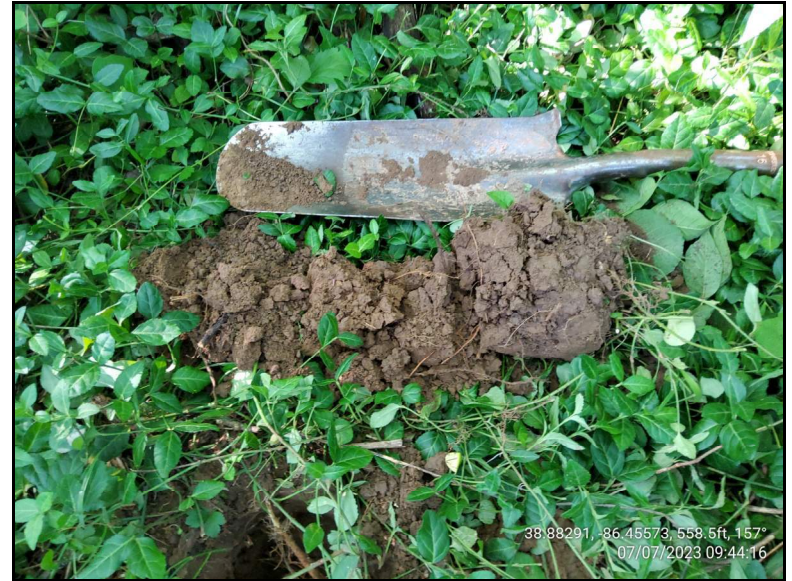
Photograph 26. DP3 soil profile. Soil is non-hydric.

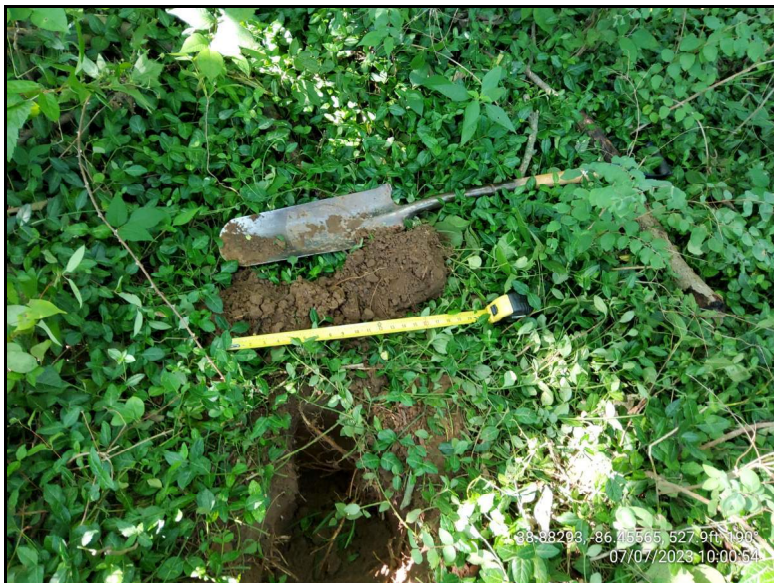
Photograph 27. DP3 soil profile. Soil is non-hydric.

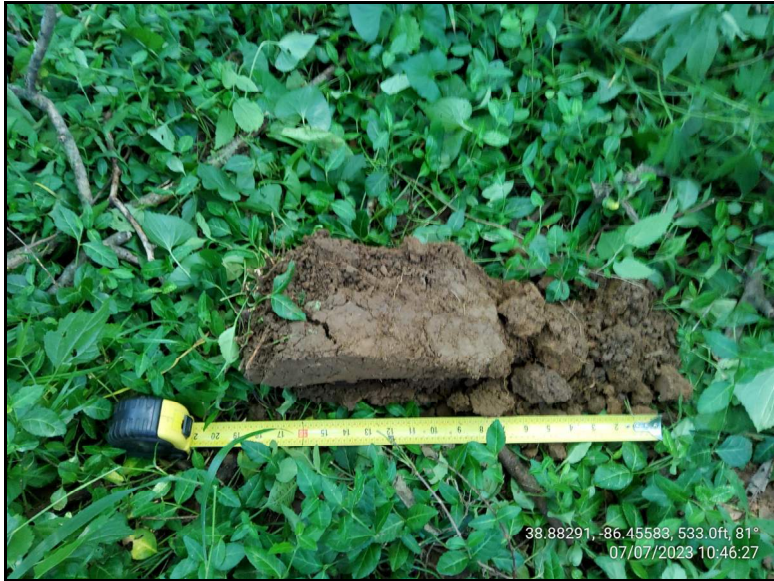
Photograph 32. DP4 soil pit.

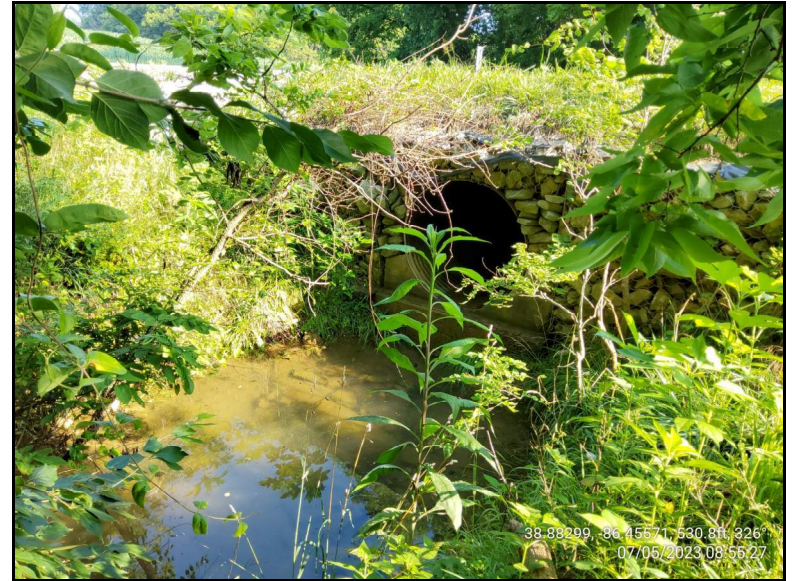
Photograph 34. Taken south of SR 58, facing northwest (upstream) in UNT to Leatherwood Creek showing the CMP outlet.

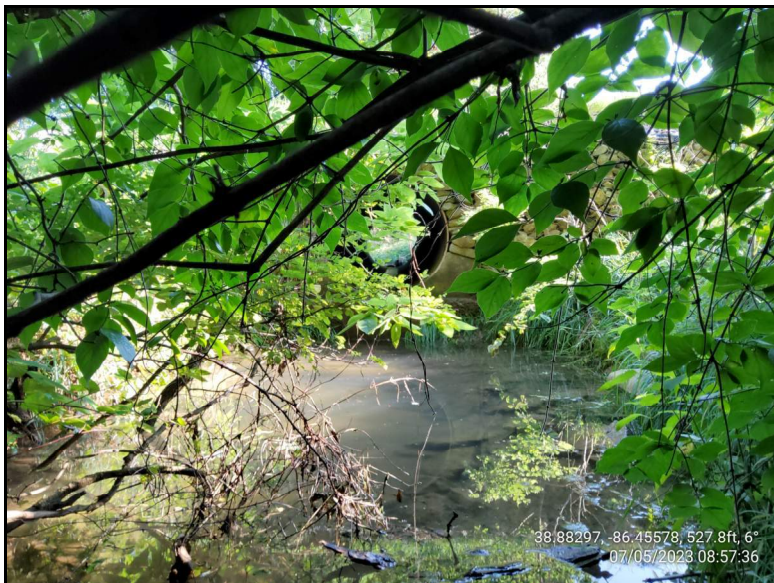
Photograph 35. Taken south of SR 58, facing north (upstream) in UNT to Leatherwood Creek showing the CMP outlet.

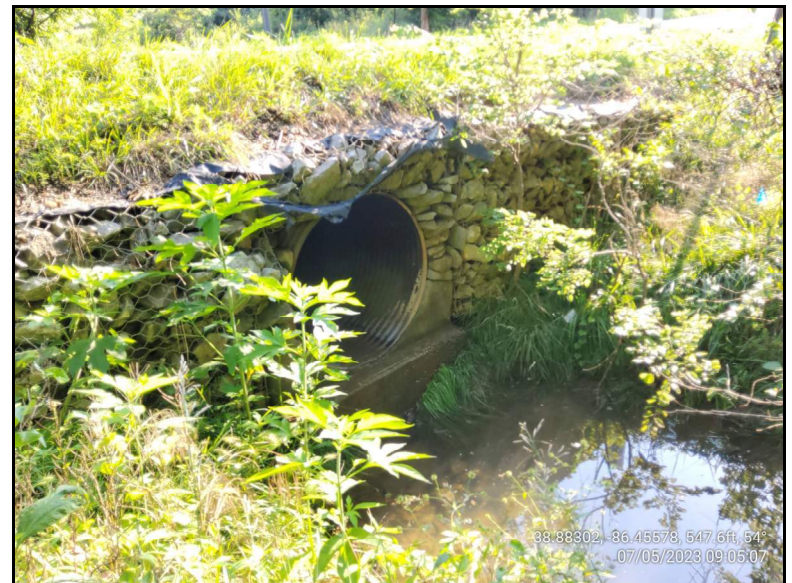
Photograph 36. Taken south of SR 58, facing northeast (upstream) in UNT to Leatherwood Creek showing the CMP outlet.

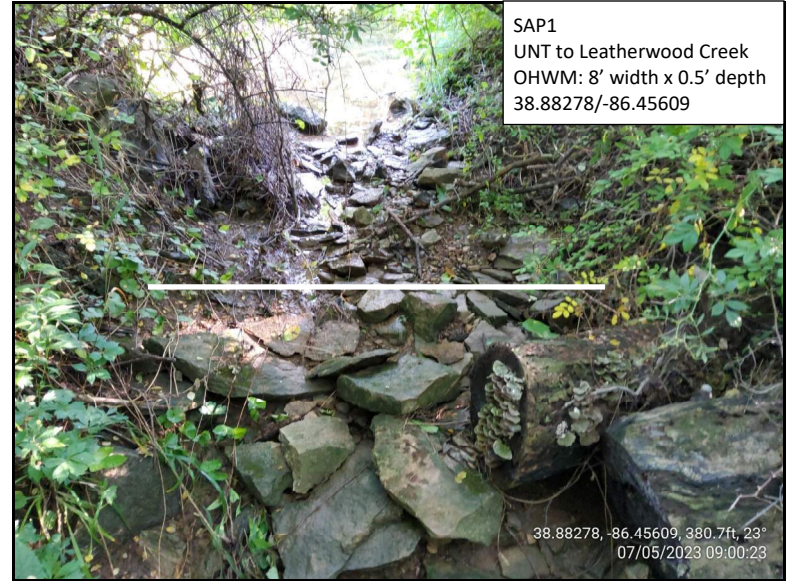
Photograph 38. Taken south of SR 58, facing north-northeast (upstream) in UNT to Leatherwood Creek. White line indicates the OHWM.

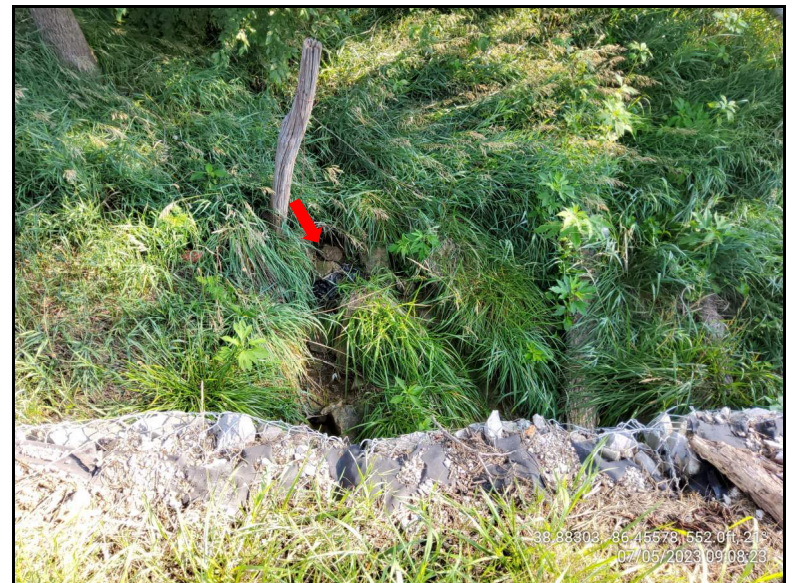
Photograph 40. Taken from SR 58, facing north (upstream) showing the CMP inlet and UNT to Leatherwood Creek (red arrow).

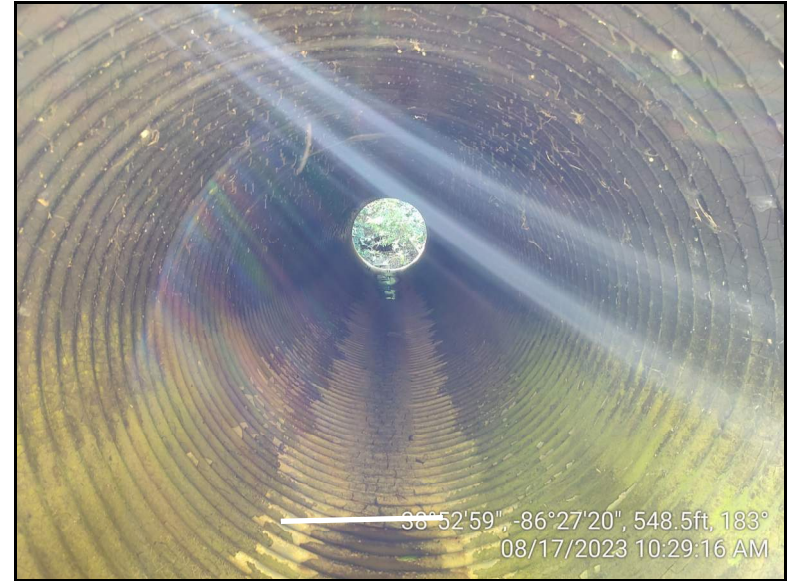
Photograph 42. Taken north of SR 58, facing south through the CMP. No sign of bat use (e.g., individuals, urine staining, or guano) or bird nests present within the CMP.

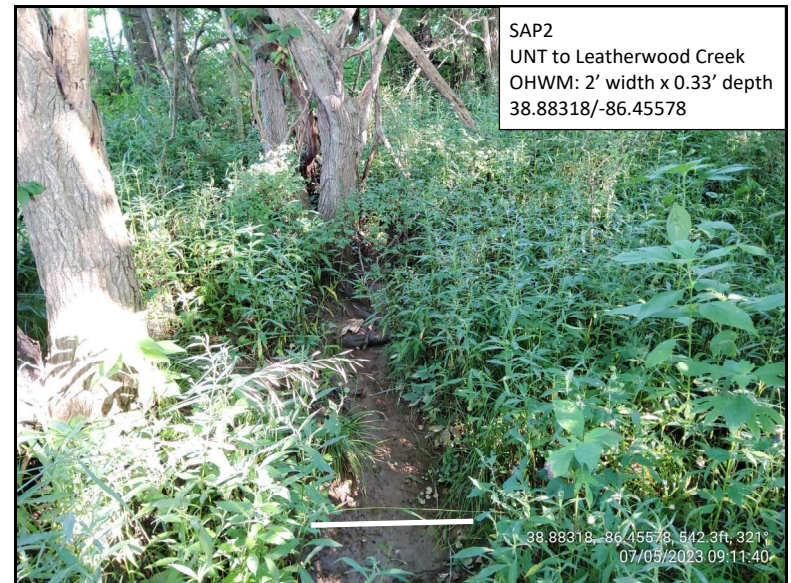
Photograph 44. Taken north of SR 58, facing northwest (upstream) in UNT to Leatherwood Creek. White line indicates the OHWM.

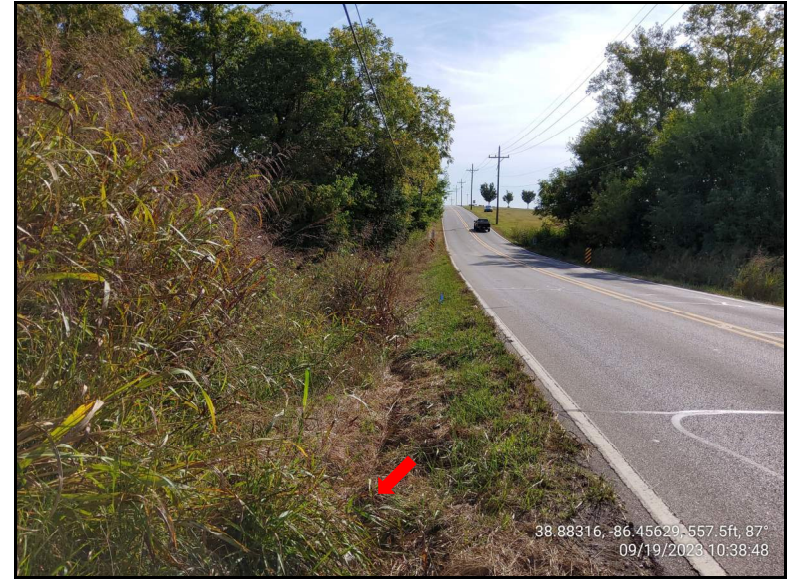
Photograph 45. Taken from SR 58 at the west end of the investigation area, facing west showing Roadside Ditch (RSD) 1 (red arrow) and roadside vegetation.

The July 2023 field investigation identified two RSDs, identified as RSD1 and RSD2 on the attached feature and photo location map (Figure 9). Roadside ditch 1 (RSD1) flows east along the north side of SR 58 and appears to convey drainage into the UNT to Leatherwood Creek. Roadside ditch 2 (RSD2) flows west along the north side of SR 58 and appears to convey drainage into the UNT to Leatherwood Creek. Dominant vegetation in the roadside ditches consist of upland and facultative upland species including Annual ragweed (*Ambrosia artemisiifolia*), Asiatic dayflower (*Commelina communis*), Early Wild-Rye (*Elymus macgregorii*), Giant Ragweed (*Ambrosia trifida*), Johnson Grass (*Sorghum halepense*), and Meadow fescue (*Festuca pratensis*). Both RSD1 and RSD2 are shallow, vegetated ditches with no defined bed and banks, and neither display an OHWM. These features will not likely fall under the jurisdiction of the USACE.

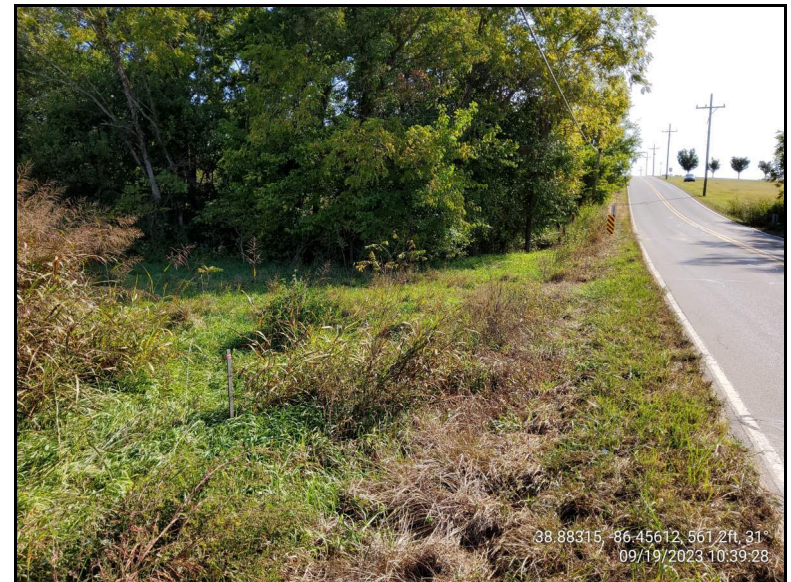
Photograph 47. Taken from SR 58 at the west end of the investigation area, facing northeast showing RSD 1 (red arrow) and roadside vegetation.

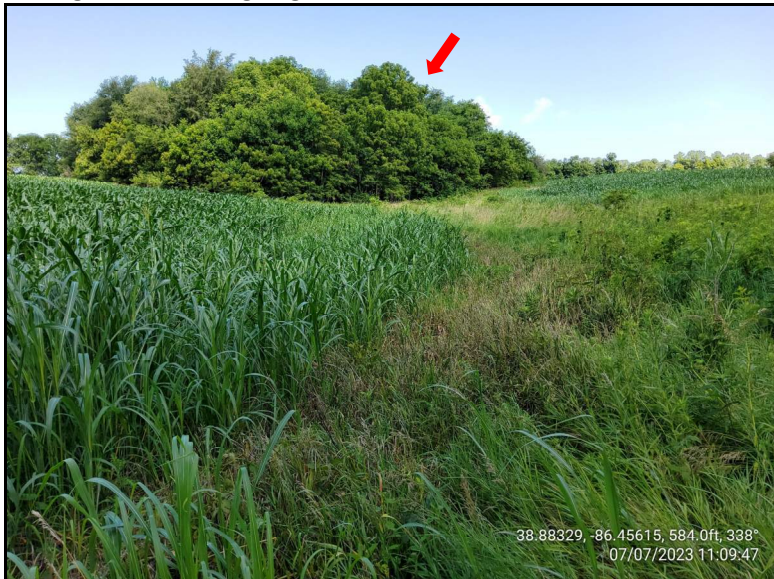
Photograph 50. Taken north of SR 58 west of the CMP, facing north-northwest showing RSD 1 (red arrow) and vegetation.

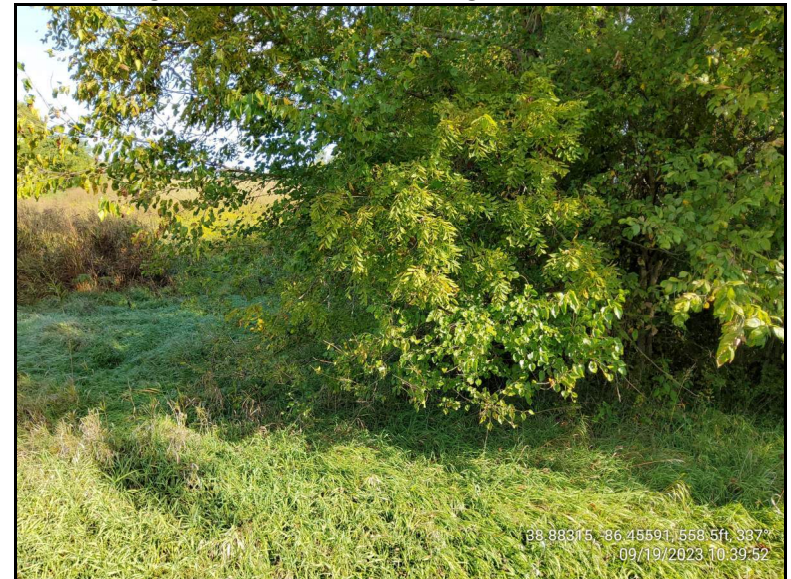
Photograph 51. Taken north of SR 58 at the west end of the investigation area, facing north-northwest showing forested wetland area (red arrow) outside of investigated area.

The USFWS NWI map (Figure 6) shows no wetlands mapped within or adjacent to the investigated area. The nearest USFWS NWI mapped feature is a freshwater emergent wetland (PEM1Ch) wetland located approximately 0.07 mile northwest of the investigated area (Photo 51).

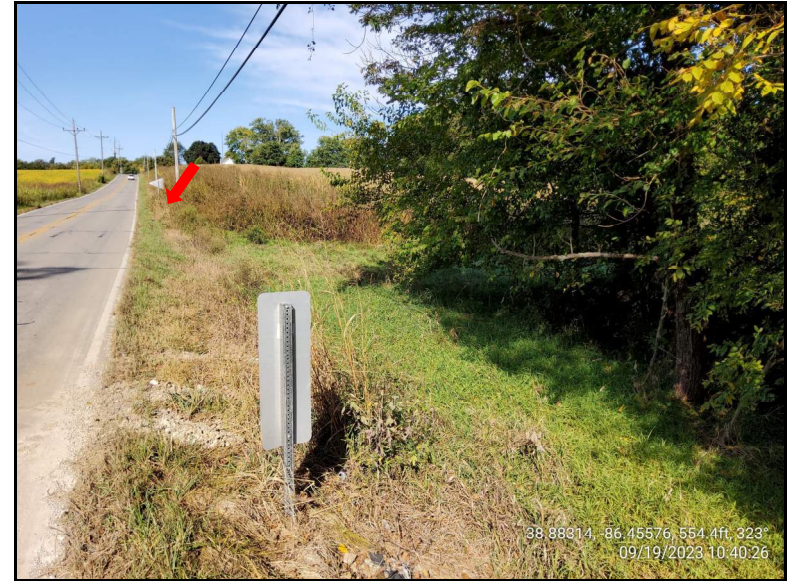
Photograph 53. Taken from SR 58 west of the CMP, facing northeast showing roadside vegetation and forested area north of CMP inlet. Red arrow indicates CMP.

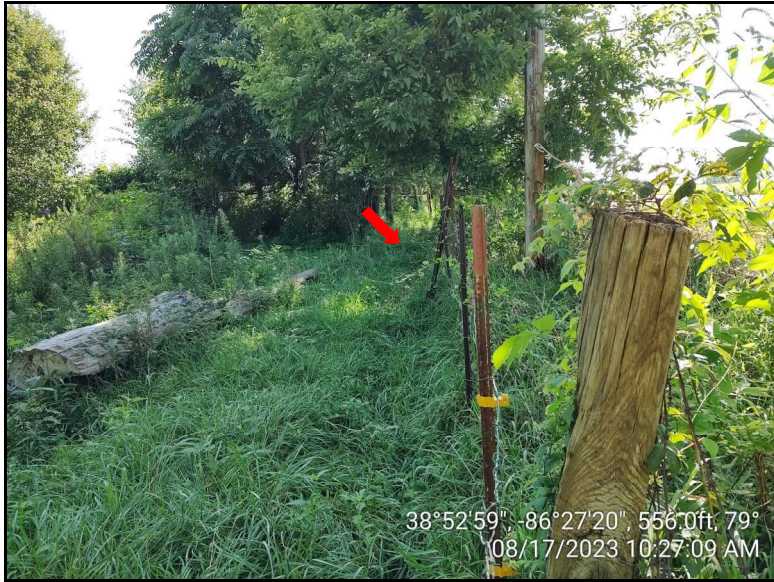
Photograph 56. Taken from SR 58 at the center of the investigation area, facing northeast showing vegetation north of CMP inlet.

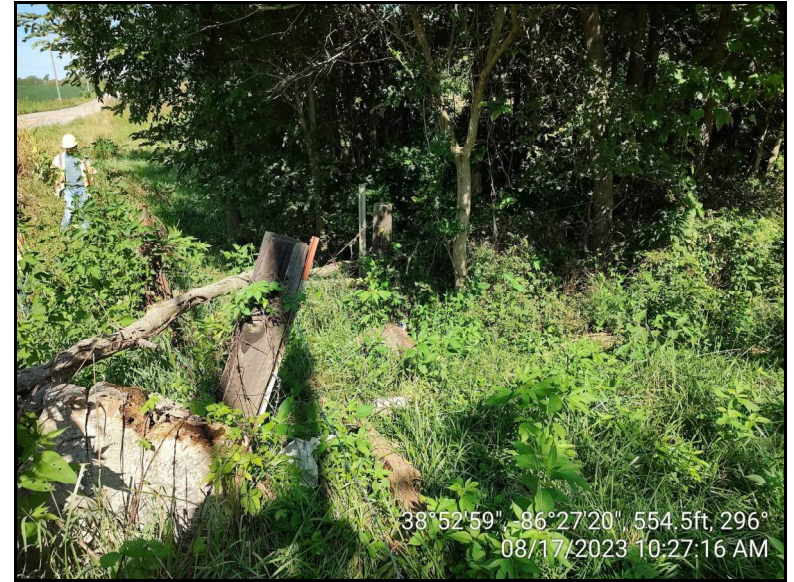
Photograph 57. Taken north of SR 58 east of the CMP, facing east showing RSD 2 (red arrow).

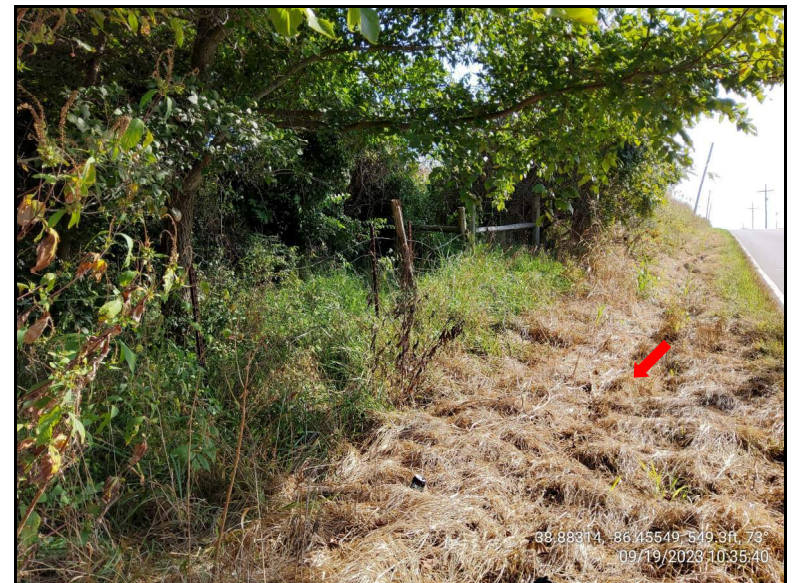
Photograph 60. Taken north of SR 58 at the east end of the investigation area, facing east-northeast showing RSD 2 (red arrow).

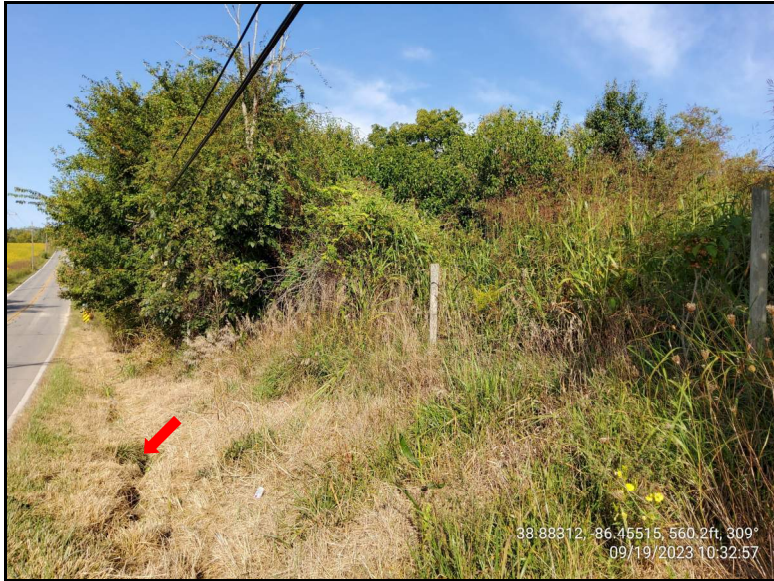
Photograph 61. Taken north of SR 58 in RSD 2, at the east end of the investigation area, facing northwest showing RSD 2 (red arrow) and roadside vegetation.

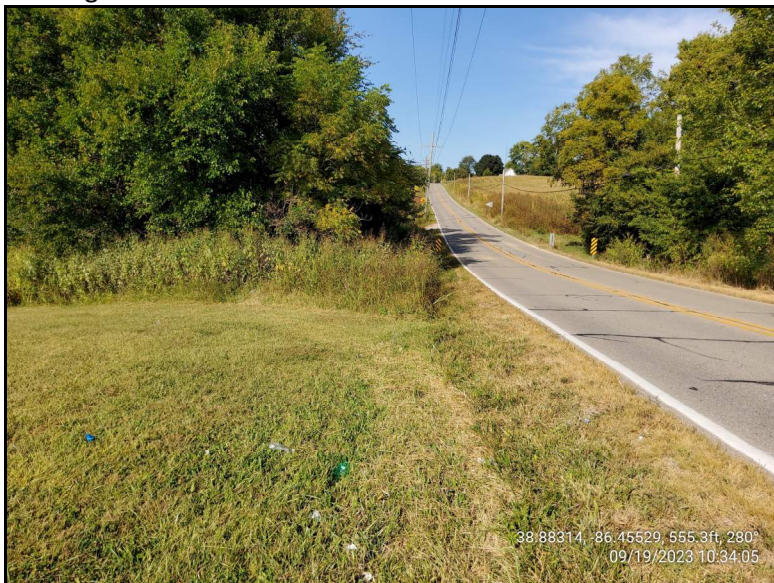
Photograph 63. Taken south of SR 58 at the east end of the investigation area, facing west showing roadside vegetation.

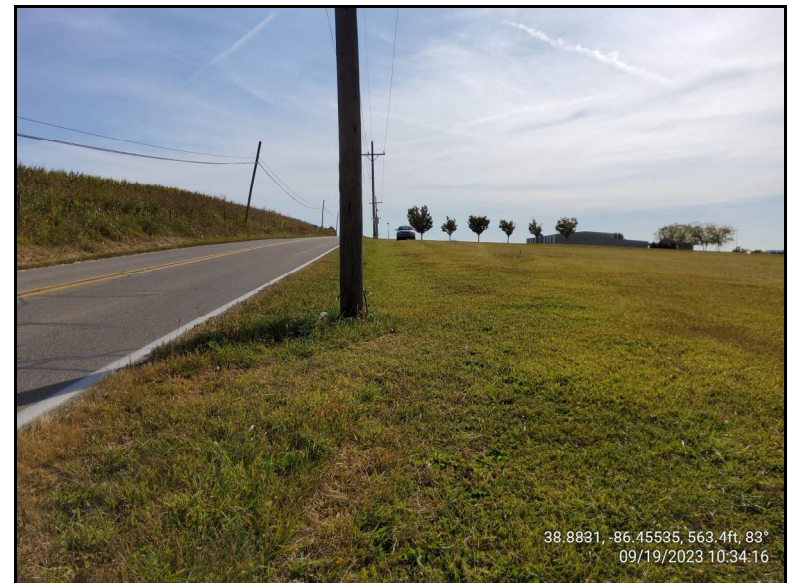
Photograph 64. Taken south of SR 58 at the east end of the investigation area, facing east showing roadside vegetation.

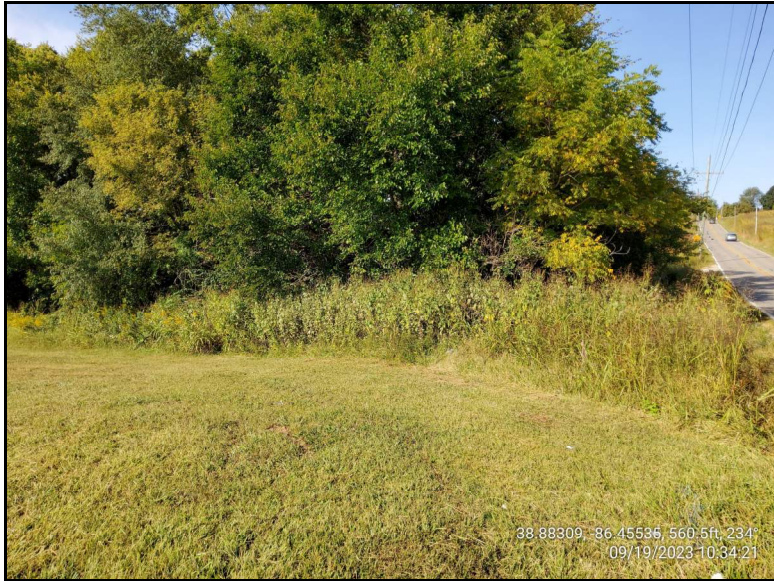
Photograph 65. Taken south of SR 58 at the east end of the investigation area, facing southwest showing vegetation.

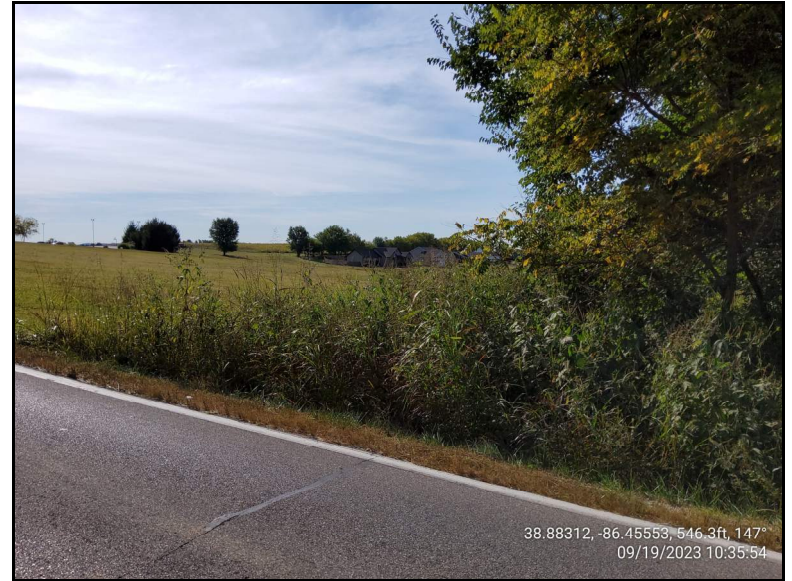
Photograph 66. Taken from SR 58 east of the CMP, facing southeast showing roadside vegetation south of SR 58.

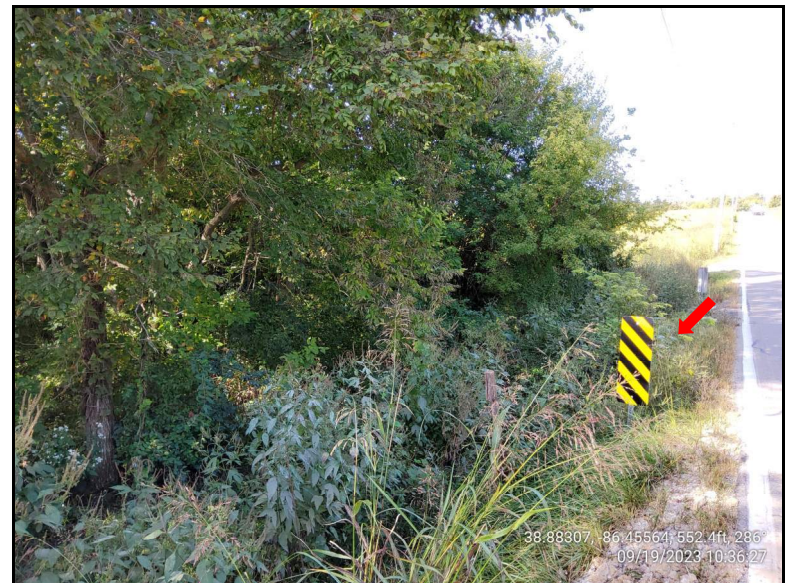
Photograph 68. Taken from SR 58 east of the CMP, facing west showing roadside vegetation south of SR 58. Red arrow indicates CMP.

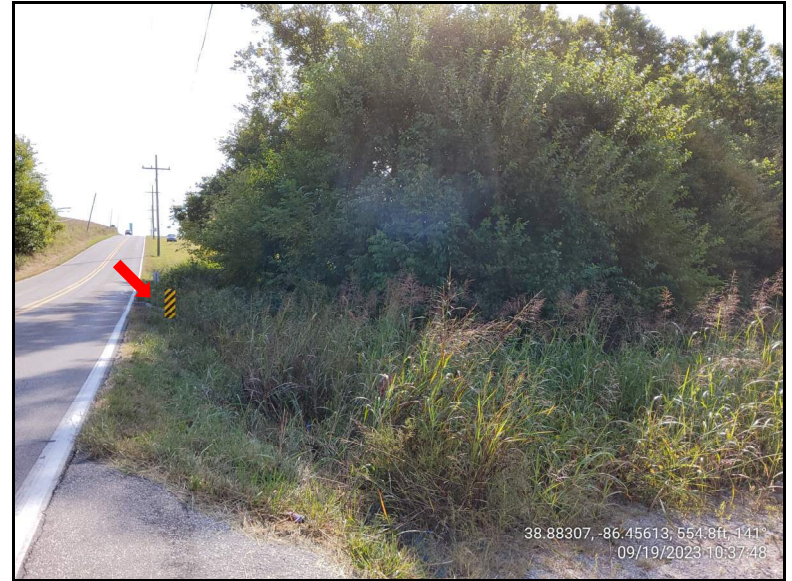
Photograph 70. Taken south of SR 58 west of the CMP, facing southeast showing vegetation and forested area. Red arrow indicates CMP.

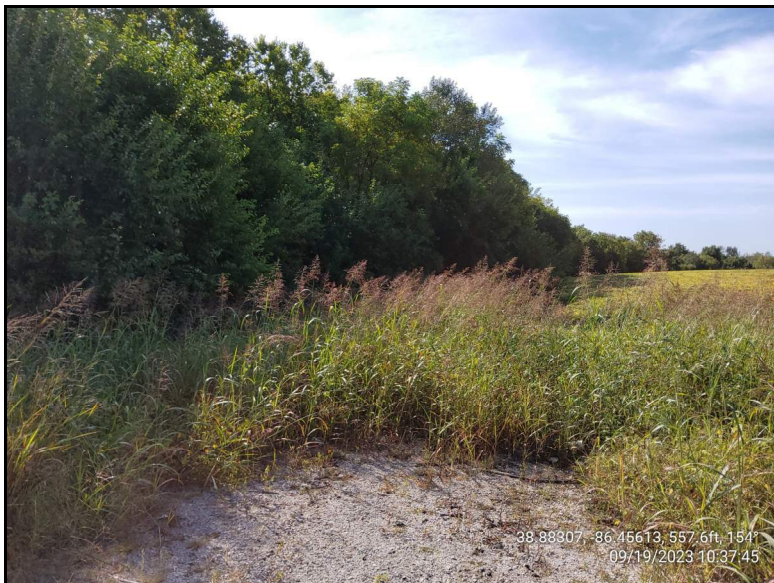
Photograph 71. Taken south of SR 58 west of the CMP, facing southeast showing vegetation and adjacent land.

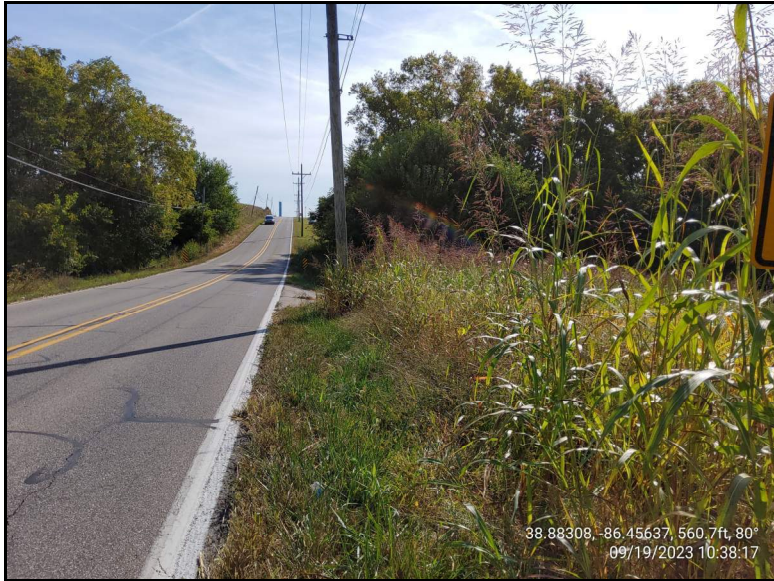
Photograph 73. Taken south of SR 58 at west end of the investigation area, facing east showing roadside vegetation.

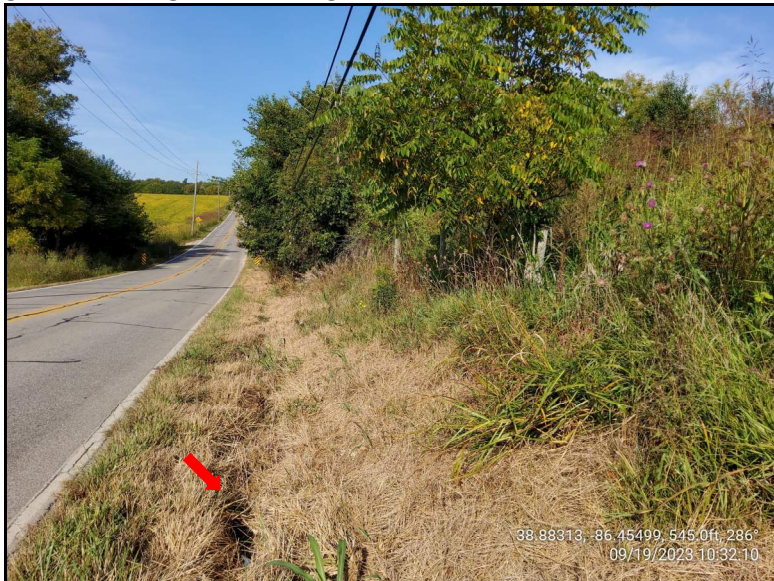
Photograph 75. Taken north of SR 58 at the east end of the investigation area, facing west showing vegetation and adjacent land. Red arrow indicates RSD 2.
