**US30 Safety Study | DRAFT PLAN**

June 1, 2017

# US30 Safety Study

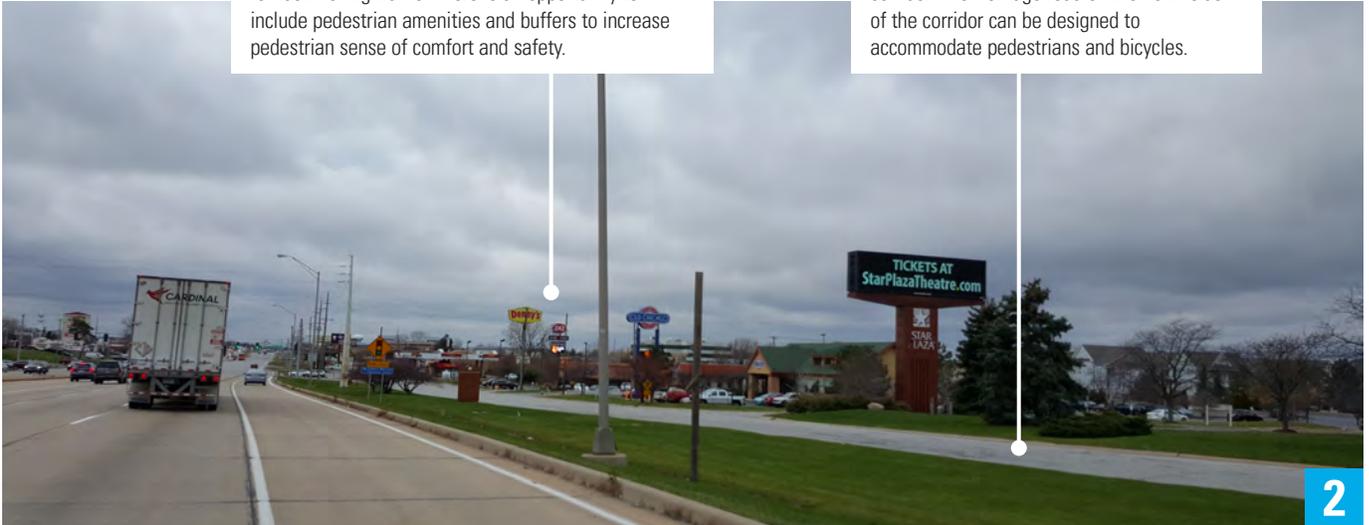
**Frontage Road Barrier**

The frontage road acts as a buffer between commercial/retail businesses and the U.S. 30 corridor. The frontage road on the north side of the corridor can be designed to accommodate pedestrians and bicycles.

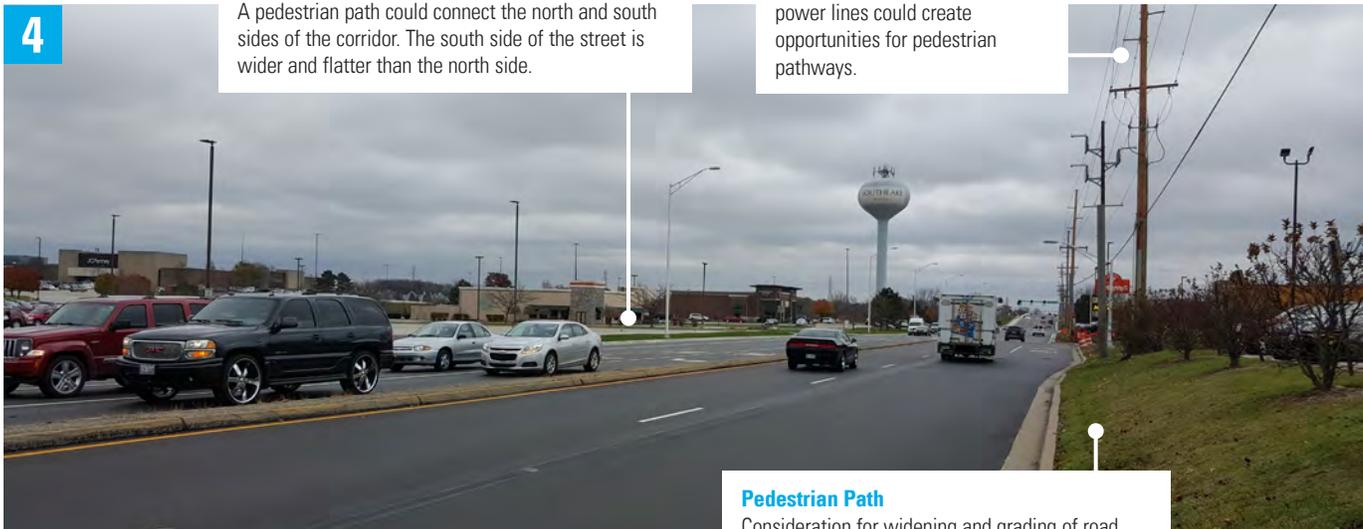
### Overhead Utilities

Removal or relocation of overhead power lines could create opportunities for pedestrian pathways.

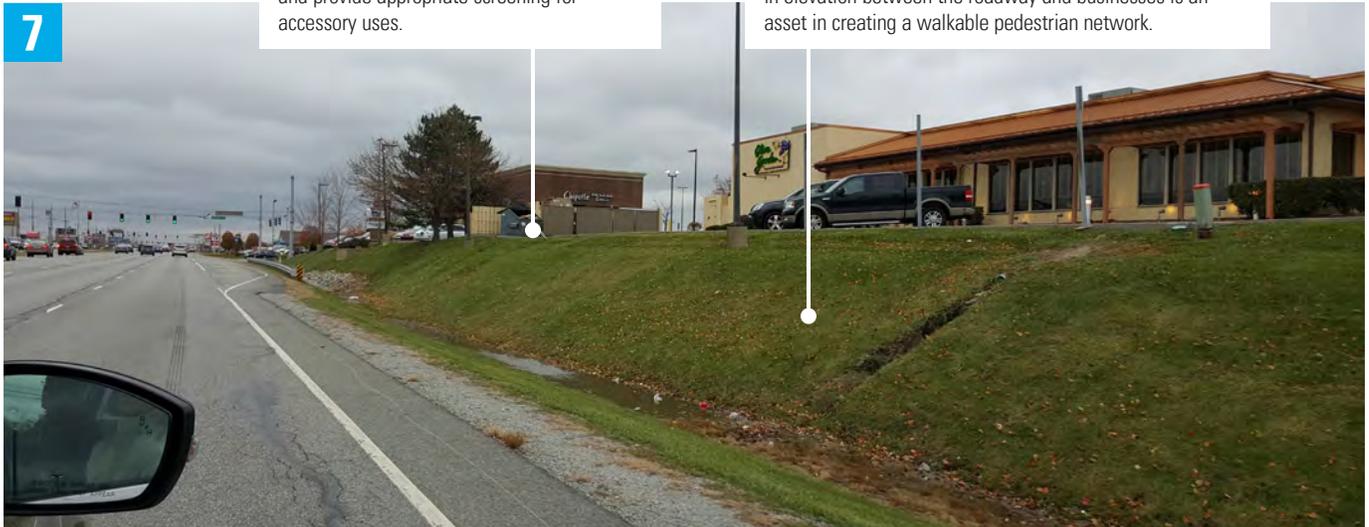
### Pedestrian Path

Landscaped buffers provide pedestrians with a greater sense of safety. A pedestrian path could enhance the corridor and encourage connectivity between uses. Changes in elevation between the roadway and businesses is an asset in creating a walkable pedestrian network.

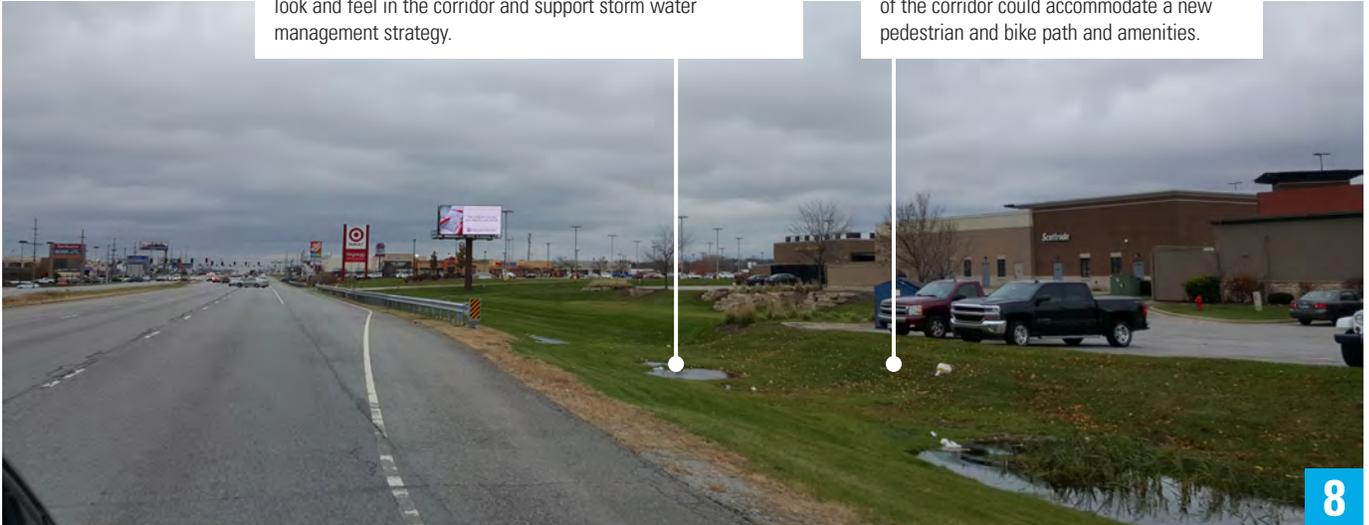
**Landscape Elements**

The landscape identity could be enhanced to create a uniform look and feel in the corridor and support storm water management strategy.

**Pedestrian Path**

A wide landscape area along the south side of the corridor could accommodate a new pedestrian and bike path and amenities.

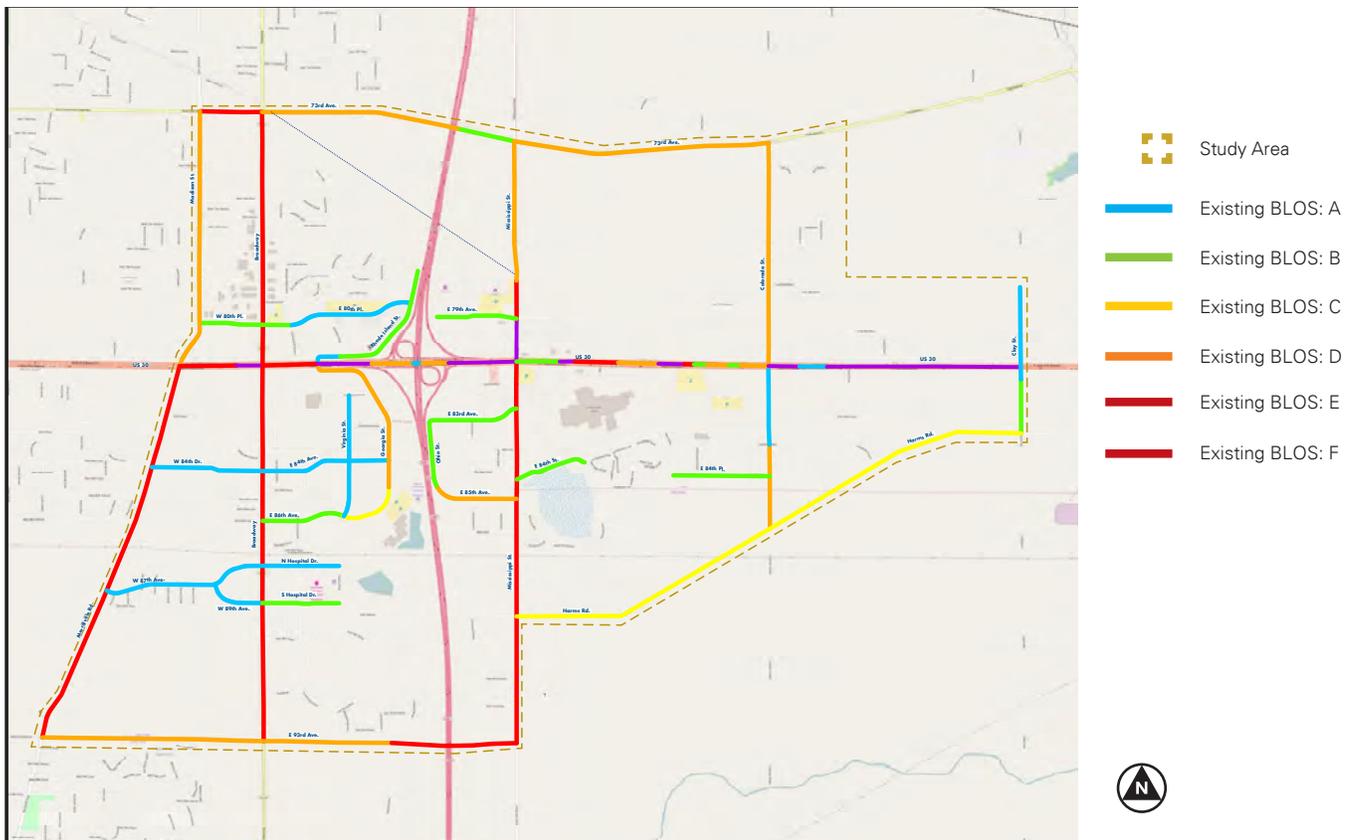
## Existing Bicycle Level of Service Data

Measurements of the mid-block geometry of each route along with the average daily traffic, speed limit, and percent of commercial traffic, were inserted into a Bicycle Level of Service Calculator (BLOS). The BLOS is a nationally-used measure of on-road bicycle level of comfort based upon a roadway's geometry and traffic conditions.

A map was created that summarizes the existing BLOS conditions by color coding those sections that are more suitable for casual riders and those that are currently more appropriate for expert riders.

The following map illustrates the existing BLOS for the routes studied. A grade of "A" through "B" indicates that the route is suitable for a casual rider. A grade that equals high "C" indicates that the route is borderline suitable for casual riders. A grade of "C" through "F" means that only expert riders would feel comfortable riding the route in its present conditions and that an improvement is needed.

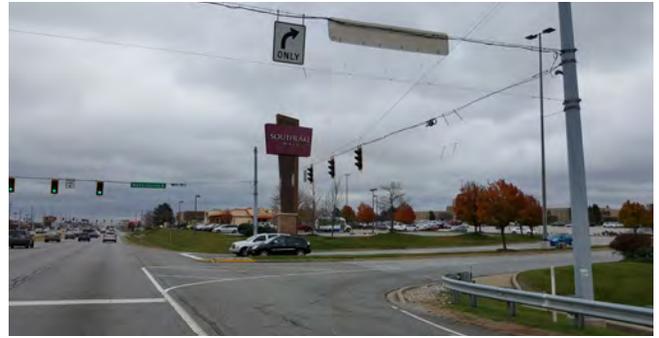
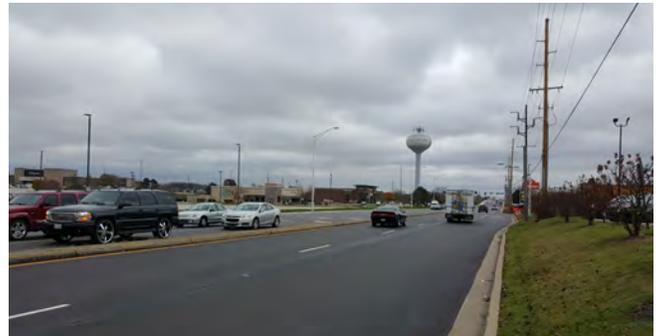
The team analyzed the same corridors for pedestrian level of service that were analyzed for bikeability conditions to see if the corridor would support both biking and walking. Corridors that currently had sidewalks on both side of the streets were deemed as highly walkable, corridors or sections of corridors with a sidewalk located only on one side were deemed borderline walkable, and sections that had sidewalks on neither side of the road were considered not walkable.

A map was then created that summarizes the existing Pedestrian Level of Service (PLOS) conditions by color coding those sections that are more suitable for walking and those that need improvement. Based upon the PLOS map it was determined that most of the residential areas fall into the A and B level and are considered on the high side of walkability. Sections that fell into the C level are considered borderline walkable, and D-F levels are considered less walkable or not walkable.

Existing conditions lack safe routes for bike and pedestrian

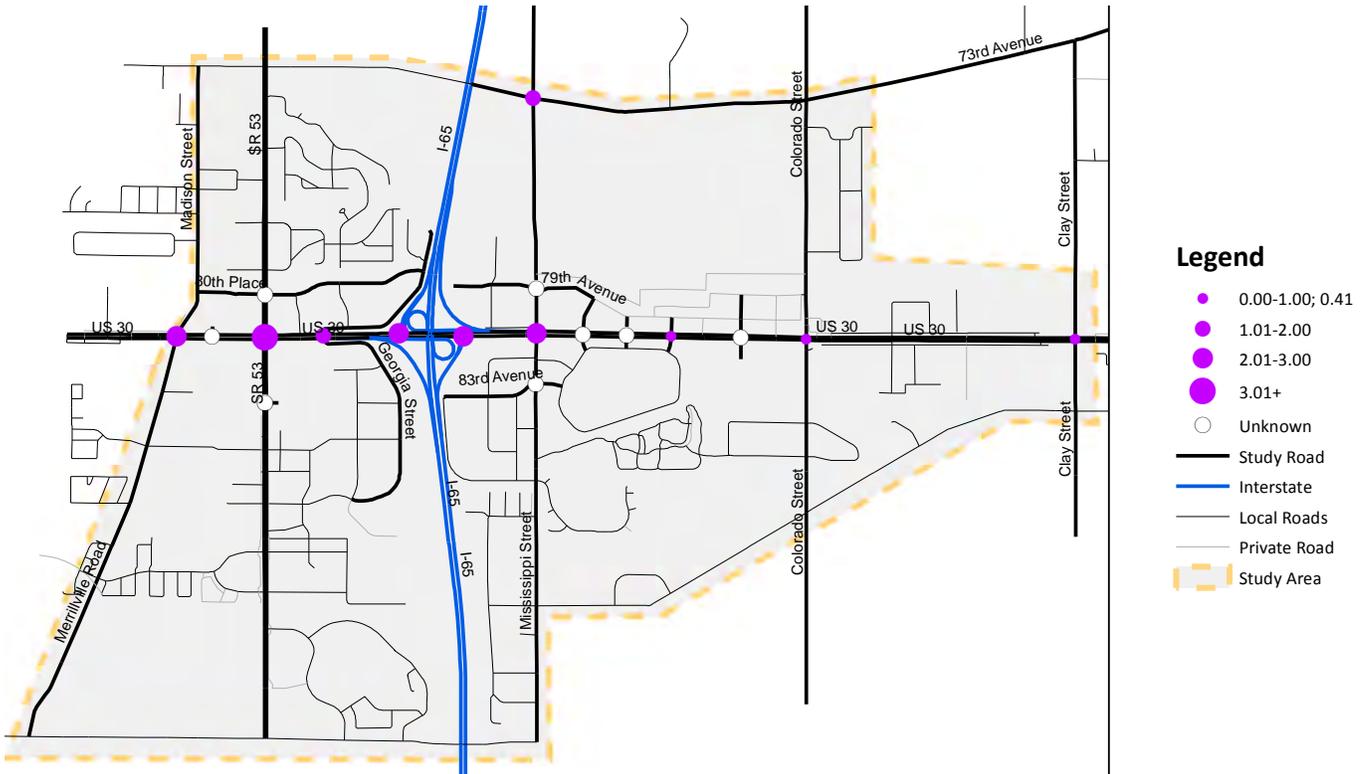
Crash Rates (per M.E.V.) - December 2012 - June 2016

Crash data from all of Lake County was provided from ARIES for a four-year period beginning in July of 2012 and ending in June of 2016. This data was then sorted down to eighteen specific study intersections primarily based on road names, mile markers, GPS coordinates, and officer narratives. It was then further broken down into specific crash data. This included data on the total number of crashes, severity of crash, manner of collision, primary factor for collision, roadway conditions, weather conditions, whether the crash was a result of an emergency vehicle being present, or if a pedestrian or bicycle was involved in the crash. This specific data gives a detailed picture of what types of crashes happened at the study intersections, and gives insight into why crashes happen.

The intersection with the highest number of crashes was U.S. 30 and Broadway Avenue with 378 crashes. Of the 378 crashes, the manner of collision of 232 of them (61.4%) was rear end crashes and the severity of 310 of these crashes (82.0%) were property damage only (PDO) crashes. This indicates that there are a high number of “fender-bender” type crashes at times of high congestion.

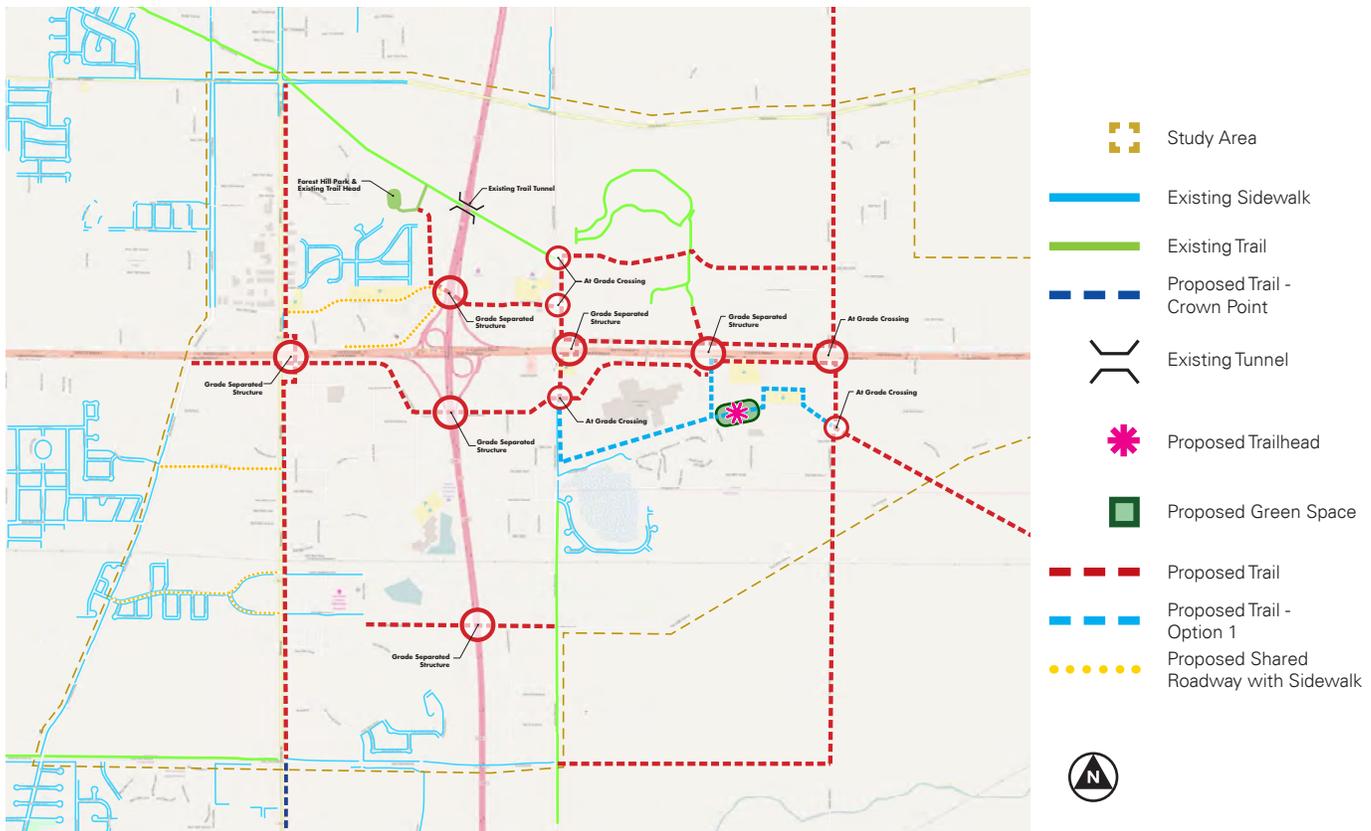
### Proposed Routes Plan

The main objective for the bike and pedestrian plan is to create safe routes from home or work to destinations in and around the US30 corridor while connecting to a larger regional network. Bike lanes are not recommended for streets with high traffic volumes and speeds. Bicycle facilities that separate users from the traffic are recommended. However, low volume low speed access streets to several commercial areas and residential areas may be able to accommodate roadway markings and signage for bikes. Trails are proposed along the south side of US30 along the entirety of the corridor and will include a tunnel under I-65. There is an opportunity to work with mall management to develop a trail on the south side

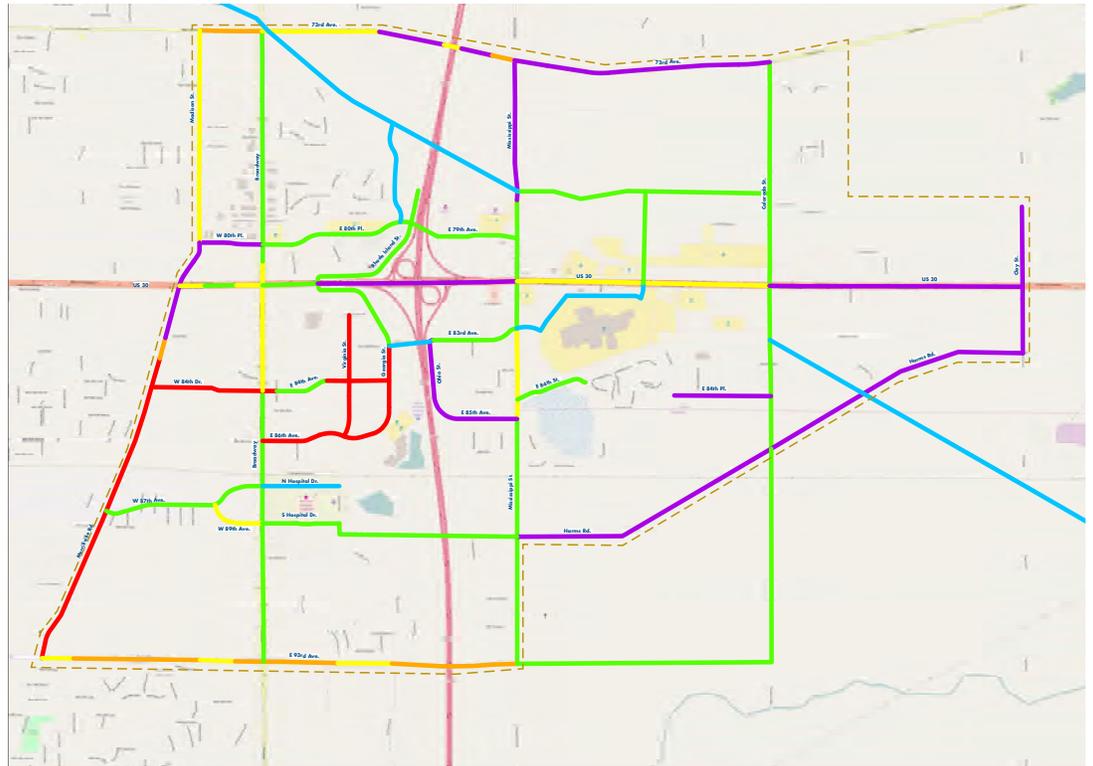
### Proposed Pedestrian Level of Service Plan

Pedestrian and bicycle level of service was analyzed with consideration for incorporation of the proposed improvements. The conditions of the corridor would support both biking and walking. The maps to the right summarize the proposed Pedestrian Level of Service (PLOS) and Bicycle Level of Service (BLOS) conditions. A score of A and B level are considered on the high side of walkability and bikeability. Sections that fell into the C level are considered borderline walkable and bikeable. Levels D-F are considered less walkable or not walkable.

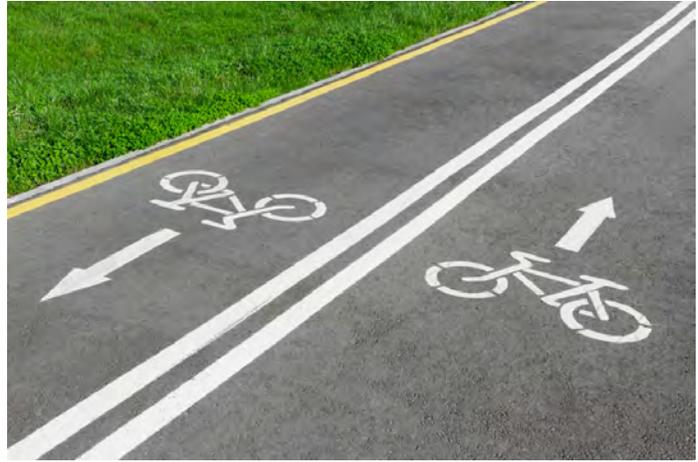
Typical Pavement Markings

A number of multi-use paths throughout the study area are proposed to support the study’s objectives of increasing multi-modal mobility and enhancing safety in the US30 corridor. The new trails will be 10’ wide and asphalt paved. The path will be shared by cyclists and pedestrians and clearly marked for direction and use. A 5’ minimum landscape buffer between the trail and roadway will create a safer experience for both drivers and pedestrians. Greater buffers should be considered where speed limits are higher. The landscape will also be a unifying element along the corridor and will help reinforce its character and identity. Amenities such as benches, trash receptacles and bike parking should be considered at strategic locations. Wayfinding signs and maps should also be used to facilitate ease of use and communicate major destinations and connections. The overall design of all of these elements will be unified throughout the corridor and should coordinate with Hobart and Merrillville standards and guidelines.

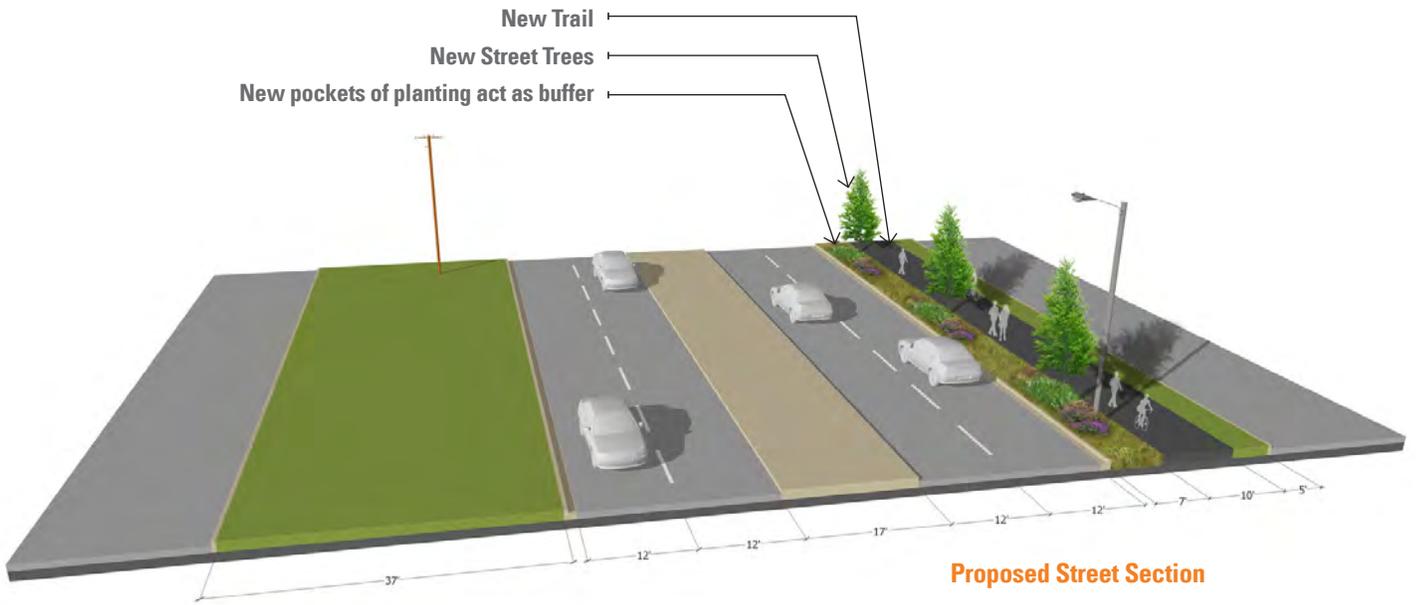
### Streetscape Design: **Broadway**

New Trail  
New Street Trees  
New pockets of planting act as buffer

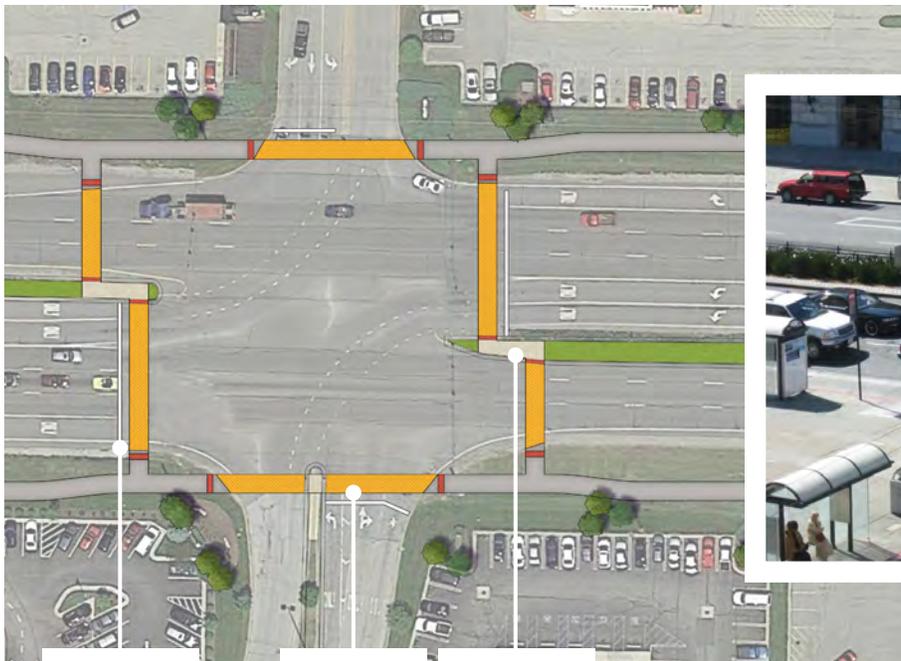
**Proposed Intersection and Crosswalk Improvements**

Pedestrian median refuge islands can be provided within the existing center median along U.S. 30. These center median refuge islands would also include additional pedestrian push buttons for the traffic signal. This would minimize the impact to vehicle operations by having pedestrians cross U.S. 30 halfway per cycle of the traffic signal during peak vehicle times (i.e. the "rush hours"). The crosswalk pavement markings would typically be offset on each half of the roadway which helps to indicate to pedestrians that they will need to pause at the center refuge island and press the push button in order to cross the other half of the roadway. Pedestrians could most likely cross U.S. 30 within one traffic signal cycle during non-peak vehicle times (i.e. during the middle of the day) as the impact to vehicle operations would be minimal. The countdown pedestrian signal heads would provide indication for pedestrians as to when there is enough time to cross all of U.S. 30 within one cycle or just halfway.

**Stop Line shifts to accommodate new crosswalk**

**Crosswalks**

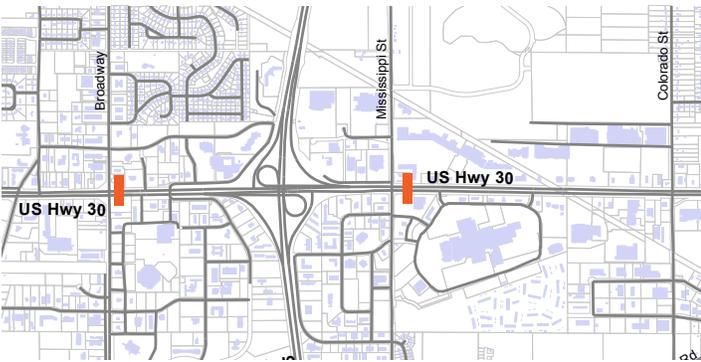
### Pedestrian Bridge Plan - Broadway

Pedestrian bridges are proposed over US30 east and west of the I-65 interchange. A bridge would provide a safe and accessible grade separated route for pedestrians and cyclists to cross US30. Comments received at public workshops supported introduction of pedestrian bridges to increase pedestrian safety and encourage greater pedestrian mobility in the study area. The bridges are proposed near Mississippi St. and Broadway St. These locations were selected because of the high volume of traffic that would be difficult for pedestrians to navigate and opportunities for connectivity to major destinations north and south of I-65. The pedestrian bridge design will provide an opportunity to enhance the character and experience of the US30 corridor through lighting, building materials and architectural form. The bridge can also accommodate gateway signage to communicate information to those visiting the area. All signage and design elements should be coordinated with existing standards and ordinances in both Hobart and Merrillville. The precedent images shown illustrate innovative bridge design and the ability of the design element to support the creation of sense of place.

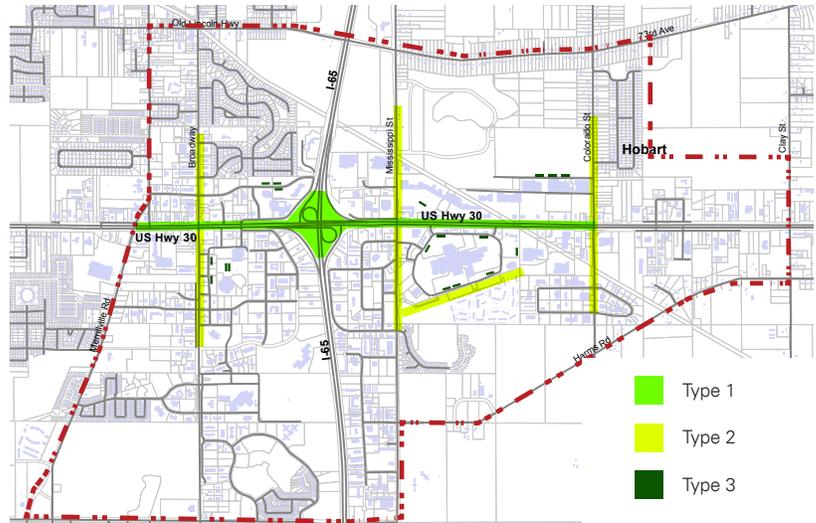
Landscape Improvements Diagram

Landscape improvements along the corridor will create cohesiveness east and west of the I-65 interchange. In addition, it will create a more visually appealing streetscape. Plant palettes can be created that have distinct colors and textures and can be arranged in bands along the highway to enhance the design, viewsheds and sense of movement within the corridor. It is commended that trees be placed in groups along US30. This will help to create scale and improve driver and pedestrian comfort while decreasing driving speeds and allowing for business signage to continue to be highly visible. The addition of street trees is shown to improve economic activity. The grouping of taller, smaller caliper trees will have a positive impact

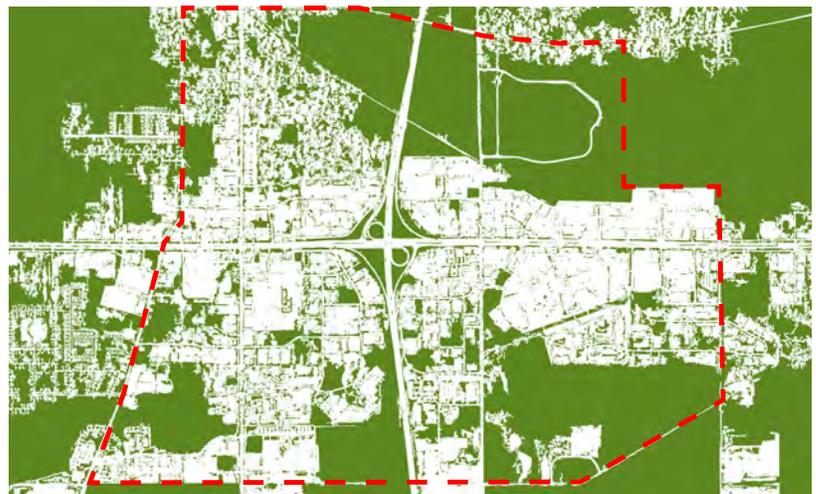
Figure ground diagram of "green" space in the study area

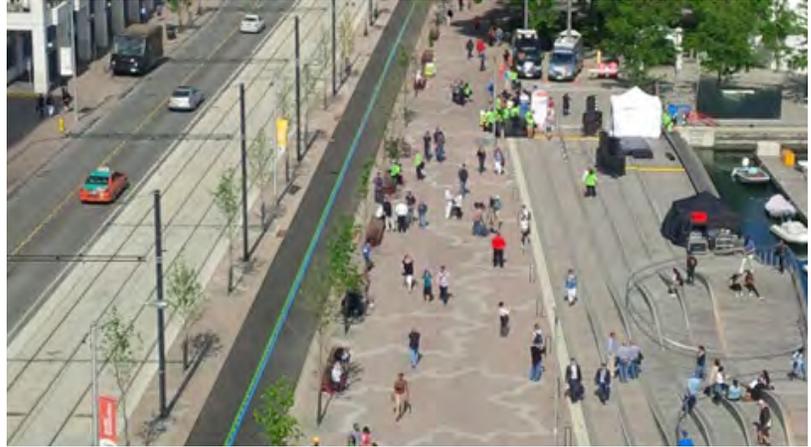
Example of designated pedestrian pathway

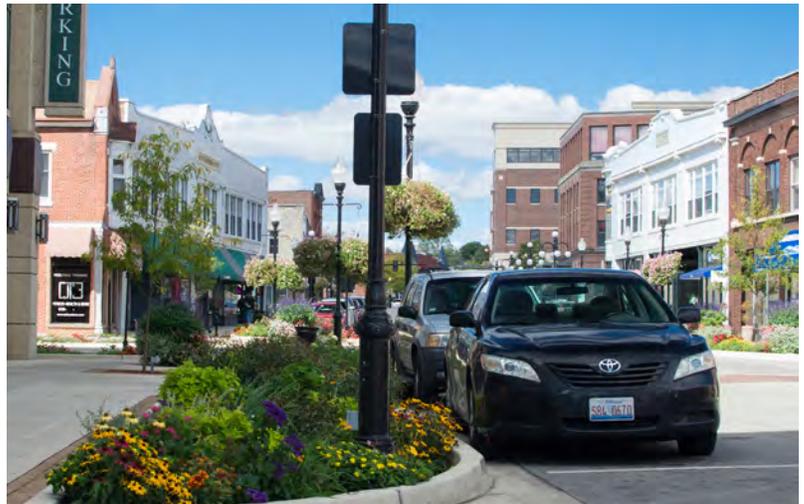
Example of planted median

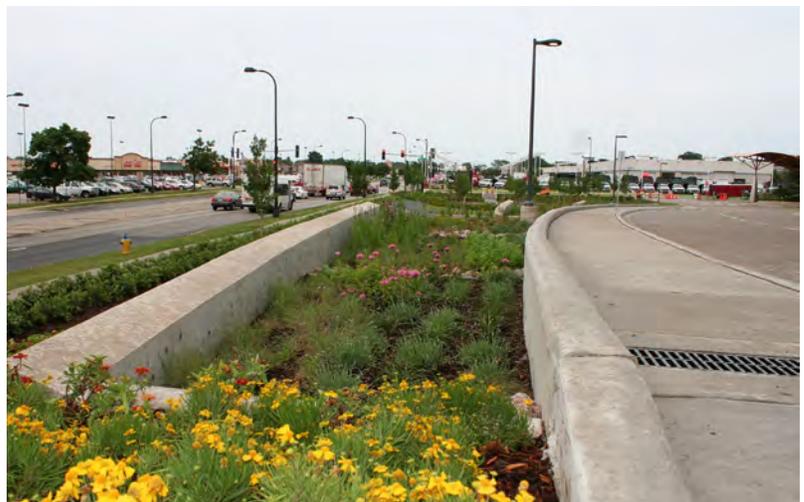
Example of median raingarden

The addition of rain garden medians along U.S. 30 will enhance the visual impact along the corridor. The addition of native plantings and wildflowers will help to soften the edges of the roadway while helping to manage stormwater. These medians are discussed further in a later section.

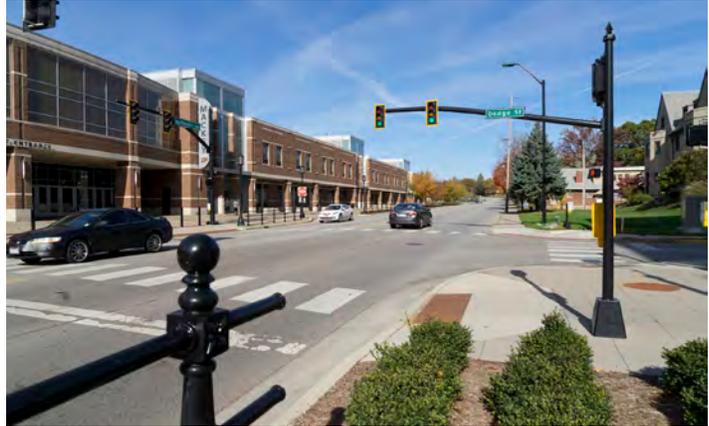
**Black Street Poles**

Currently, utility poles and other streetside elements are mismatched metals or paint colors. It is our recommendation that all street light, traffic signal, advertisement and all other utility poles be painted black. This will create a sense of cohesion along the corridor while drawing less attention to these elements. The images below demonstrate how this low cost option creates a more aesthetically pleasing palette of elements.

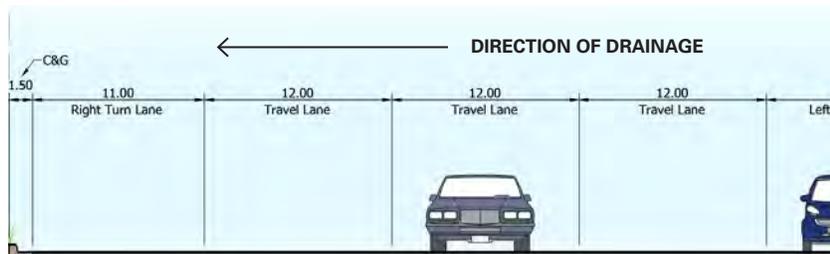
**Current Median Configuration**

The implementation of rain gardens within the open areas of the center median could be considered to beautify the corridor, provide traffic calming and serve storm water runoff functions. A divided roadway section that has an inverted crown (both roadways draining toward the median) consolidates rain gardens to one location, larger underground detention cells can be created, typically encounters fewer utility conflicts in the center of the road, and can utilize existing storm sewer or culverts that may be existing within the median. With the addition of curb and gutter at the existing inside edge of the travel lane, there are several areas along the US 30 corridor that are currently grass medians, that could potentially accommodate a center median rain garden.

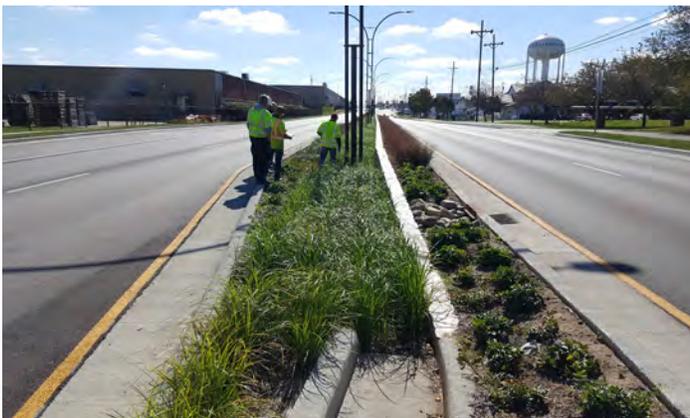
These images to the left portray the center median rain gardens. Features such as rip-rap at the location where water enters (image above) will help to collect any garbage and sediments to help reduce maintenance and increase plant survivability. A 12-18" maintenance zone of gravel could also be added around the perimeter to allow workers a safe area to stand out of the roadway while performing maintenance.

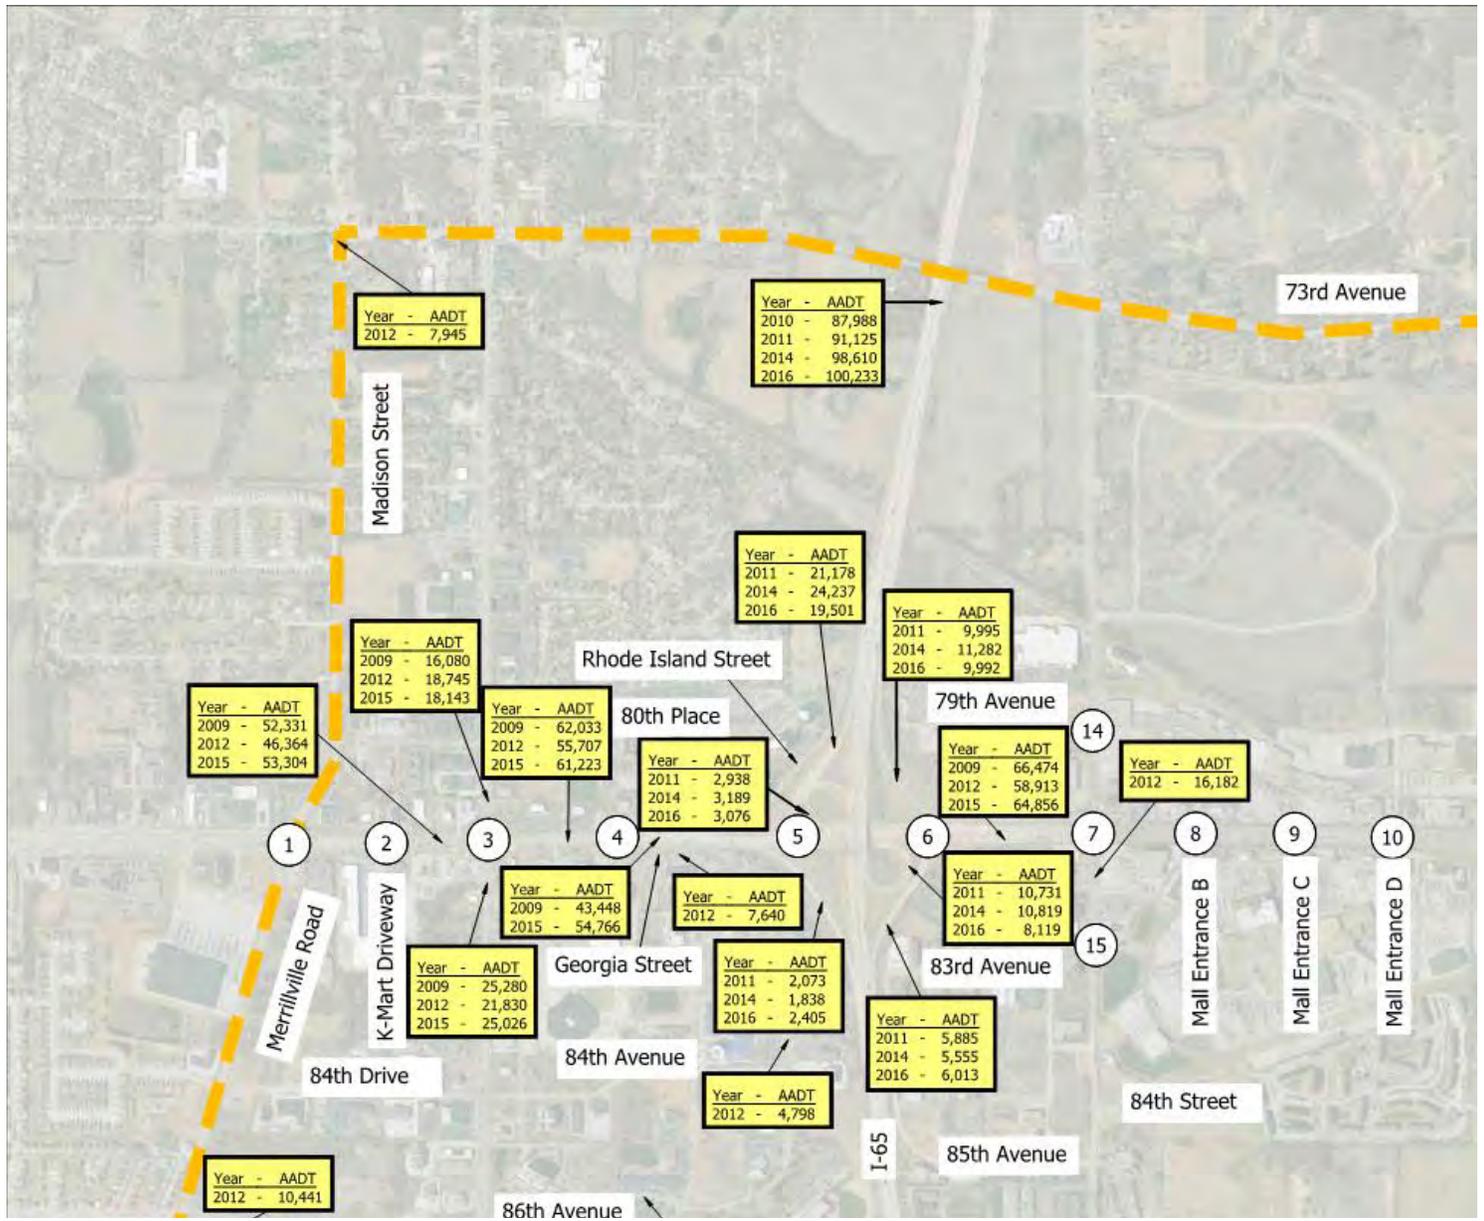
**TRAFFIC VOLUME - FIGURE 2  
COLLECTED AADT'S**

NOTE:  
Annual Average Daily Traffic (AADT) vehicle volumes obtained from INDOT Traffic Count Database System (TCDS).

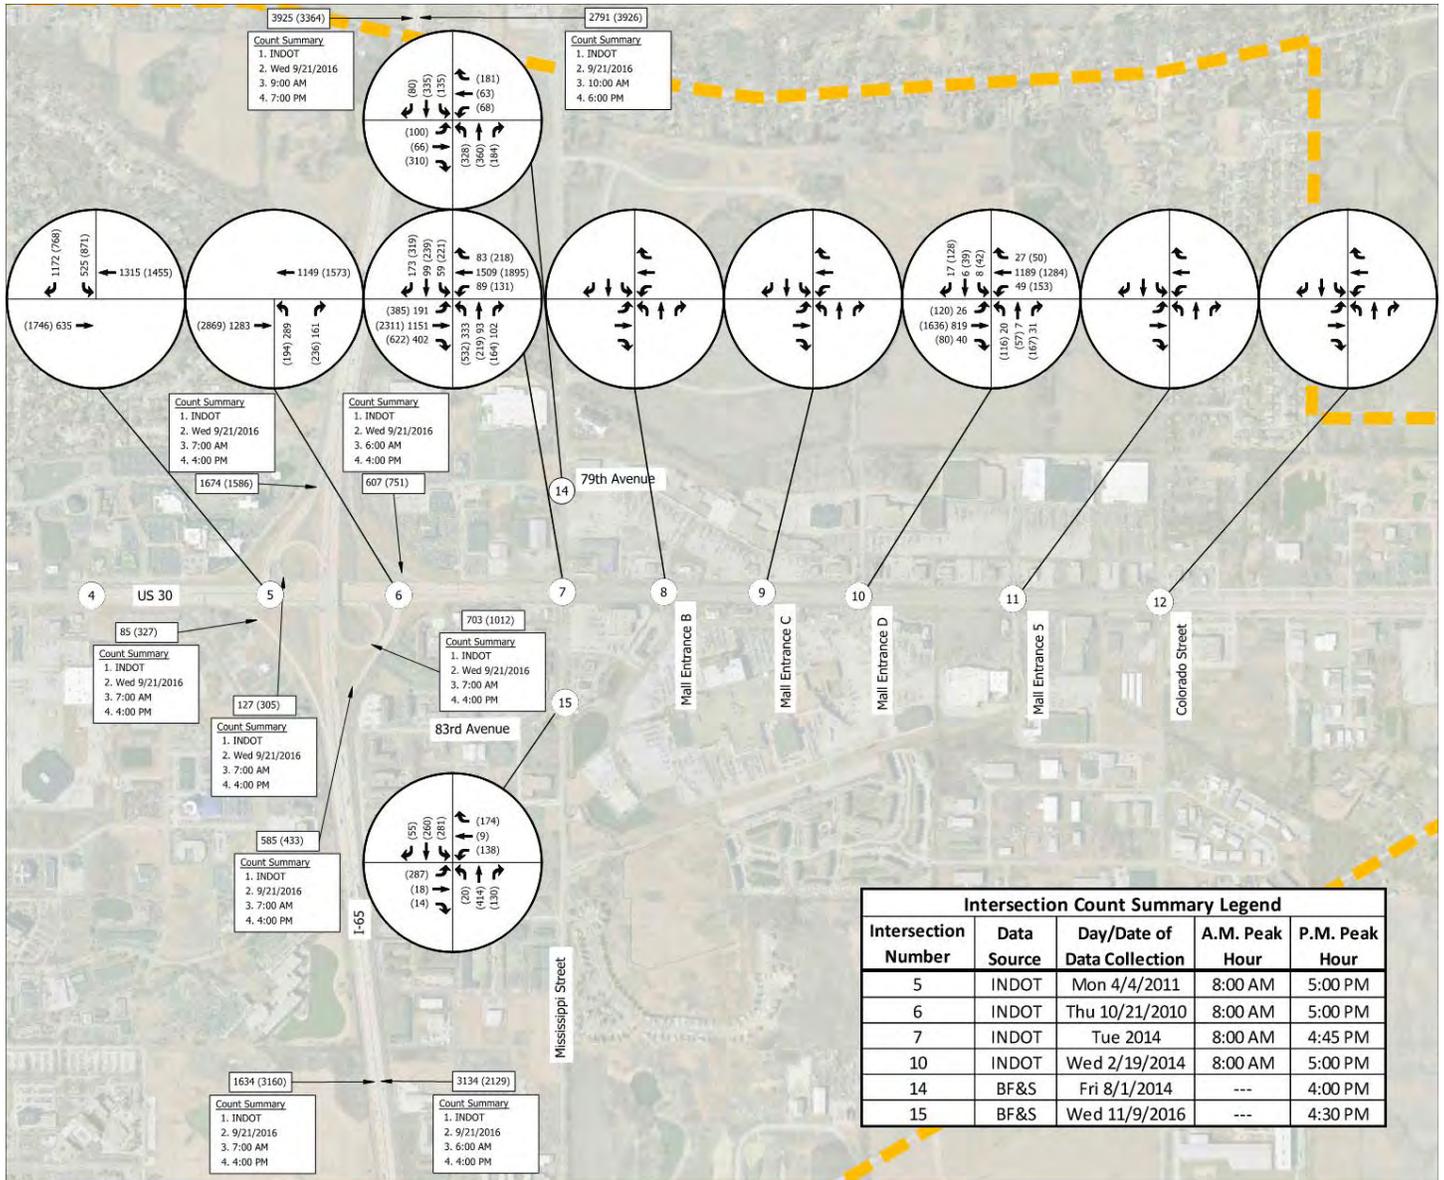
**TRAFFIC VOLUME - FIGURE 3B**  
**COLLECTED INTERSECTION TMC'S AND INTERCHANGE VOLUMES FOR PEAK HOURS**

Intersection Number	Data Source	Day/Date of Data Collection	A.M. Peak Hour	P.M. Peak Hour
5	INDOT	Mon 4/4/2011	8:00 AM	5:00 PM
6	INDOT	Thu 10/21/2010	8:00 AM	5:00 PM
7	INDOT	Tue 2014	8:00 AM	4:45 PM
10	INDOT	Wed 2/19/2014	8:00 AM	5:00 PM
14	BF&S	Fri 8/1/2014	---	4:00 PM
15	BF&S	Wed 11/9/2016	---	4:30 PM
