indiana
TOLL ROAD

ANNUAL STATE OF THE ITR REPORT
JULY 1, 2014—JUNE 30, 2015

Annual State of the ITR and
Capital Improvement Programs Report
July 1, 2014 – June 30, 2015

July, 2015

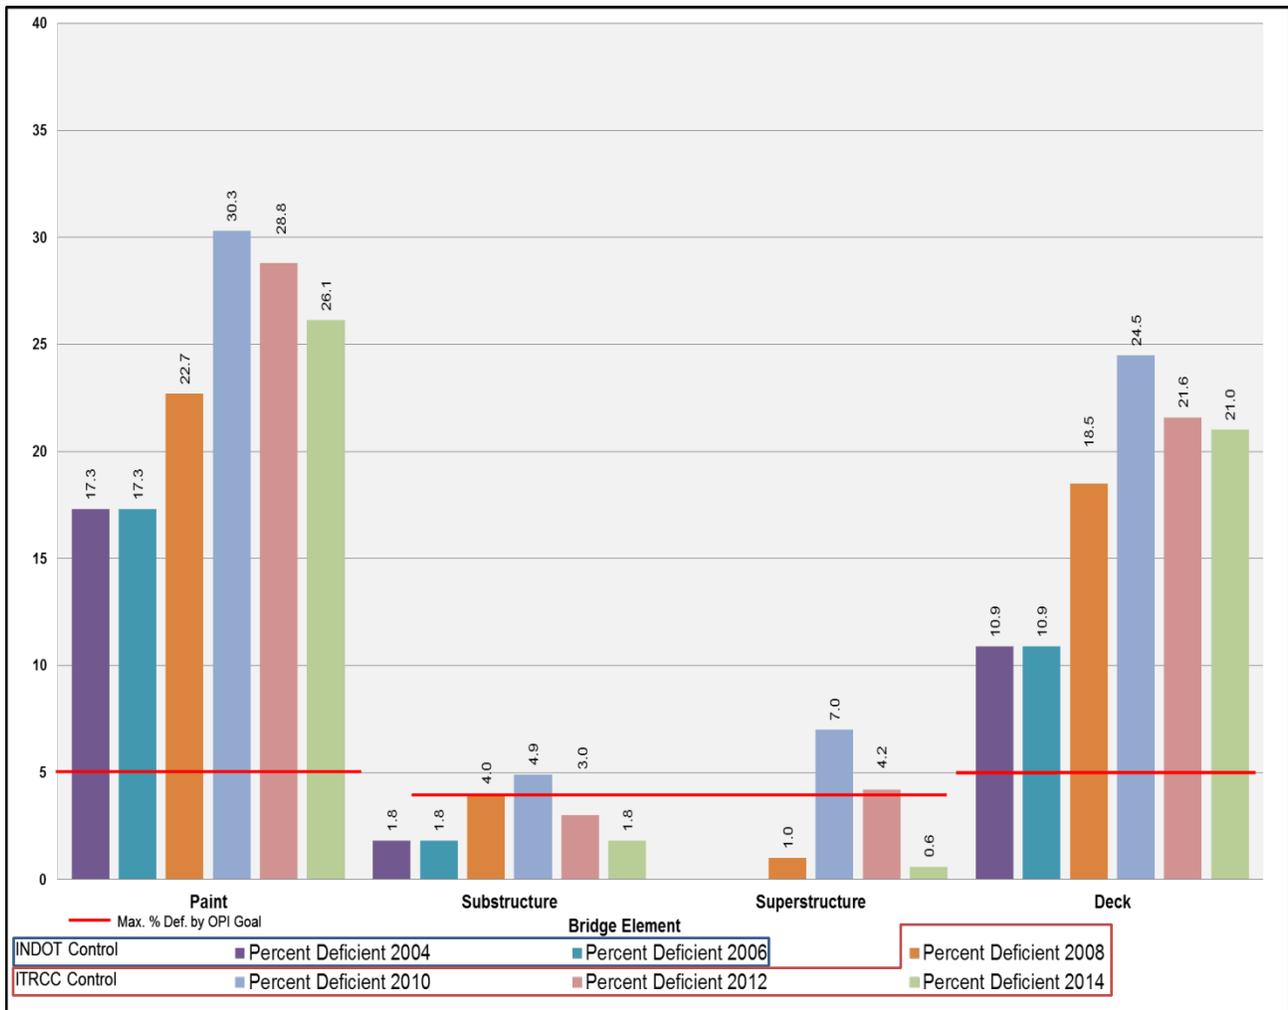
Figure 2.1: Bridge Condition Ratings

The following figure details the conditions of the bridge elements over the period from 2004 to 2014 and results are based on NBIS biennial inspections performed during this period. In general, the protective paint coating is the most deficient element with condition of the concrete bridge decks being the second-most deficient. Statistically, the paint and wearing surface ratings, the deck, superstructure, and substructure ratings have improved. The most recent inspections were performed by INDOT Certified Bridge Inspection Team Leaders and were inspected in a thorough and complete manner in accordance with the NBIS standards.

As the following table details, the majority of bridge elements are rated as “excellent” or “good”. There has been a decrease in the percent deficiencies of the individual items compared to the previous year.

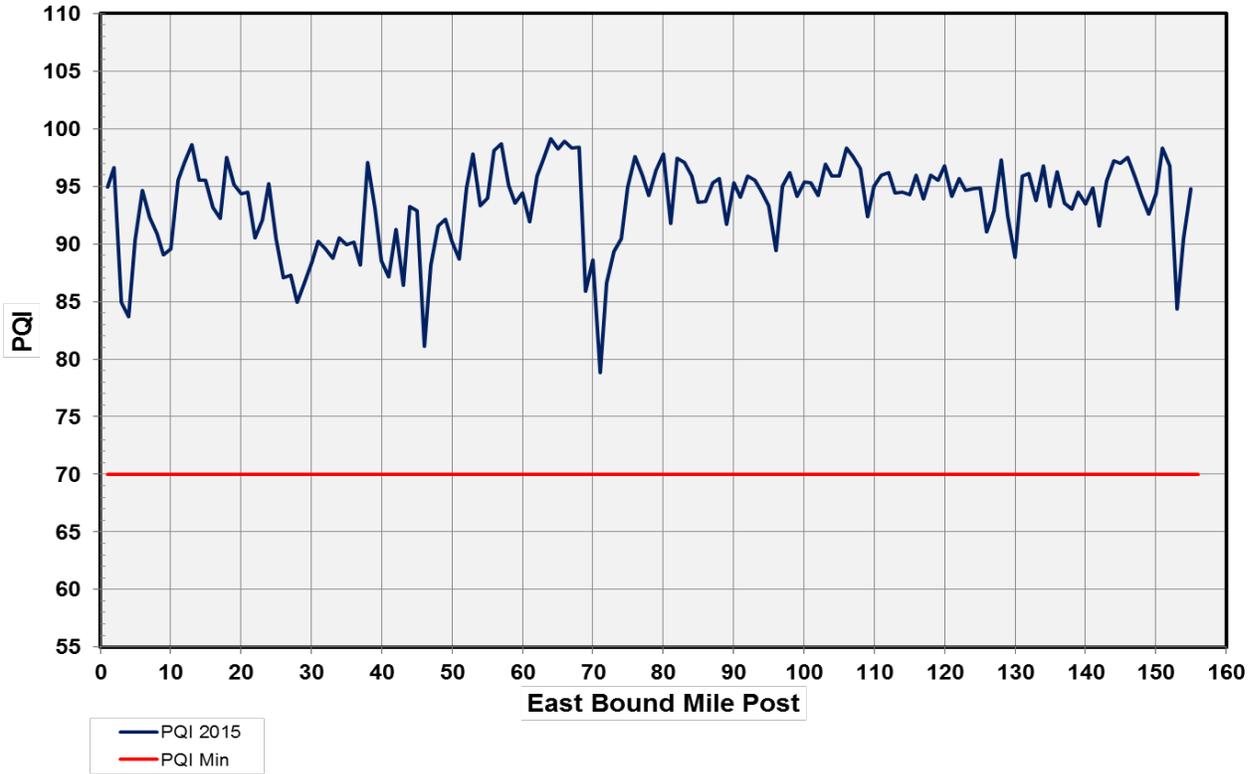
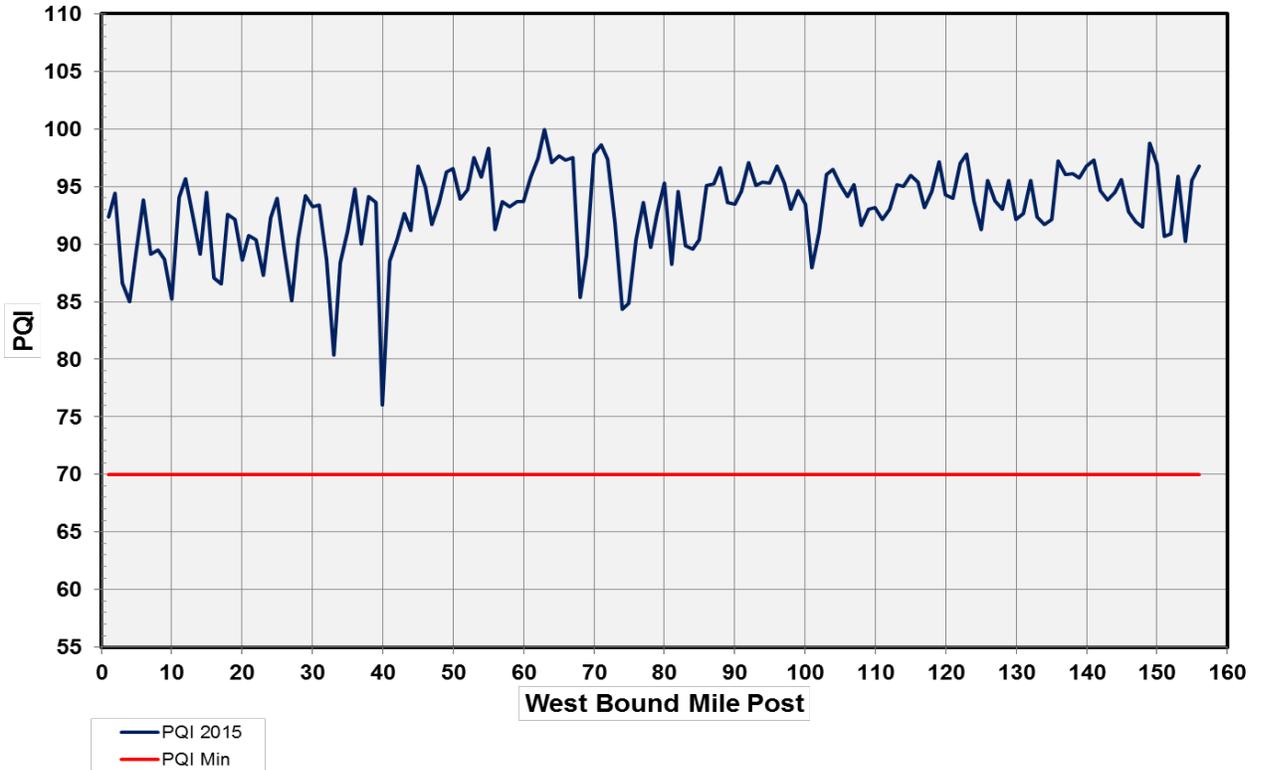
As the following tables and figures illustrate, the average PQI for the Toll Road mainline is 93, which is considered "excellent". 0% of the mainline is rated in "poor" condition and 0.6 % is rated in "fair" condition. The Toll Road District's OPI goals for mainline PQI have been met. Furthermore, in accordance with the OPI Manual ratings system, the Toll Road mainline is rated a 6 on a scale from 0 (worst) to 6 (best) for the mainline pavement.

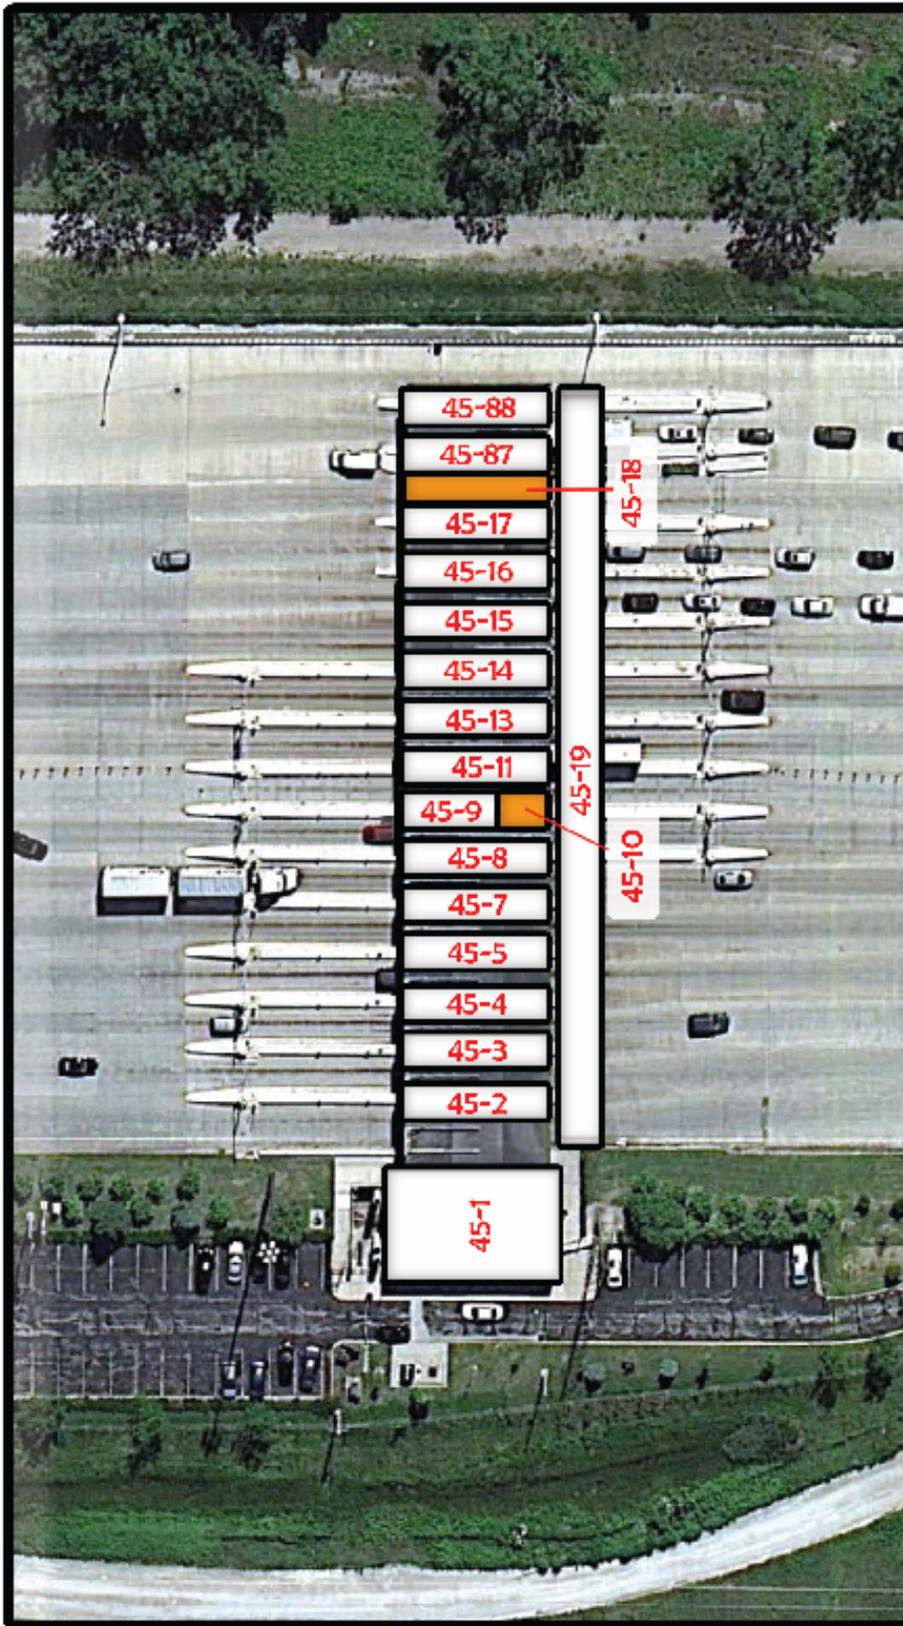
TOLL PLAZA
WEST-POINT
1 BARRIER
Mile Point 1.1

Priority	Discipline	Findings/Remarks	Completed
1	Electrical	Conduit in stairwell is rusted and open. Replace conduit.

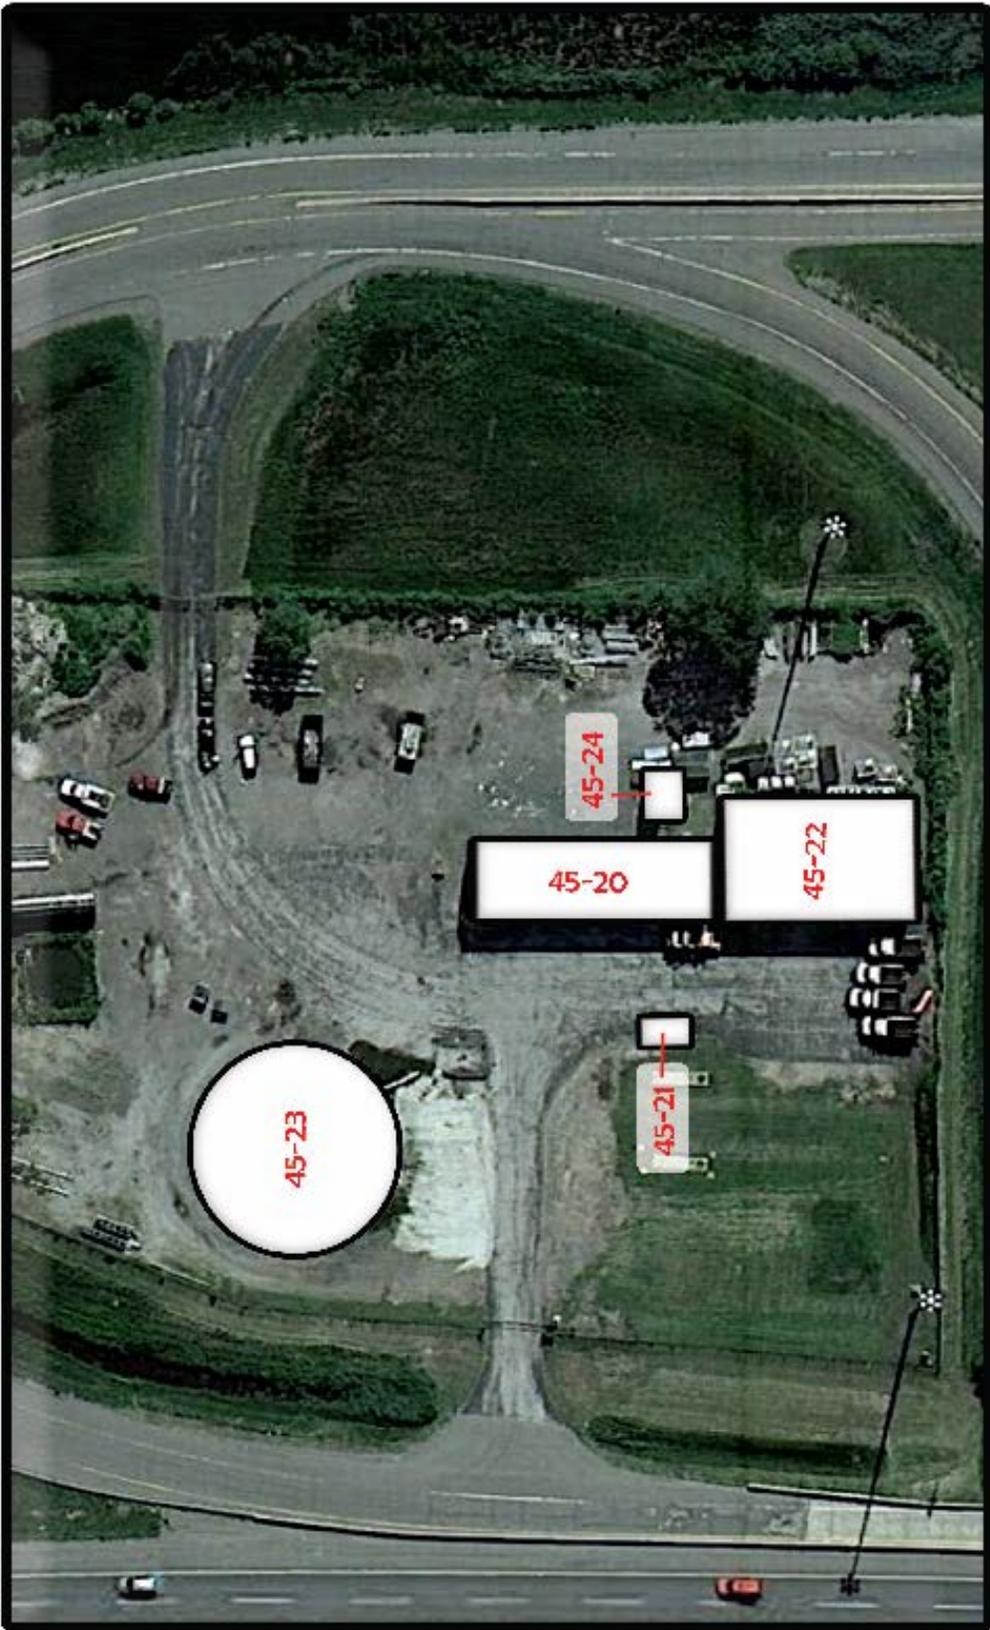
**AUXILIARY
STORAGE AREA**
Mile Point 4.6

Priority	Discipline	Findings/Remarks	Completed
1	Architectural	Door lock set is missing to kitchen area. Install door lock set.	
1	Architectural	Entrance door is an exit and lacks proper exiting door hardware. Install door exiting hardware (life safety).	
1	Architectural	Replace the door frame hardware in the N/W corner of the building and the door on west wall. The door is rusted shut and has no door handle (life safety).	
1	Electrical	Provide emergency egress lighting as existing emergency lighting is not operational.	
1	Electrical	Near Northern door, provide proper support of outlet box cover.	
1	Plumbing	Replace p-trap that is leaking in garage at service sink.

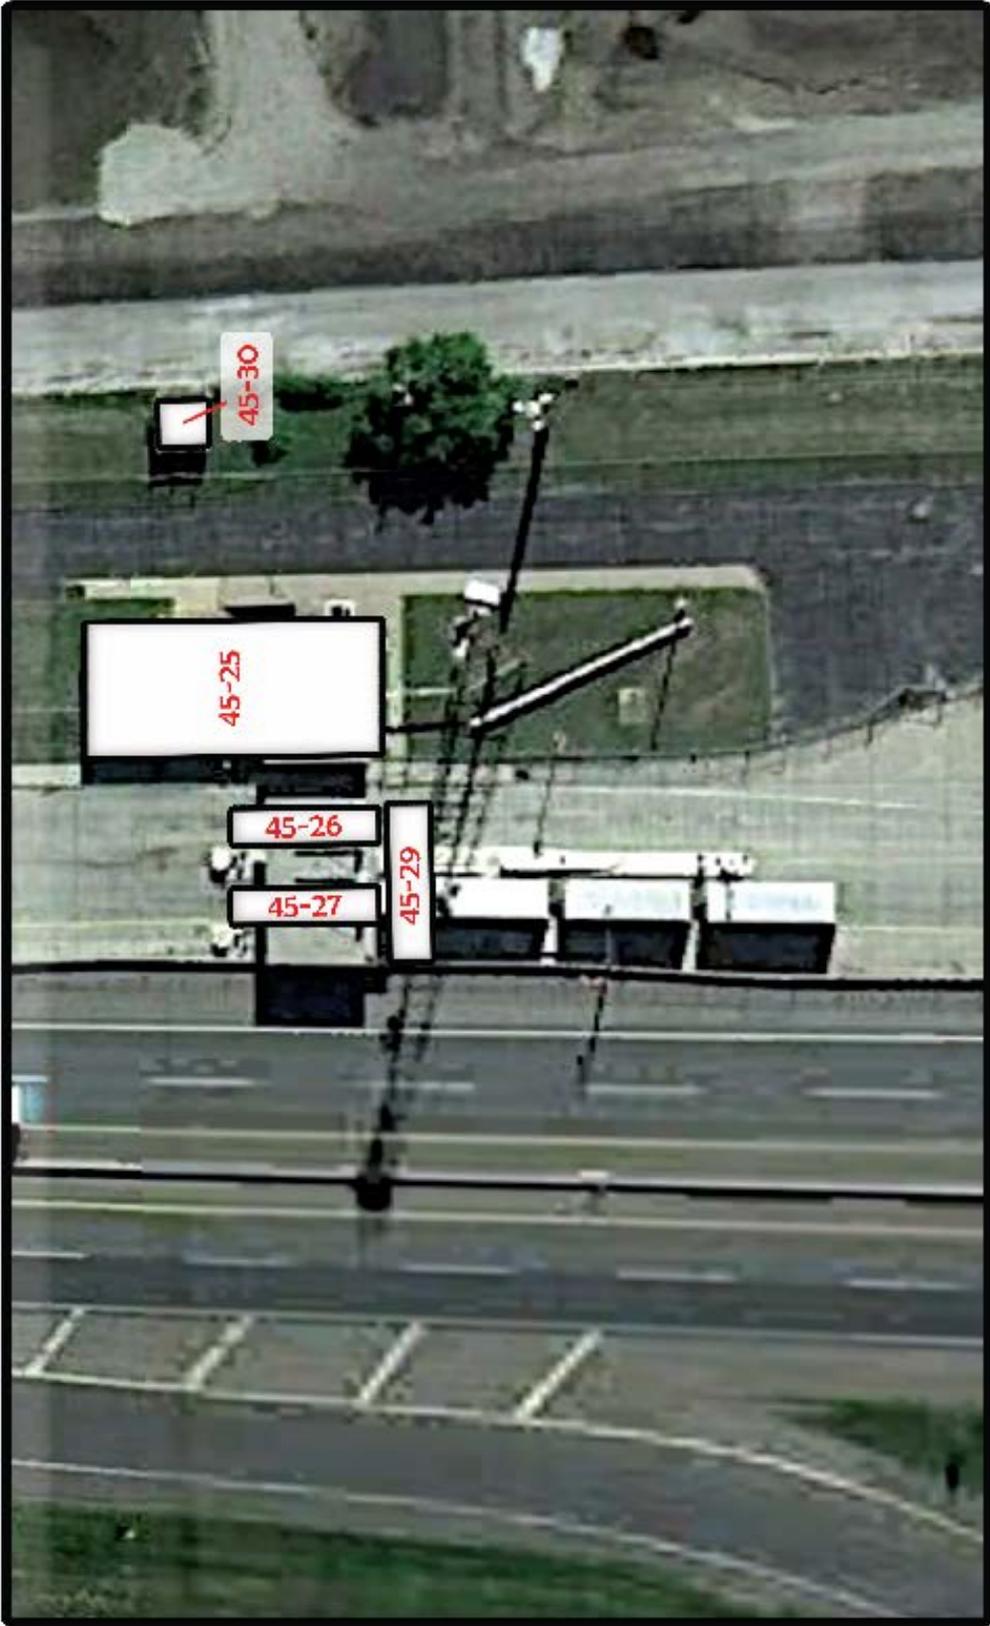
TOLL PLAZA
5 (W)
CALUMET
AVENUE
Mile Point 4.7

Priority	Discipline	Findings/Remarks	Completed
1	Architectural	Replace rusted and bent panel on the entrance door. The pair of doors/frame/hardware are missing door handles. Install new handles.

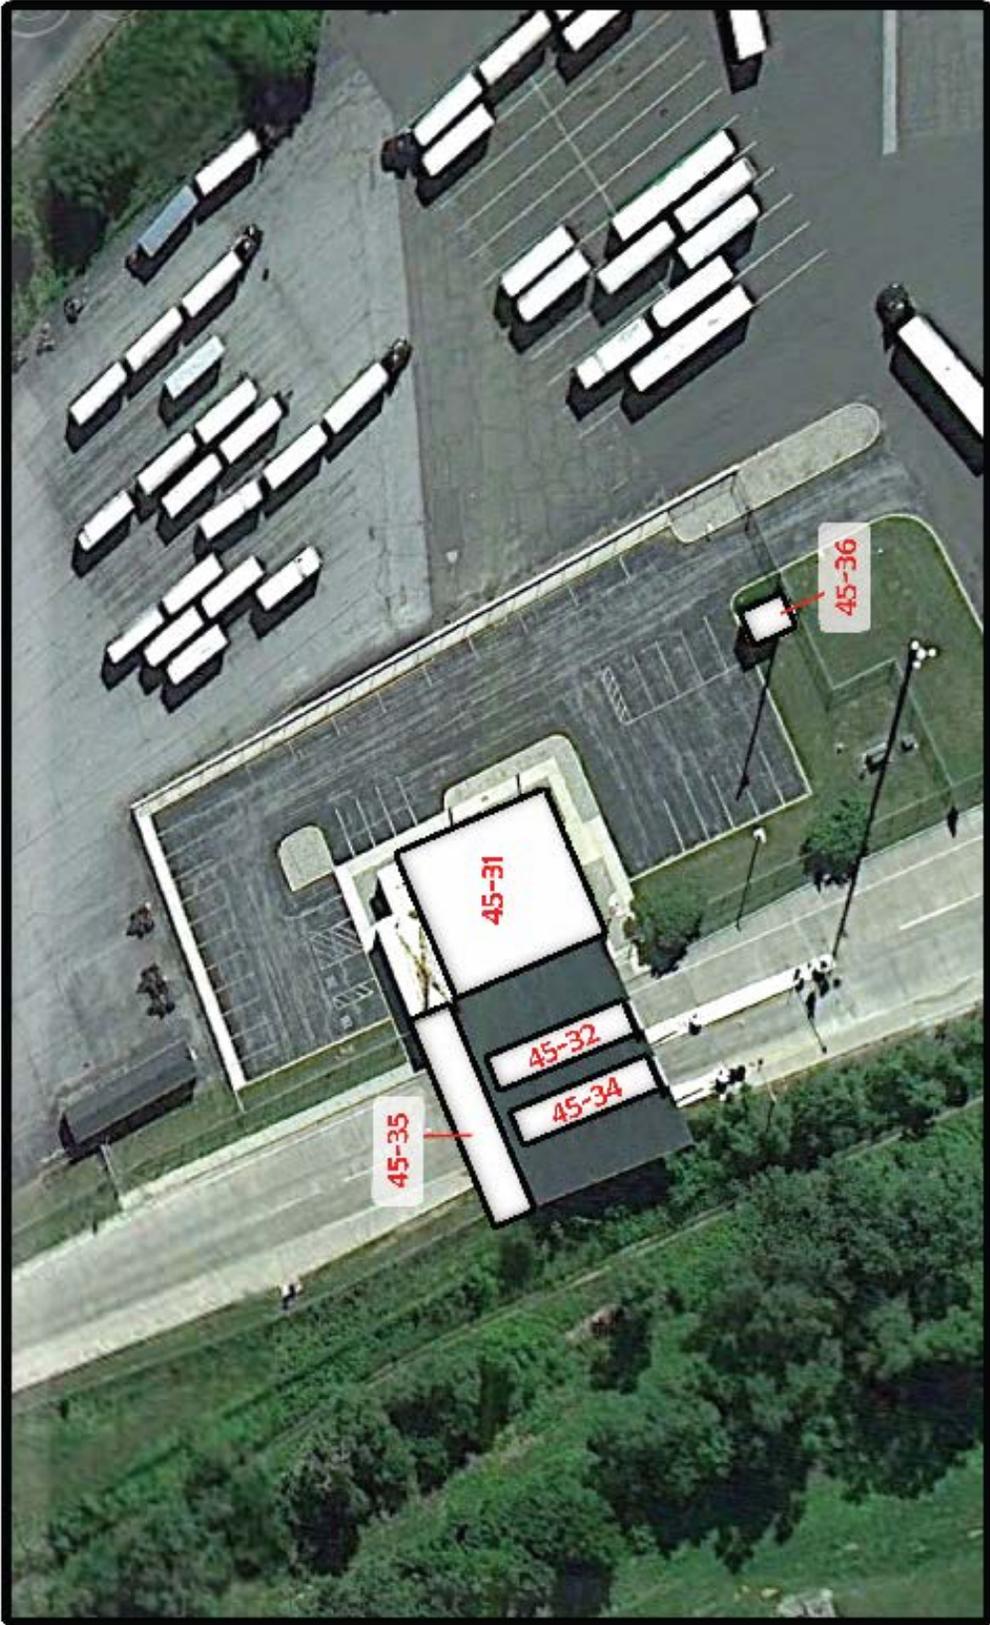
TOLL PLAZA
5 (E) AVENUE
Mile Point 4.7

Priority	Discipline	Findings/Remarks	Completed
1	Architectural	Repair broken roof leader.	
1	Electrical	Replace missing canopy light fixture lense or replace fixture.	
1	Mechanical	Near the West end of the canopy, there is a broken roof drain pipe that needs to be replaced.

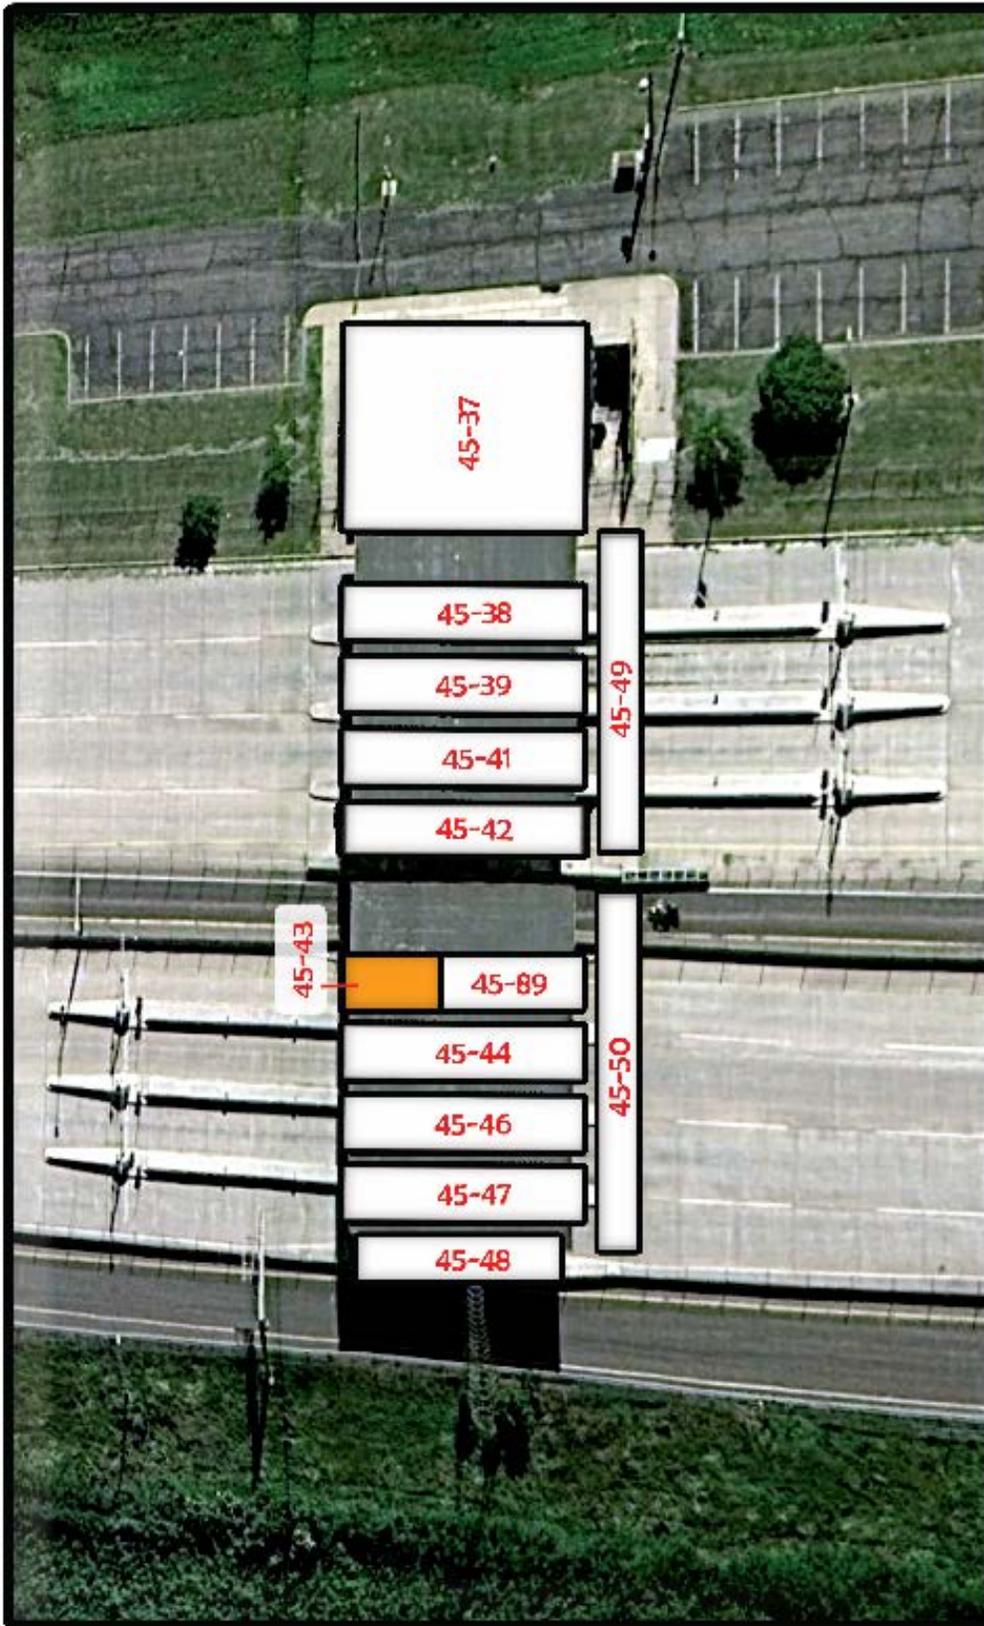
TOLL PLAZA
CLINE
10
AVENUE
Mile Point 10.1

Priority	Discipline	Findings/Remarks	Completed
1	Architectural	Heavy corrosion of steel frame - replace components and paint as req'd.

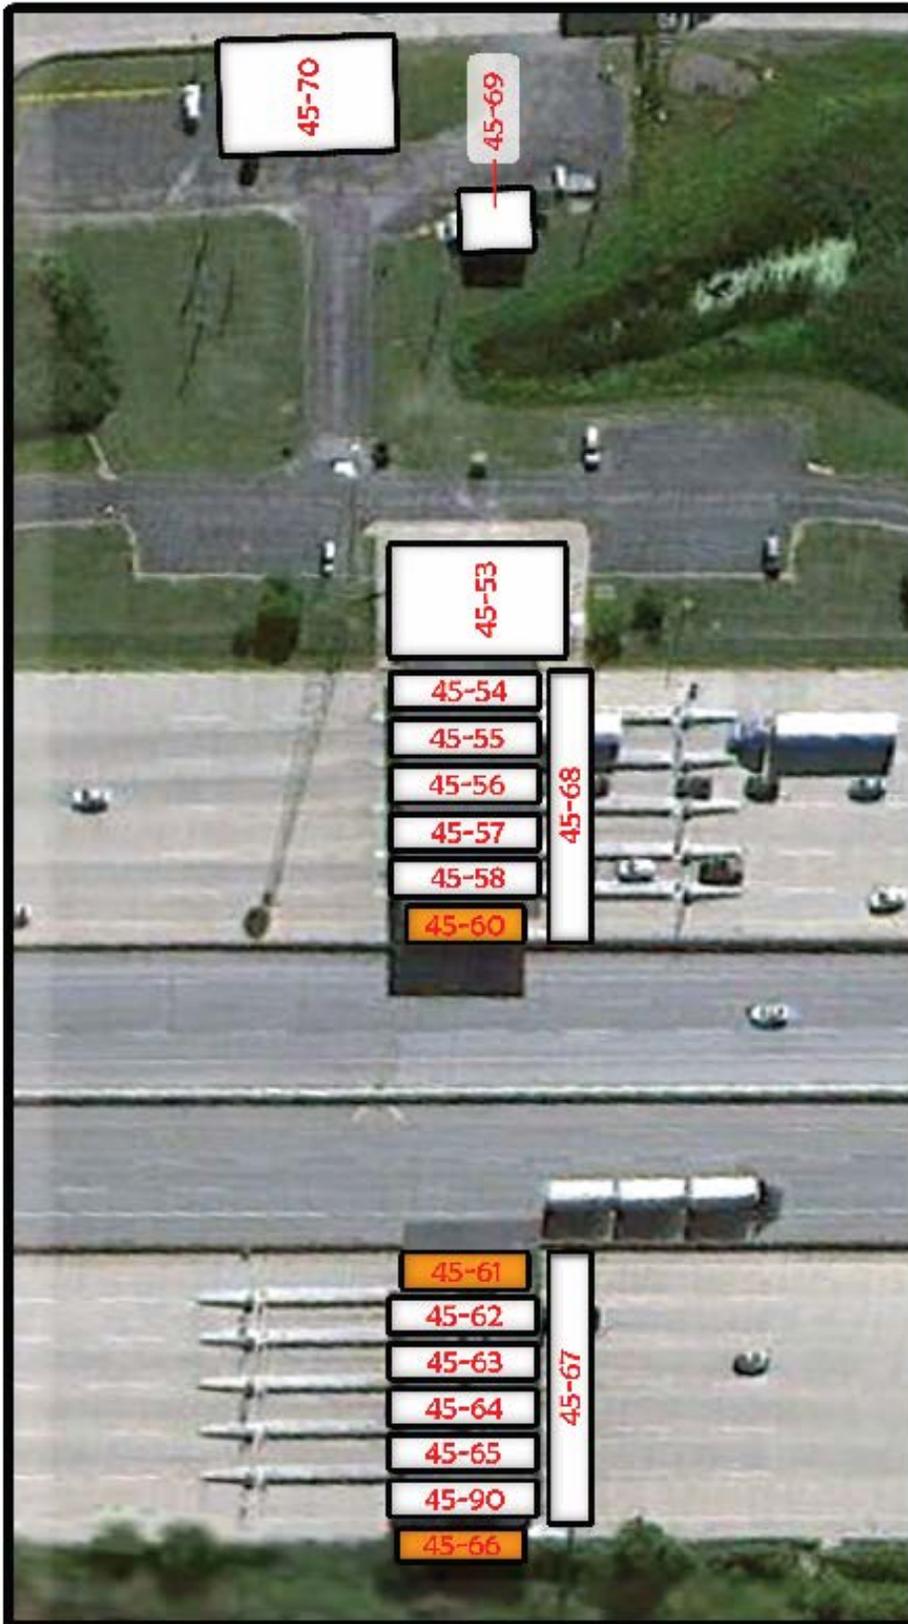
TOLL PLAZA
17^{CARY EAST}
Mile Point 16.7

Priority	Discipline	Findings/Remarks	Completed
1	Electrical	Provide exit/emergency egress lighting in basement and in tunnel.	
1	Mechanical	Building equipped with a rooftop unit, install clean filters in unit.	
1	Plumbing	Drinking fountain is not operable. Repair or remove.

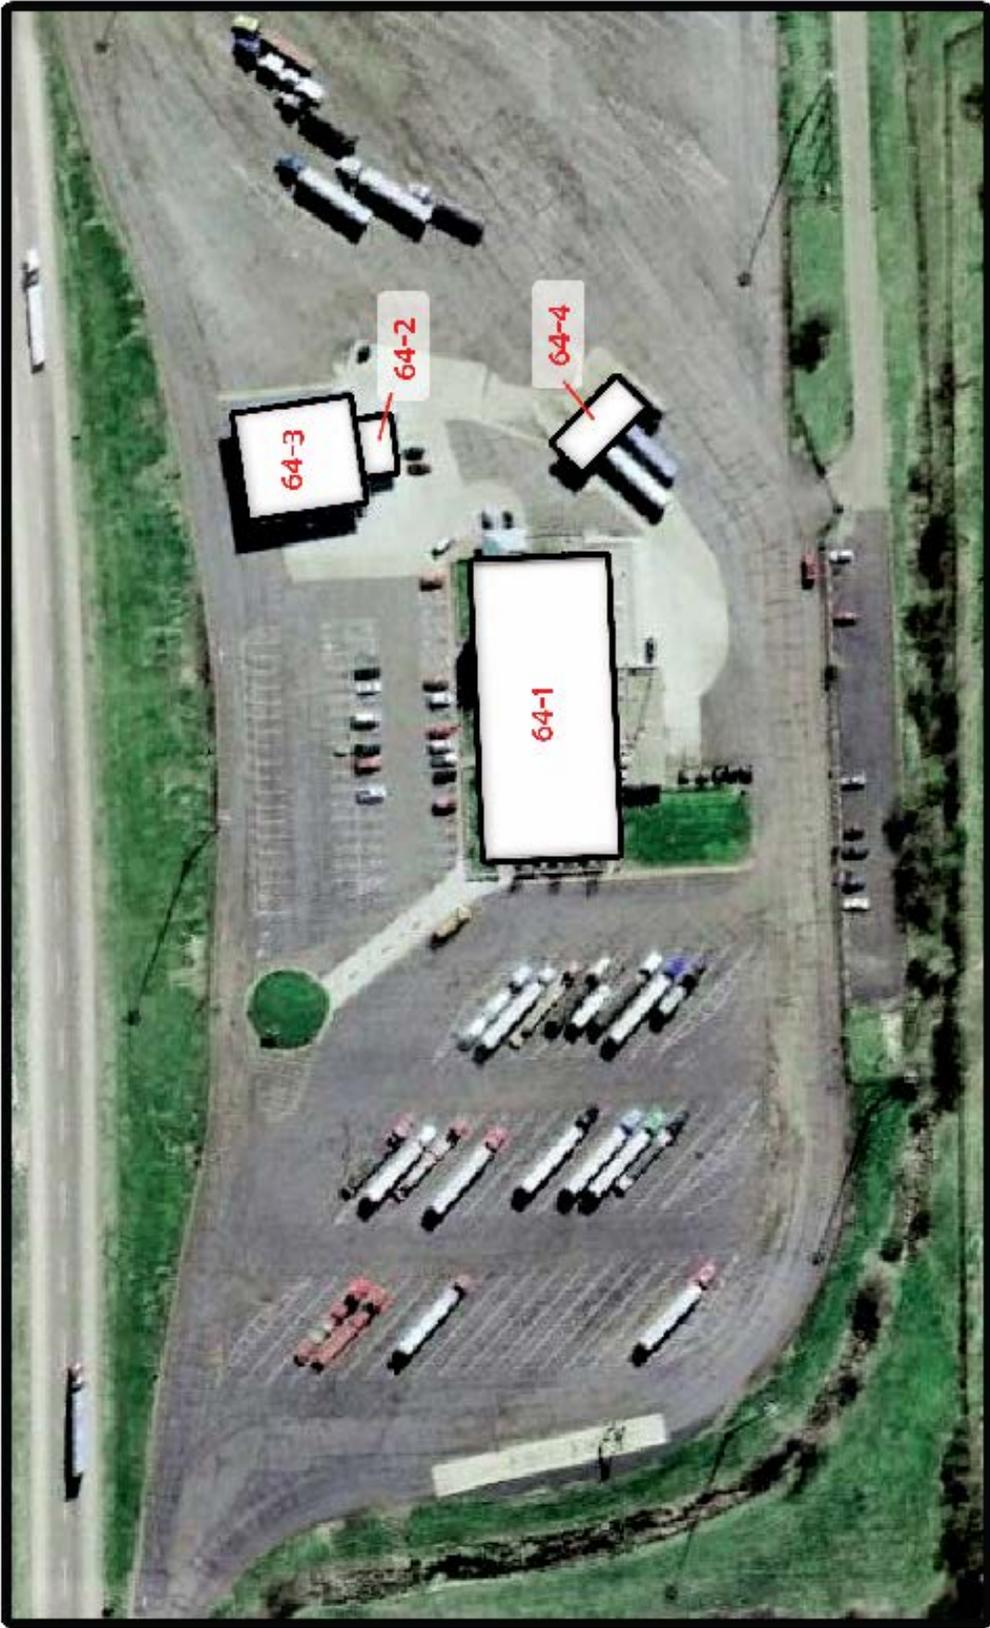
TRAVEL PLAZA
1 (SOUTH)
Mile Point: 217

Priority	Discipline	Findings/Remarks	Completed
1	Architectural	Replace window pane that is broken in Food Service office area.	
1	Architectural	Repoint chimney cup. The mortar is missing and/or deteriorated.	
1	Architectural	Basement: No exit lights were observed.	
1	Architectural	Exterior: entire perimeter caulk joint to wall on concrete slab over areaway, west side.	
1	Electrical	Elect. Equipment Room Door is missing and there are open panels w/live wiring inside, although taped. Install Electrical Equipment Room door and repair and lock panel covers.	
1	Electrical	Provide cover plate for receptacle in Game Room.	
1	Electrical	In Storage Room near the entrance to the Convenience Store, one light fixture is out. Ballast cover missing. Lense covers missing. Repair or replace.	
1	Mechanical	In Food Service Office, clean elements on electric unit heater.	
1	Mechanical	The condensing units on roof top neoprene is missing or badly deteriorated. Replace with UV stable conduit covering.

1	Plumbing	Drum line is leaking in the corridor in basement area. Repair the drain line.

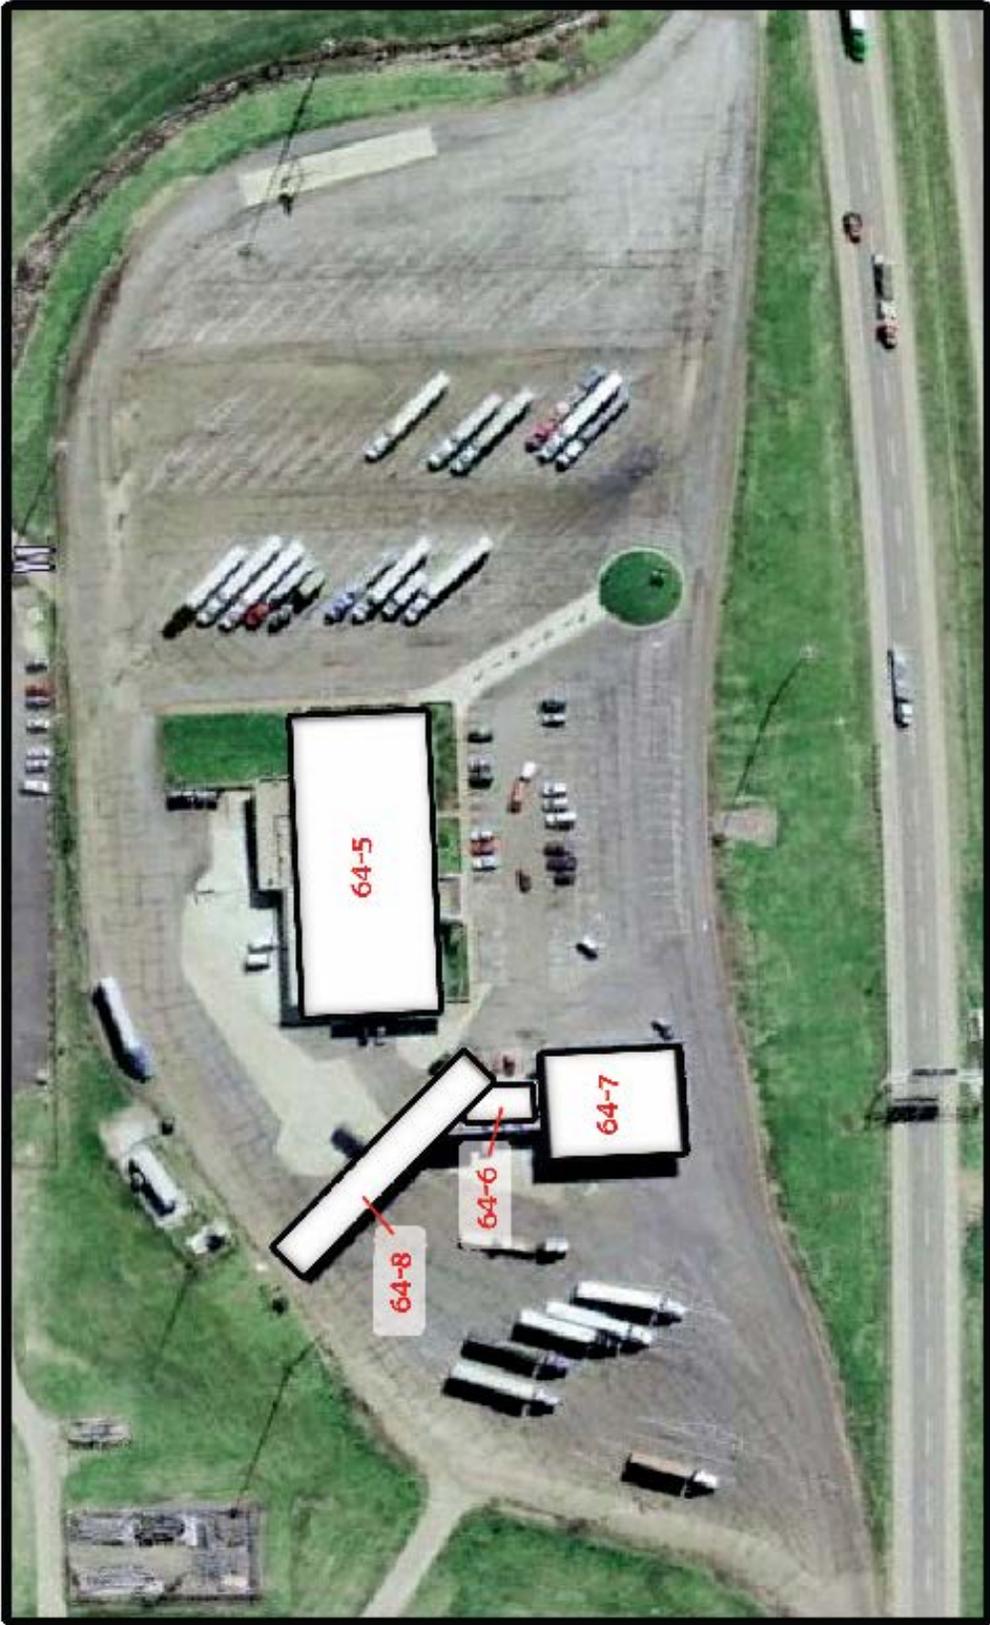
TRAVEL PLAZA
1 (NORTH)
Mile Point 2L7

Priority	Discipline	Findings/Remarks	Completed
1	Architectural	Mens janitor closet ceiling tiles are water damaged and require repair.	
1	Architectural	Cap stone and chimney need repointing.	
1	Architectural	Roof: replace cracked and deteriorated sealant on cap stone.	
1	Architectural	Exterior: Repair/regROUT sill @ SE corner	
1	Architectural	Basement: No exit lights were observed.	
1	Architectural	Roof: Replace broken glass in clerestory.	
1	Architectural	Exterior: Replace sealant in vertical control joint.	
1	Architectural	Window at clerestory is broken and needs replacement.	
1	Electrical	No functioning lighting in Transformer Vault. This is a critical item.	
1	Electrical	There are exiting control switches by rear Loading Dock door that are mounted below a grease removal pipe. Should be reinstalled per appropriate code.	
1	Electrical	Transformer Vault doors open into vault. Should open out.	
1	Electrical	There are no lights in the basement. Install emergency lights.

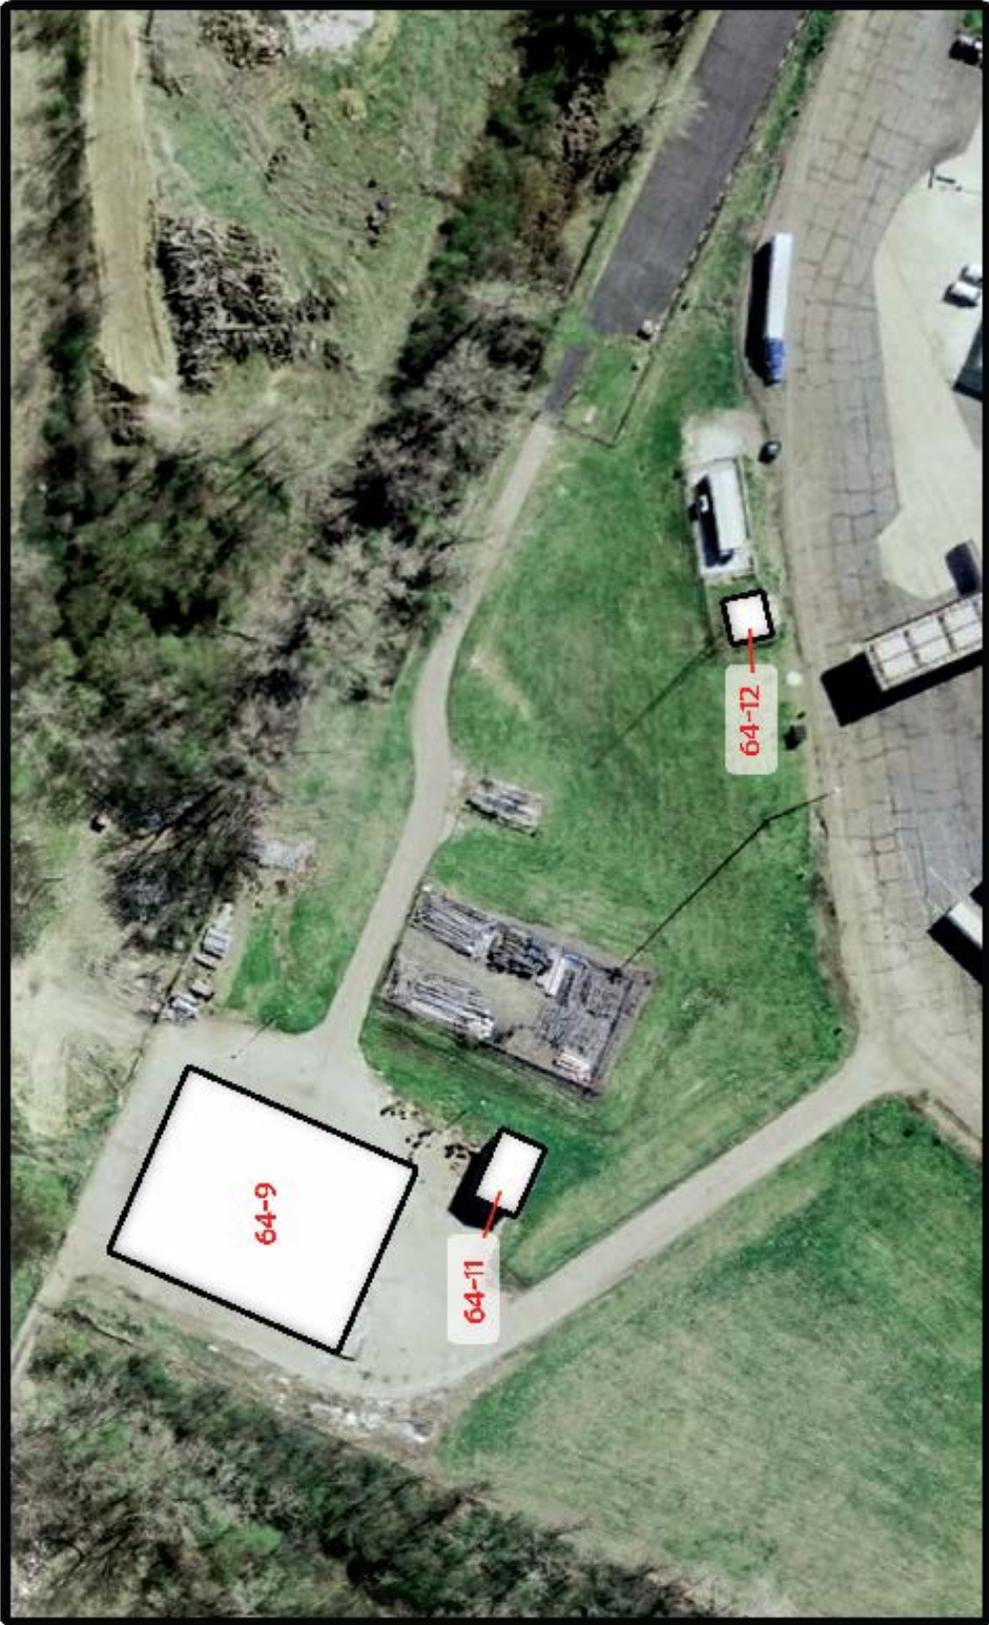
**AUXILIARY
STORAGE AREA**
Mile Point 21.6

Priority	Discipline	Findings/Remarks	Completed
1	Architectural	Exterior: Connection of wall and fabric panel is loose on west wall near O.H. door and on the north wall. Reattach.	
1	Architectural	Exterior: Replace the backer-rod and sealant at the base of the wall along entire perimeter of the building.

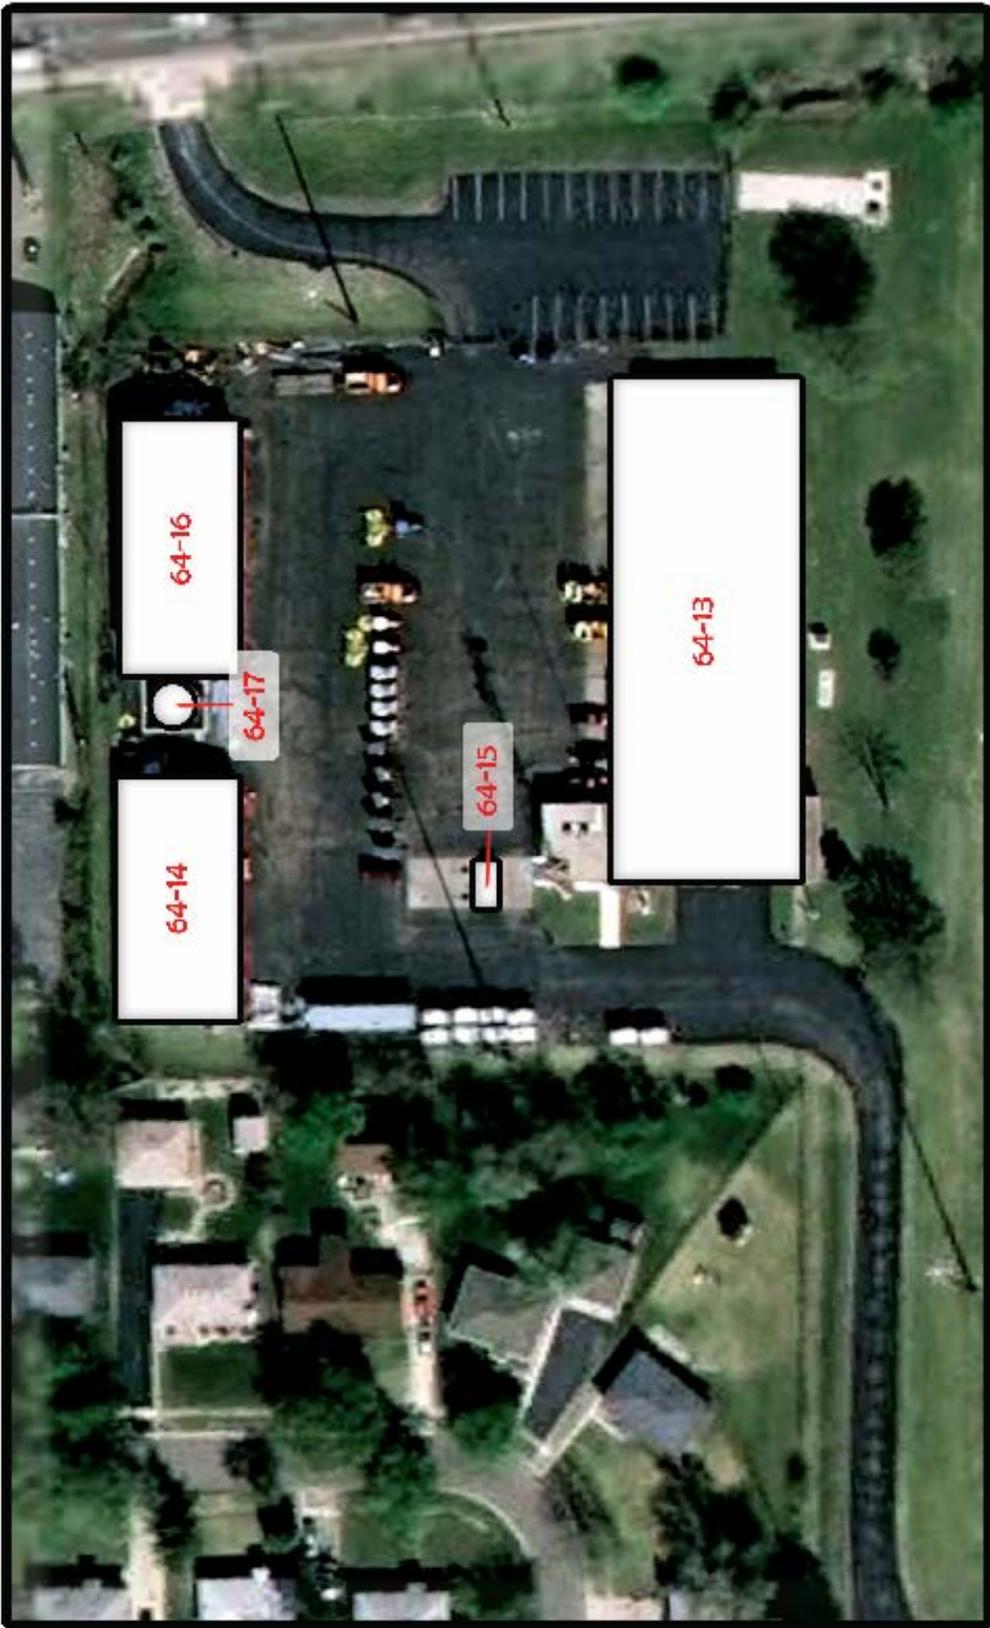
**MAINTENANCE
BLDG PORTER**
Mile Point 23.5

Priority	Discipline	Findings/Remarks	Completed
1	Architectural	There are large openings in exterior metal wall panels.	
1	Architectural	Exterior: missing down spouts on south elevation that need to be installed. Also repair gutter connections that are loose.	
1	Electrical	Install combination exit and emergency egress lighting throughout the building.	
1	Electrical	Provide GFI protection for all receptacles in building.

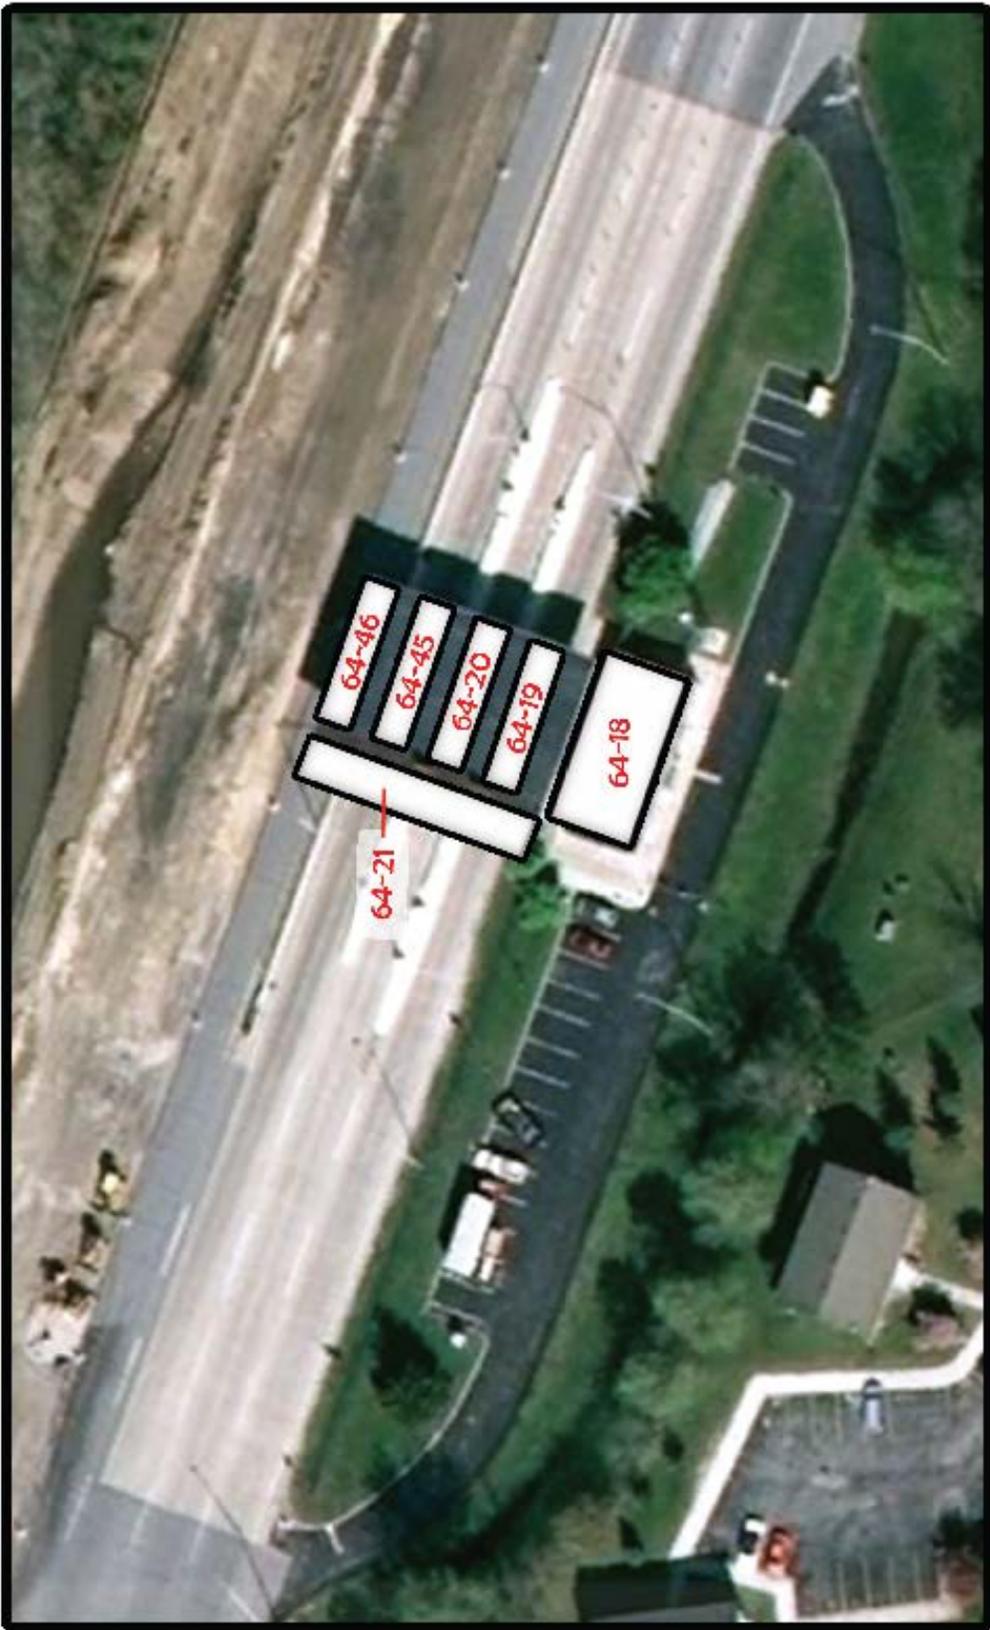
TOLL PLAZA
23 MILE CREEK
Mile Point 23.8

Priority	Discipline	Findings/Remarks	Completed
1	Architectural	Roof: Rubber roof membrane stretched, pulled out of coping, leaving open roof in multiple locations.	
1	Architectural	Exterior: Remove rust, prime & paint street columns.	
1	Architectural	Exterior: Replace broken glass panels, north side.	
1	Electrical	Provide combination exit/emergency egress lights in all areas of the building including Basement.

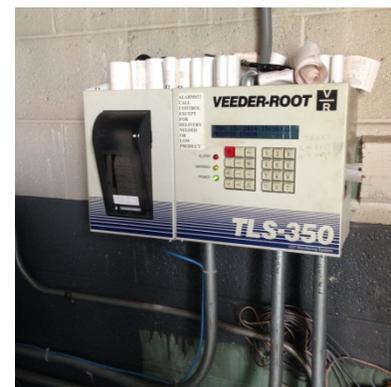
Figure 7.6: Veeder-Root Control Panel

ITRCC operates seventy-one (71) underground storage tanks (USTs) throughout various facilities, such as the Administration Building, Maintenance Areas, Toll Plazas, and Travel Plazas. The tanks are primarily used for the storage of gasoline and diesel fuel. In order to closely monitor the various underground fuel storage tanks, ITRCC has been contracting outside services to test for tank and piping system leakage and corrosion. The USTs are continuously monitored for leak detection by the Veeder-Root system. The piping tightness and

leak detection tests are conducted on an annual basis to confirm tightness.

Fuel management units (FuelMaster) have been installed at ITRCC gasoline and diesel fuel tanks that vend fuel to vehicles (i.e., are not for backup generators). The majority of these systems were installed in 1998-1999. There are three USTs that do not have Veeder-Root systems at Travel Plaza 1, 7, and 8. These are not currently required by regulation, but may be in the future. In August 2012, the ITRCC began the Veeder-Root Improvement Project which involved installation of relays and an automatic reporting system that meet current UST monitoring requirements. FuelMaster fuel management system improvements involved establishing communication and return to operations at remote sites.
