indiana
TOLL ROAD

ANNUAL STATE OF THE ITR REPORT
JULY 1, 2014—JUNE 30, 2015

Annual State of the ITR and
Capital Improvement Programs Report
July 1, 2014 – June 30, 2015

July, 2015

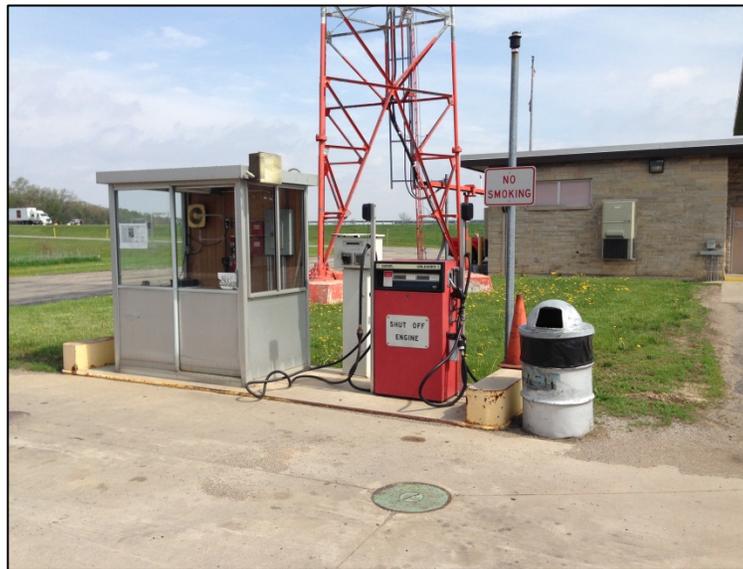
Figure 7.7: Example of Fueling Station

Notification for GDF with a throughput of greater than 10,000 gallons per month was completed in 2010. Compliance with the standard which includes recordkeeping and possible retrofits was achieved by January 10, 2011.
