Indianapolis Power & Light (IPL) is pleased to provide the Commission with the root cause analysis report from the 26 S. Meridian Street Network Event on August 13, 2014.

**ROOT CAUSE ANALYSIS
FOR
26 S. MERIDIAN STREET
NETWORK EVENT ON
AUGUST 13, 2014**

Prepared by T&D Engineering
Issued on October 3, 2014

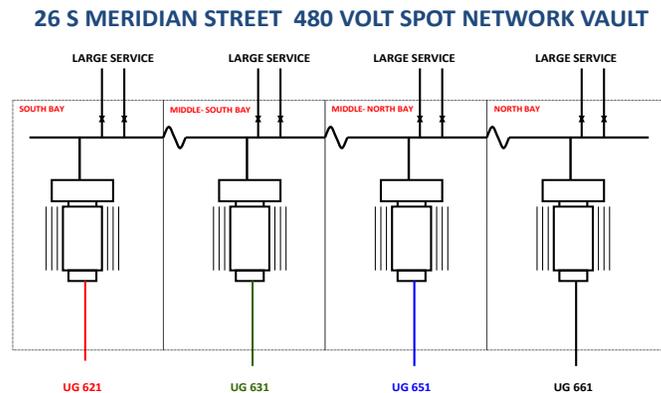
The diagram below shows the layout of the 480-volt spot network vault at 26 S. Meridian Street where the event occurred on the UG 651 network protector.

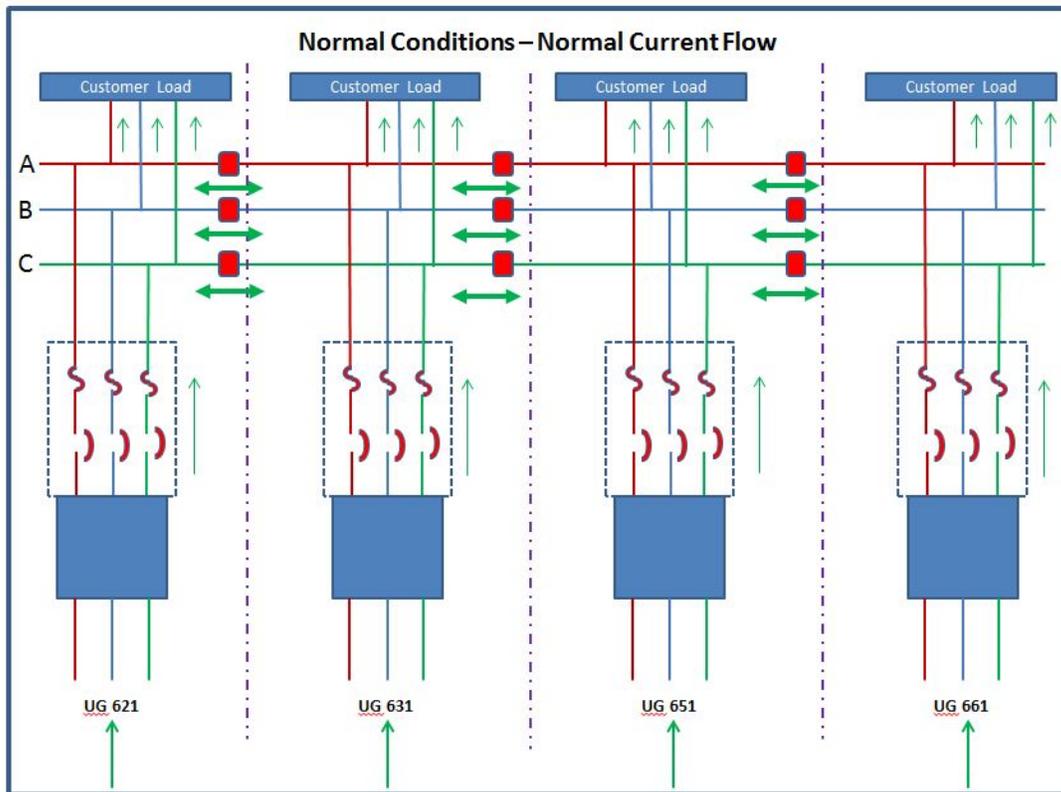
Normal Power Flow Under Normal Conditions

Before the a discussion of the two possible event scenarios begins, it may be helpful to understand what the normal condition in the 26 S. Meridian Street vault would have looked like. The picture below depicts how the power would be flowing to the customer loads under normal conditions. Each of the four network transformers would have been supplying approximately an equal amount of power. Power would flow from the network transformer through the network protector and into the collector bus. Customer loads are connected in each of the four transformer bays to the collector bus. Power would be flowing through the collector bus to the customer loads.

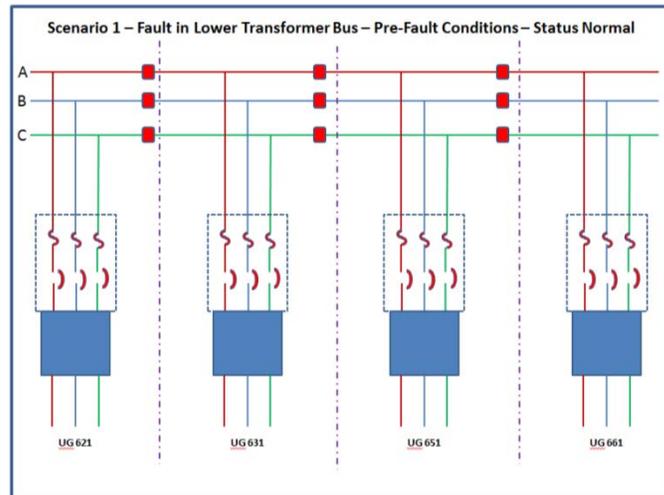
Figure 1 shows the pre-fault event conditions in the vault at 26 S. Meridian Street prior to 1:25 p.m. The network protectors on all four network transformers are believed to have been closed, based on Network SCADA records prior to 1 p.m. The customer load that was being served would have been spread relatively even across the four network transformers.

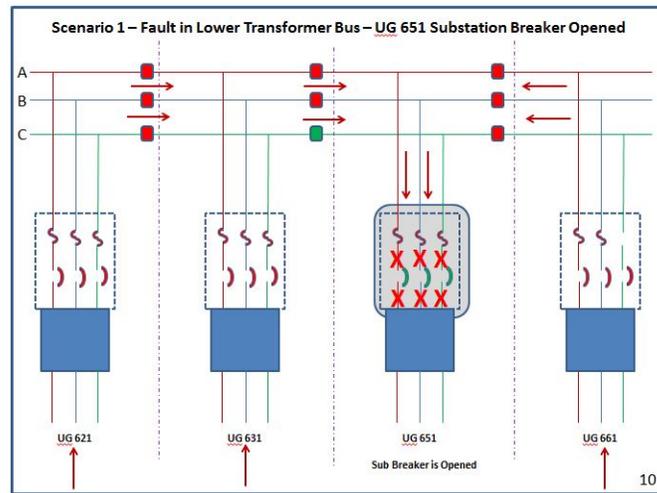
Figure 10 shows the point where the Gardner Lane UG 651 Primary feeder breaker is opened by the operator in the TOCC. Operators in the TOCC had been analyzing and discussing how to best isolate the 26 S. Meridian Street vault from the network. As they looked at the ECS PI historian data for the four Gardner Lane feeders they observed there was higher and more erratic current flow on the UG 651 feeder than on the other three feeders. The decision was made to open the Gardner Lane UG 651 Feeder Breaker by ECS SCADA control to see if that would de-escalate the situation in the field. If it didn't, then operators were prepared to drop all five primary feeders in the Gardner Lane South secondary network. At 1:40 p.m. the operator in the TOCC opened the UG 651 Primary feeder breaker by SCADA control. The immediate report from the scene was that the banging had nearly stopped and the smoke immediately was lessening.

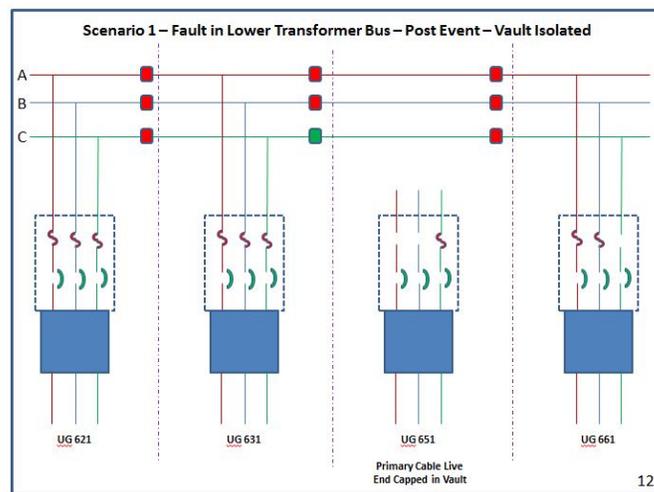
Figure 12 shows the final steps that were taken to isolate the 26 S. Meridian Street vault from the network to allow IPL field crews to safely perform work in the vault and begin inspecting the damage. Prior to entering the vault, the customers served by

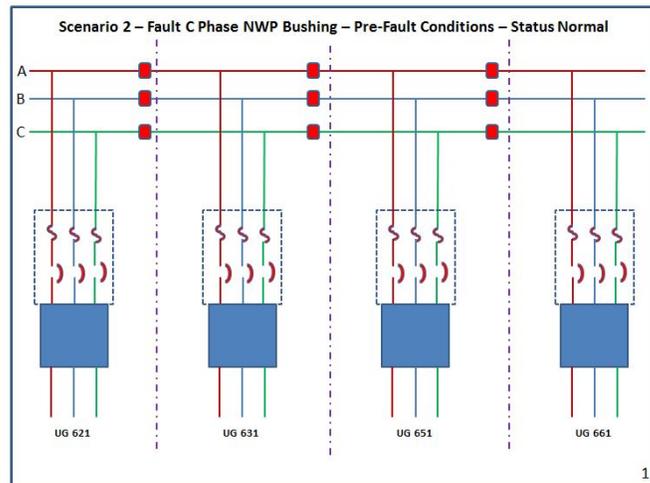
Figure 13 shows the pre-fault event conditions in the vault at 26 S. Meridian Street prior to 1:25 p.m. These are the same conditions described in Scenario 1. The network protectors on all four network transformers are believed to have been closed, based on

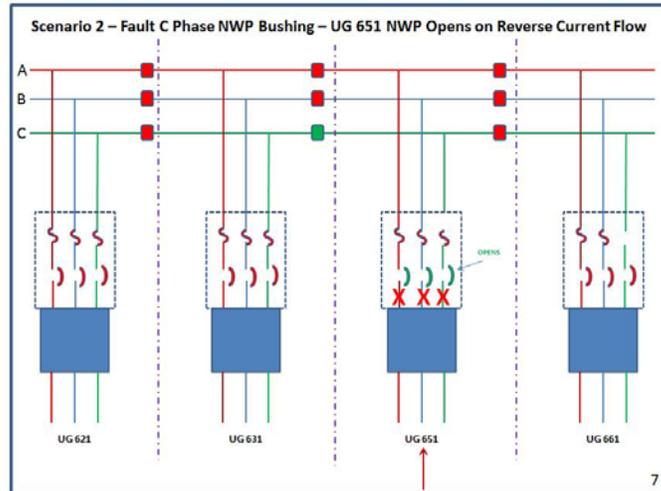
Figure 19 shows that the UG 651 network protector has opened from the reverse current flow on A and B phases from the fault shown above in Figure 18. All fault current is again being supplied only by the UG 651 network transformer. Fault current

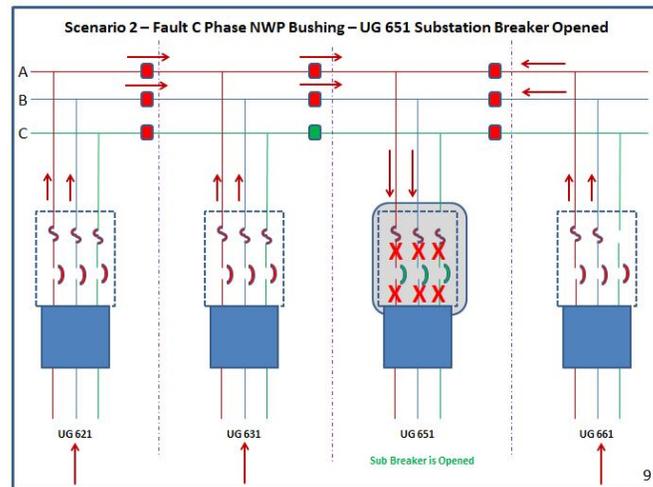
Figure 21 shows the point where the Gardner Lane UG 651 Primary feeder breaker is opened by the operator in the TOCC. Operators in the TOCC had been analyzing and discussing how to best isolate the 26 S. Meridian Street vault from the network. As

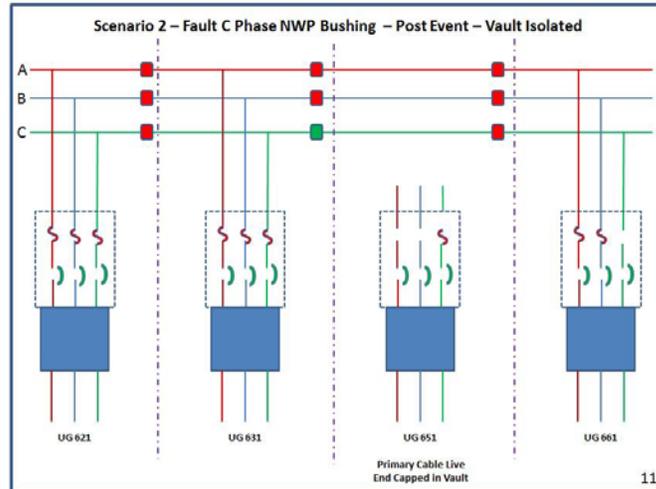
Figure 23 is the same as Figure 12 in Scenario 1 which shows the final steps that were taken to isolate the 26 S. Meridian Street vault from the network to allow IPL field crews to safely perform work in the vault and begin inspecting the damage. Prior to entering the vault, the customers served by the vault were asked to shut their loads down and open their main service disconnect to isolate their loads from the vault. That was accomplished at 4:20 p.m. Field crews entered the vault at 4:30 p.m. and manually opened the network protectors on UG 621, UG 631, and UG 661.

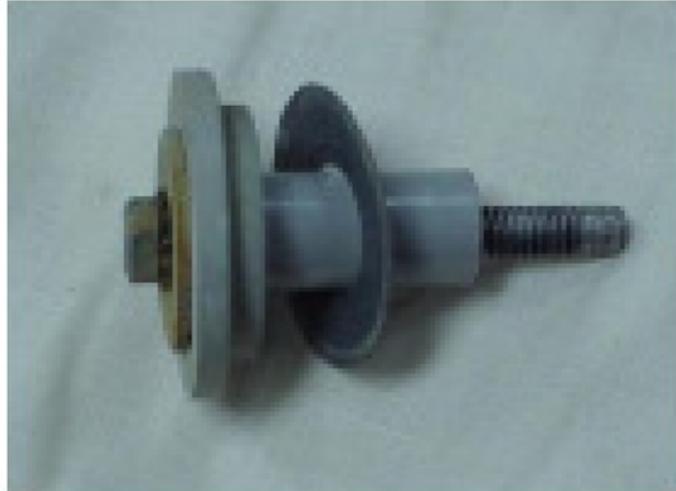
Failed Unit Findings:

Signs were apparent that several Arc Flash strikes initiating from the Transformer Bus to Tank or the Mounting Bolts of the Transformer Bus had occurred.
