#### Are you smarter than a Bridge Inspector?

Cristy Burlage, PE INDOT Bridge Inspection Area Engineer
Jake Gould, PE INDOT Bridge Inspection Area Engineer

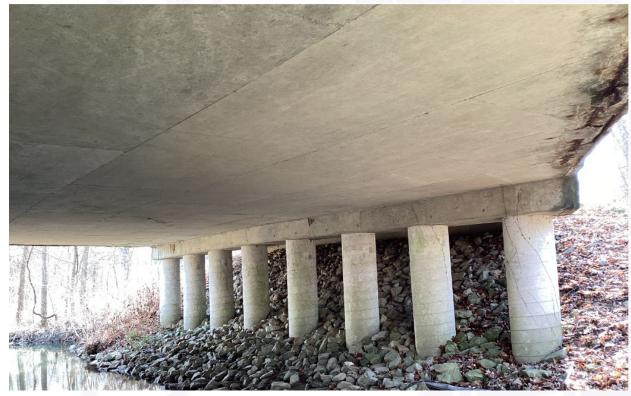
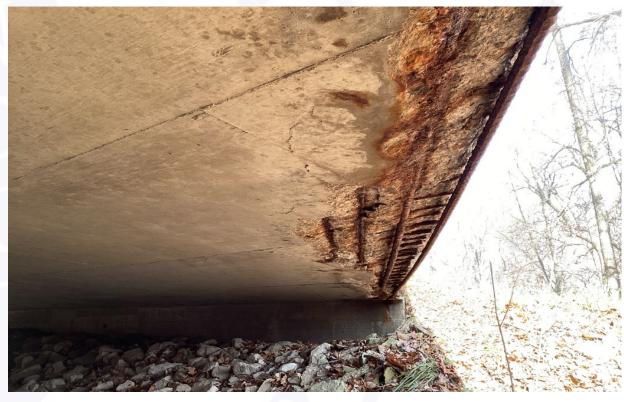
• 075-32-06871

Component	Rating	Comment
Superstructure	?-	All copings have heavy spalling with exposed and hanging steel. Steel has minor surface rust and section loss. Up to four bars on each coping are exposed with spalling up to 2' wide. All spans have a hairline longitudinal crack along the centerline with spans A & B also having rust staining.

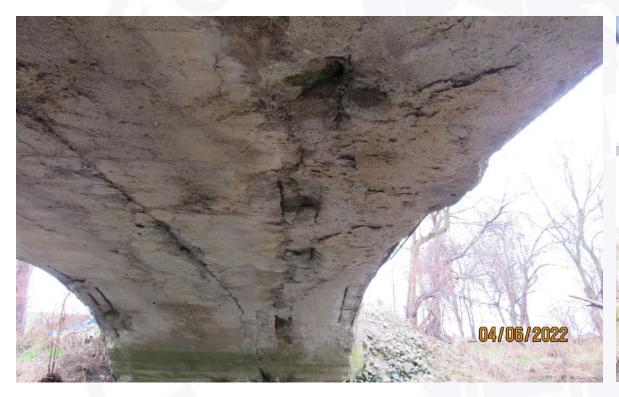
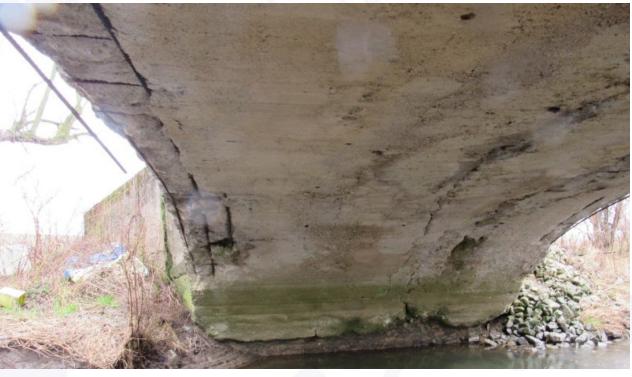
#### • Clinton 095

Component	Rating	Comment
Culvert	•	Large hole/spall at the base of the arch at the southwest corner $2'-3'$ deep. Heavy cracking, spalling, delaminations, and exposed steel throughout the arch and headwalls. 8 longitudinal bars exposed. Much of the exposed steel is no longer in contact with the concrete. The southwest wingwall previously failed. Other wingwalls are cracked and leaning (SE = $3''$ , NE = $1''$ , NW = $4.5''$ )

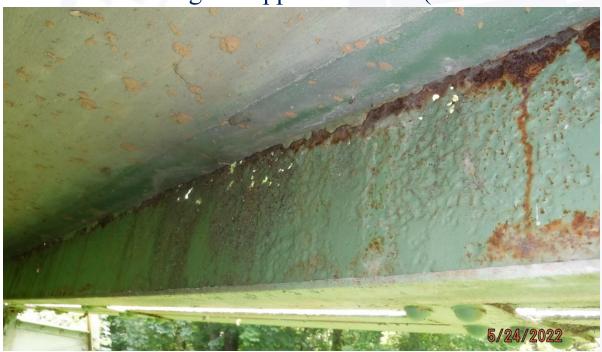
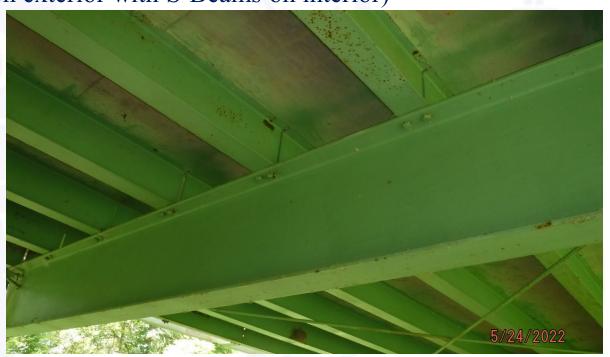
- Orange 91
  - Pony Truss with Floor Beam / Stringer System
  - 8 stringers support the deck (2 channel beams on exterior with S-Beams on interior)

Member	Rating	Comments
Stringers		Simple span with top flanges embedded. <5% section loss for interior stringers. Exterior stringers with rust perforations throughout web and 25% section loss to web. Exterior top and bottom flanges have light pitting and 0% section loss. Northwest stringer with 2" tall rust perforation at the abutment bearing.

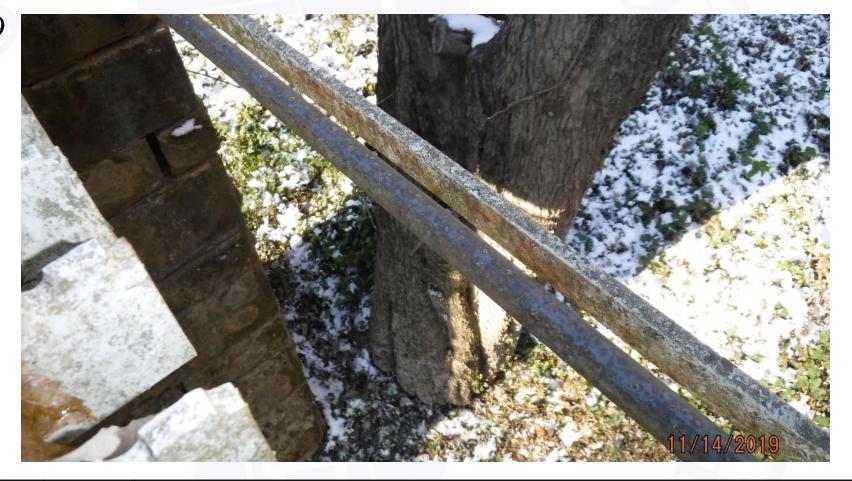
• Martin 59

Location / Member	Fatigue Category	Rating	Comments
L0-L2	A	?	Interior member replaced with 0% section loss. Exterior member loose and partially ineffective. Approximately 25% loss of load carrying capacity.

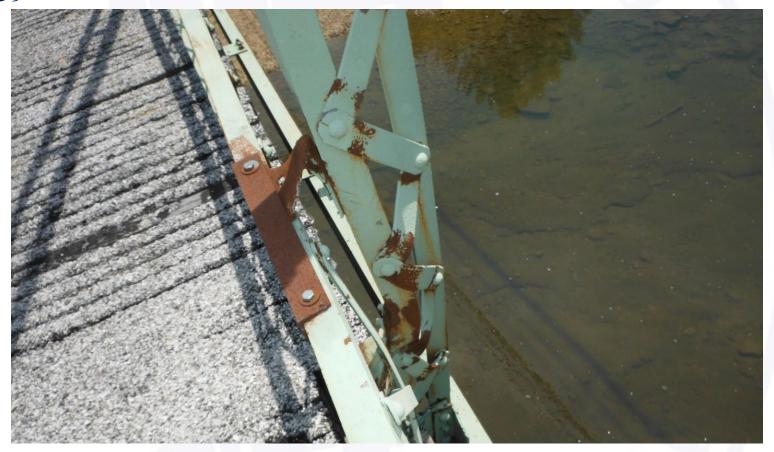
• Lawrence 139

Location / Member	Fatigue Category	Rating	Comments
U4-L4	D	?	Major impact damage to the member at rail height. Moderate pitting with 10% section loss

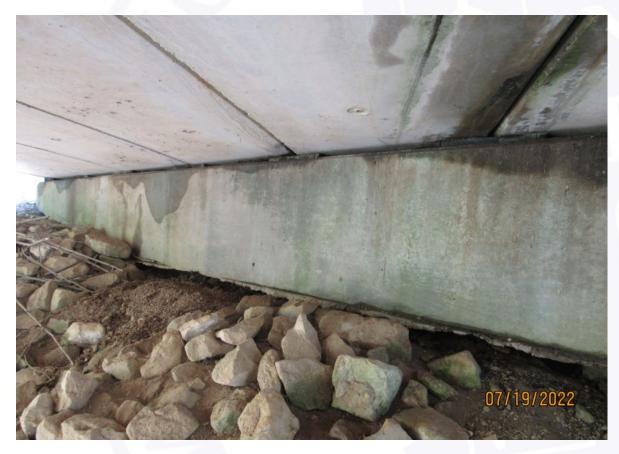
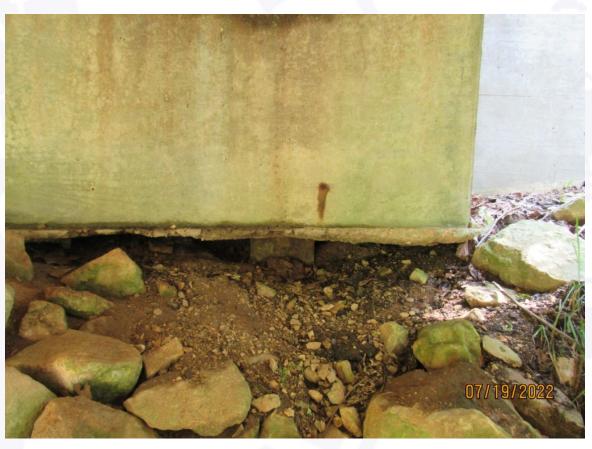
#### • Lawrence 125

Component	Rating	Comment
Scour		Both end bents are partially undermined ~1' with exposed piles along the entire length. Good riprap protection on the slopes.
