Bridge Inspection Report

064-31-06286 A
SR 64
over
BRANCH BLUE RIVER

SR-64 Structure Replacement

**SR-64 Structure Replacement
DES 1900066
Depauw, Indiana**

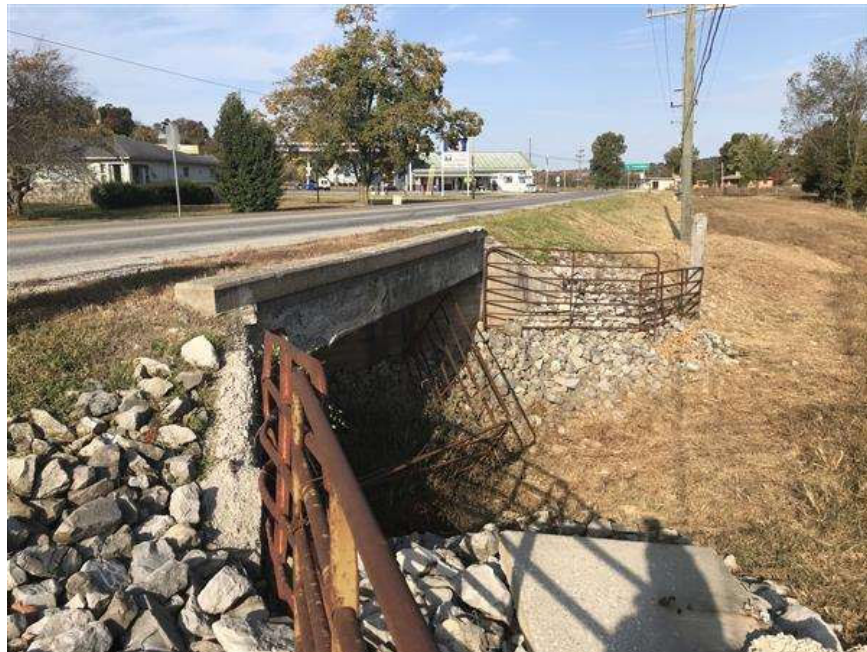
Overall the structure is in fair condition. All cardinal directions in this report are based on the roadway direction of travel and not compass readings.

Comments:
 There are several small spalls with exposed rebar on the west side of slab at the west abutment. There are two spalls with exposed rebar near the south end on the underside of the slab. The wingwalls have cracking and scaling with efflorescence.
