National Register of Historic Places Registration Form

historic name Angola Commercial Historic District

state Indiana code IN county Steuben code 151 zip code 46703

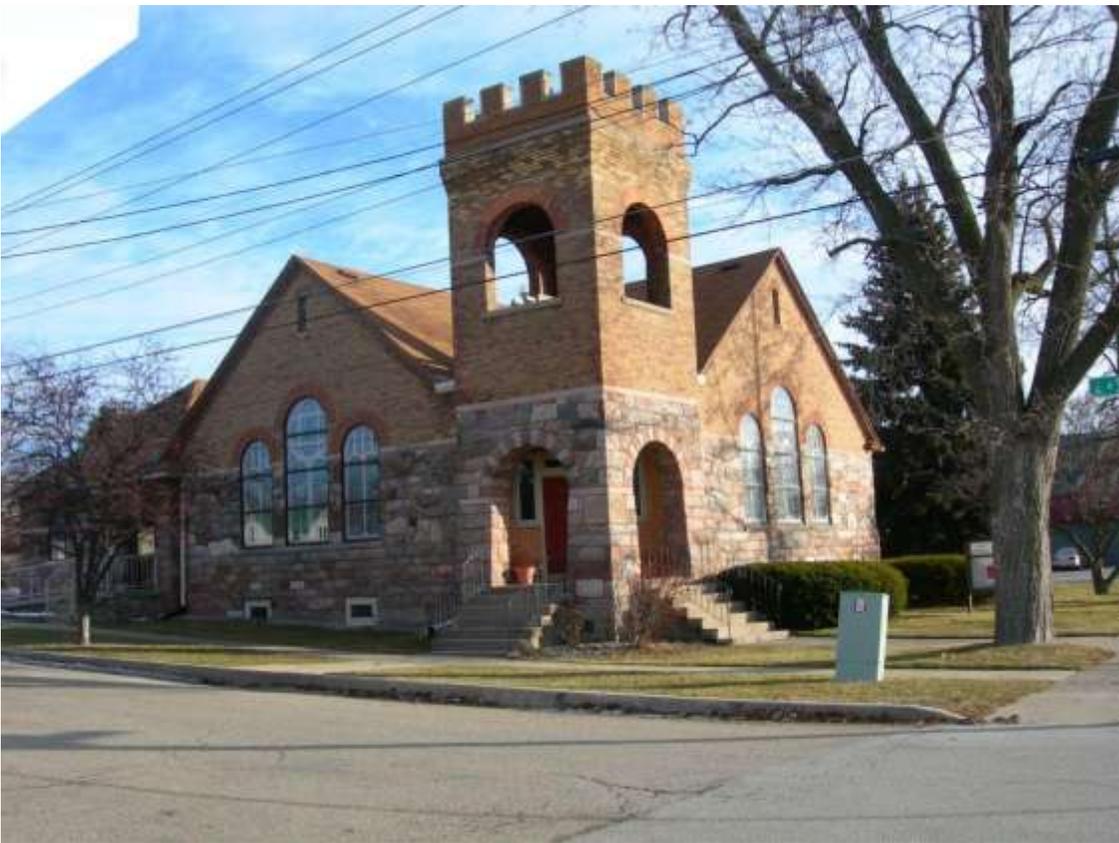
Angola Commercial Historic District, Steuben Co., IN photo 2

The Romanesque Revival style is found in the Congregational Church at 314 West Maumee Street, constructed in 1899 (photo 0002). The style is represented by its heavy, rusticated stone base that tapers out at its wide arched tower entries and groupings of wide arched windows. The Late Gothic Revival style is found on the First Methodist Church at 220 West Maumee Street (photo 0003). The building's high, pointed arched window openings and buttressed gabled ends and tower are indicators of that style. The Collegiate Gothic style is found on the Angola Masonic Lodge at 25-35 South Public Square (photo 0034). The main indicators of the style found on this building are at its deeply recessed entries with tall limestone surrounds with narrow turreted corners on the front facade. A modern Gothic Revival building is found in the small prayer chapel behind the Congregational Church, with buttressed, high gabled end walls and Gothic arched openings.

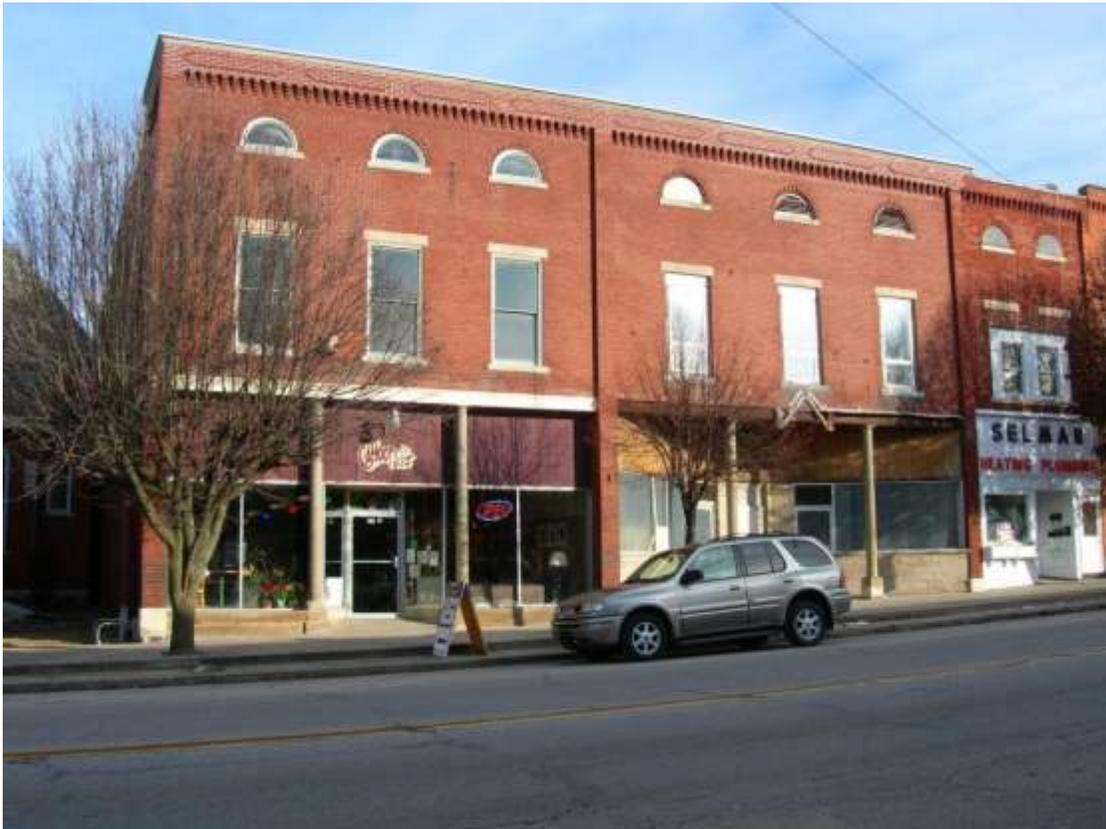
Angola Commercial Historic District, Steuben Co., IN photo 4

Early 20th Century buildings, lacking any exemplary details of a particular style, but well executed in their masonry work, or having similar masonry details such as framed brick panels in their second level facades are found at 105, 213 and 217 West Maumee Street and at 45 South Public Square. 217 West Maumee and 45 South Public Square lend themselves most to the Craftsman style applied to commercial facades. Another masonry detail warrants listing, probably practiced by the same builder, found on three separate buildings at 212, 214-218 and 117-119 West Maumee Street. All three buildings have in their attic level a half-round arched opening, some with louvers and others with windows, with construction dates around 1890. (photos 0004 & 0010)

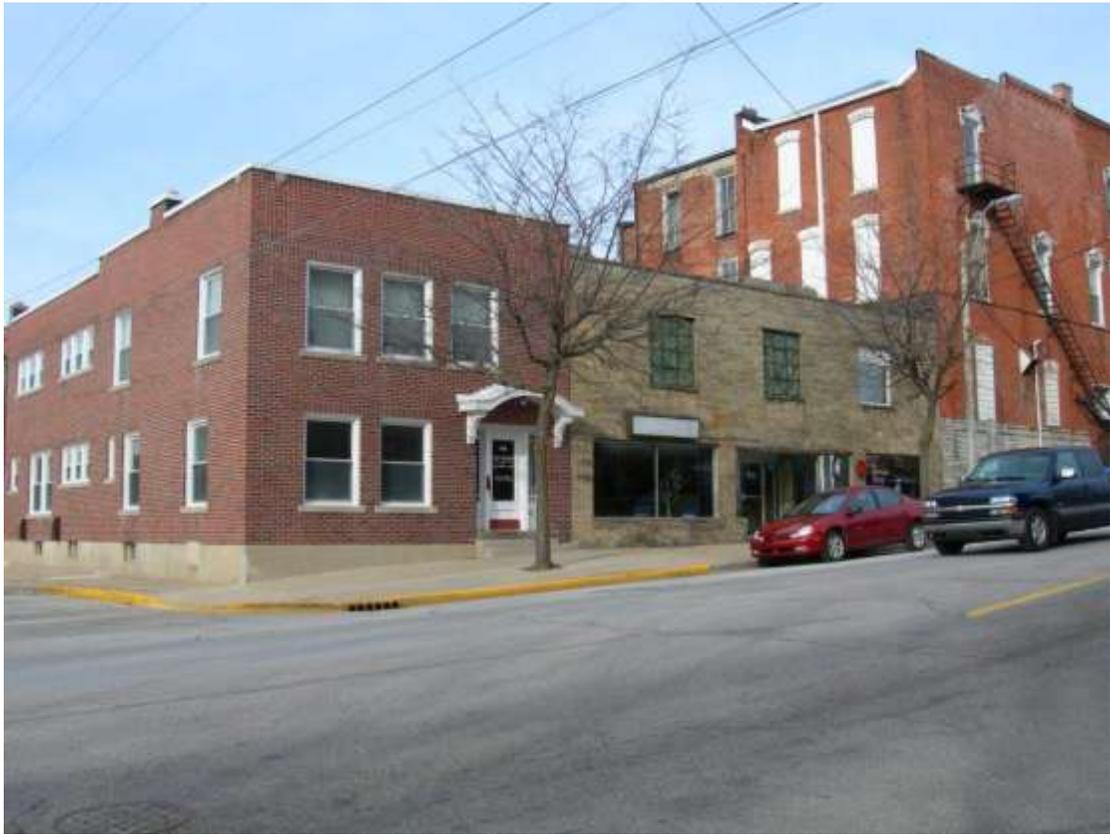
Angola Commercial Historic District, Steuben Co., IN photo 18

Modern styles are found in reserved application, rounding out the period of significance. The Art Deco style is found on the Strand Theater marquee at 60 North Public Square and in a break out of the more formal Colonial Revival style applied to the Police and Fire Department building at 202 West Gilmore Street (photo 0001), with its ribbed stone detailing, curving over the top of the parapet in the center of the building. A Moderne detail is found on 108 South Wayne Street with its recessed entry framed by curved glass display windows (photo 0018, right).

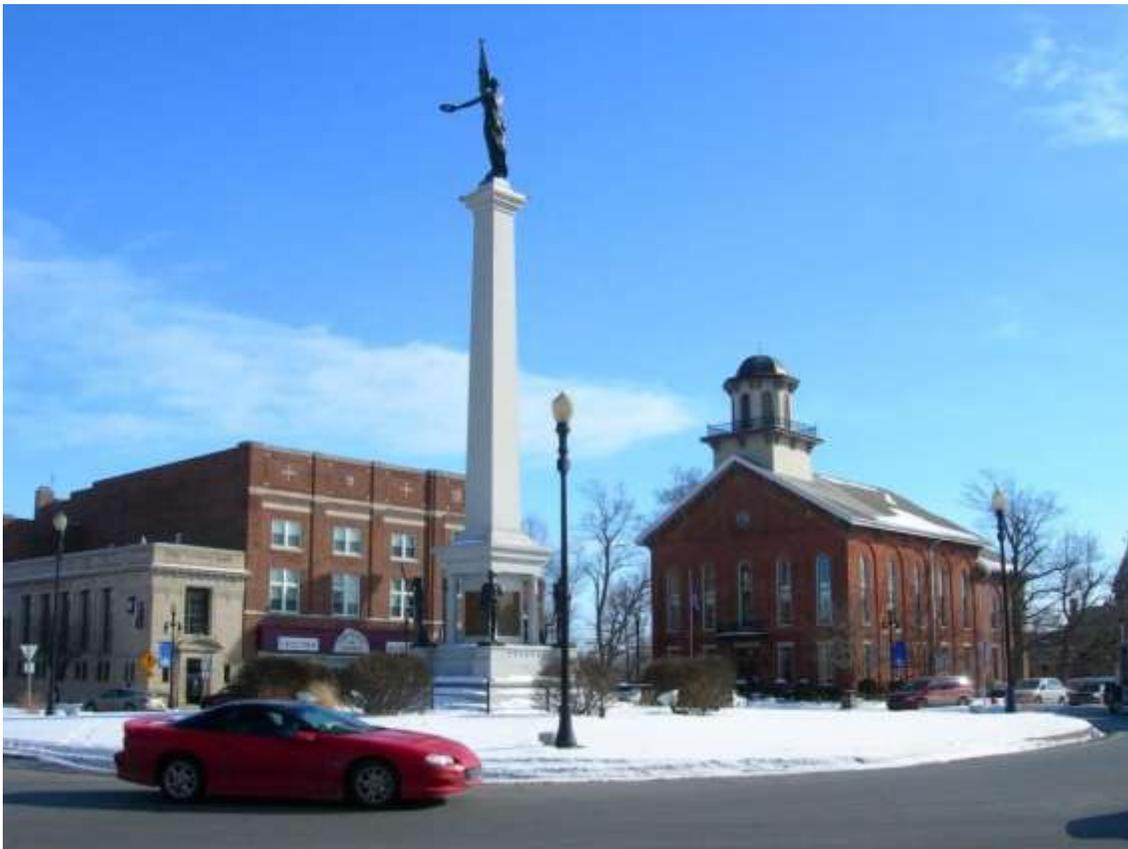
Angola Commercial Historic District, Steuben Co., IN photo 27

Commercial/Beaux Arts. Photo 0021, right & photo 0034, left and photo 27, left
