National Register of Historic Places Registration Form

historic name Morehouse, Levi and Lucy, Farm

street & number 5038 Morehouse Road

city or town West Lafayette

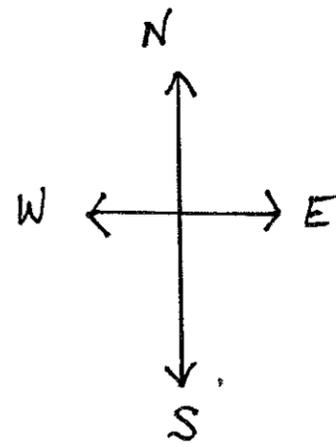
LEVI AND LUCY MOREHOUSE FARM
SITE MAP

The Levi and Lucy Morehouse Farm consists of 25.27 acres and is located just northwest of West Lafayette in the west half of the southwest quarter of Section 26, Township 24 North, Range 5 West, Wabash Township, Tippecanoe County, Indiana. The farmstead is located on the edge of the prairie and separates a growing number of subdivisions and small parcels to the east and south and nearly empty farm country to the north and west. This property contains six contributing resources; the farmhouse; dairy barn with corncrib; Midwestern 4-portal barn with attached granary; metal hog house; machine shed; and brick springhouse. The farm is referenced in the Tippecanoe County Interim Report, Indiana Historic Sites and Structures Inventory (1990) and was listed in the Indiana Register of Historic Sites and Structures in November 2006.

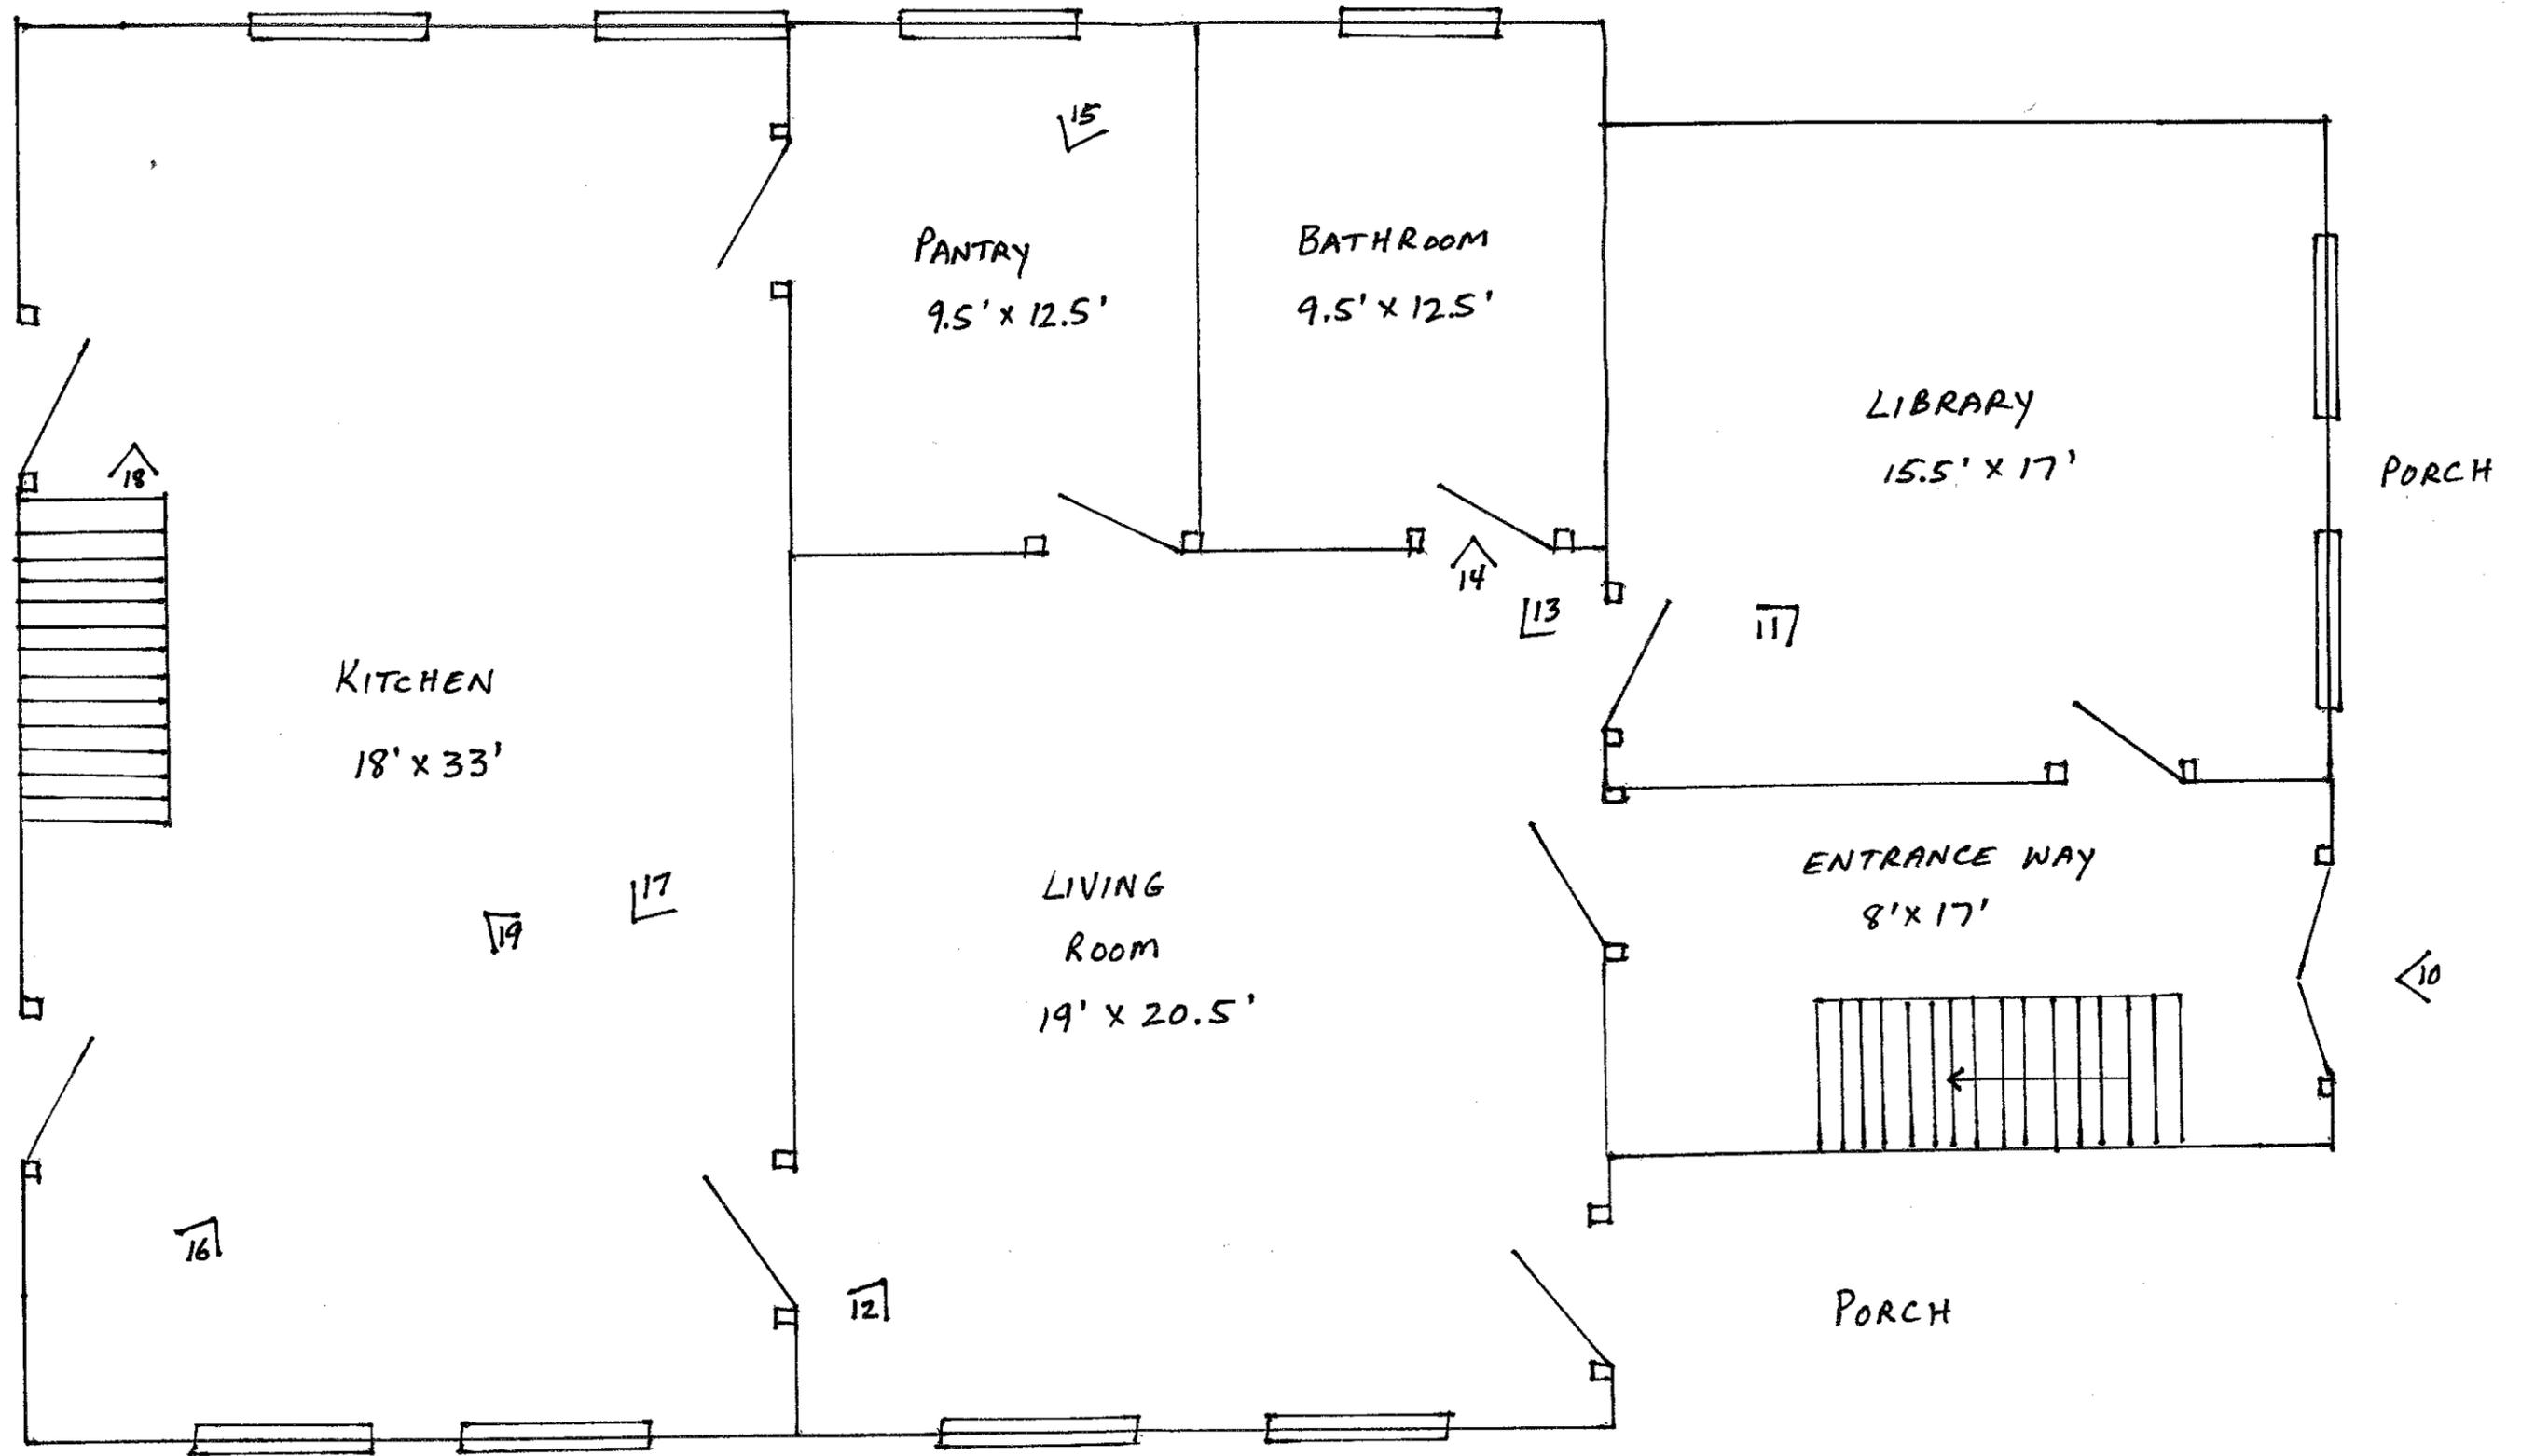
LEVI AND LUCY MORE HOUSE FARM
FARMHOUSE - 1ST FLOOR LAYOUT

The east section of the first floor of the house contains the front main-entrance hallway and a front parlor. The front hallway remains intact with its original plastered walls and ceiling, doors, moldings, flooring, and a curved stairway leading to the second floor (photo 10). The stairway is made of walnut and ash with steps and risers of yellow poplar that still have the original faux painting. The newel has an octagonal plinth, turned base, tapered, octagonal shaft and deep turned circular cap. Balusters are turned and vasiform in profile, supporting a molded handrail. The plastered wall under the stairway is curved to match the stairway above.

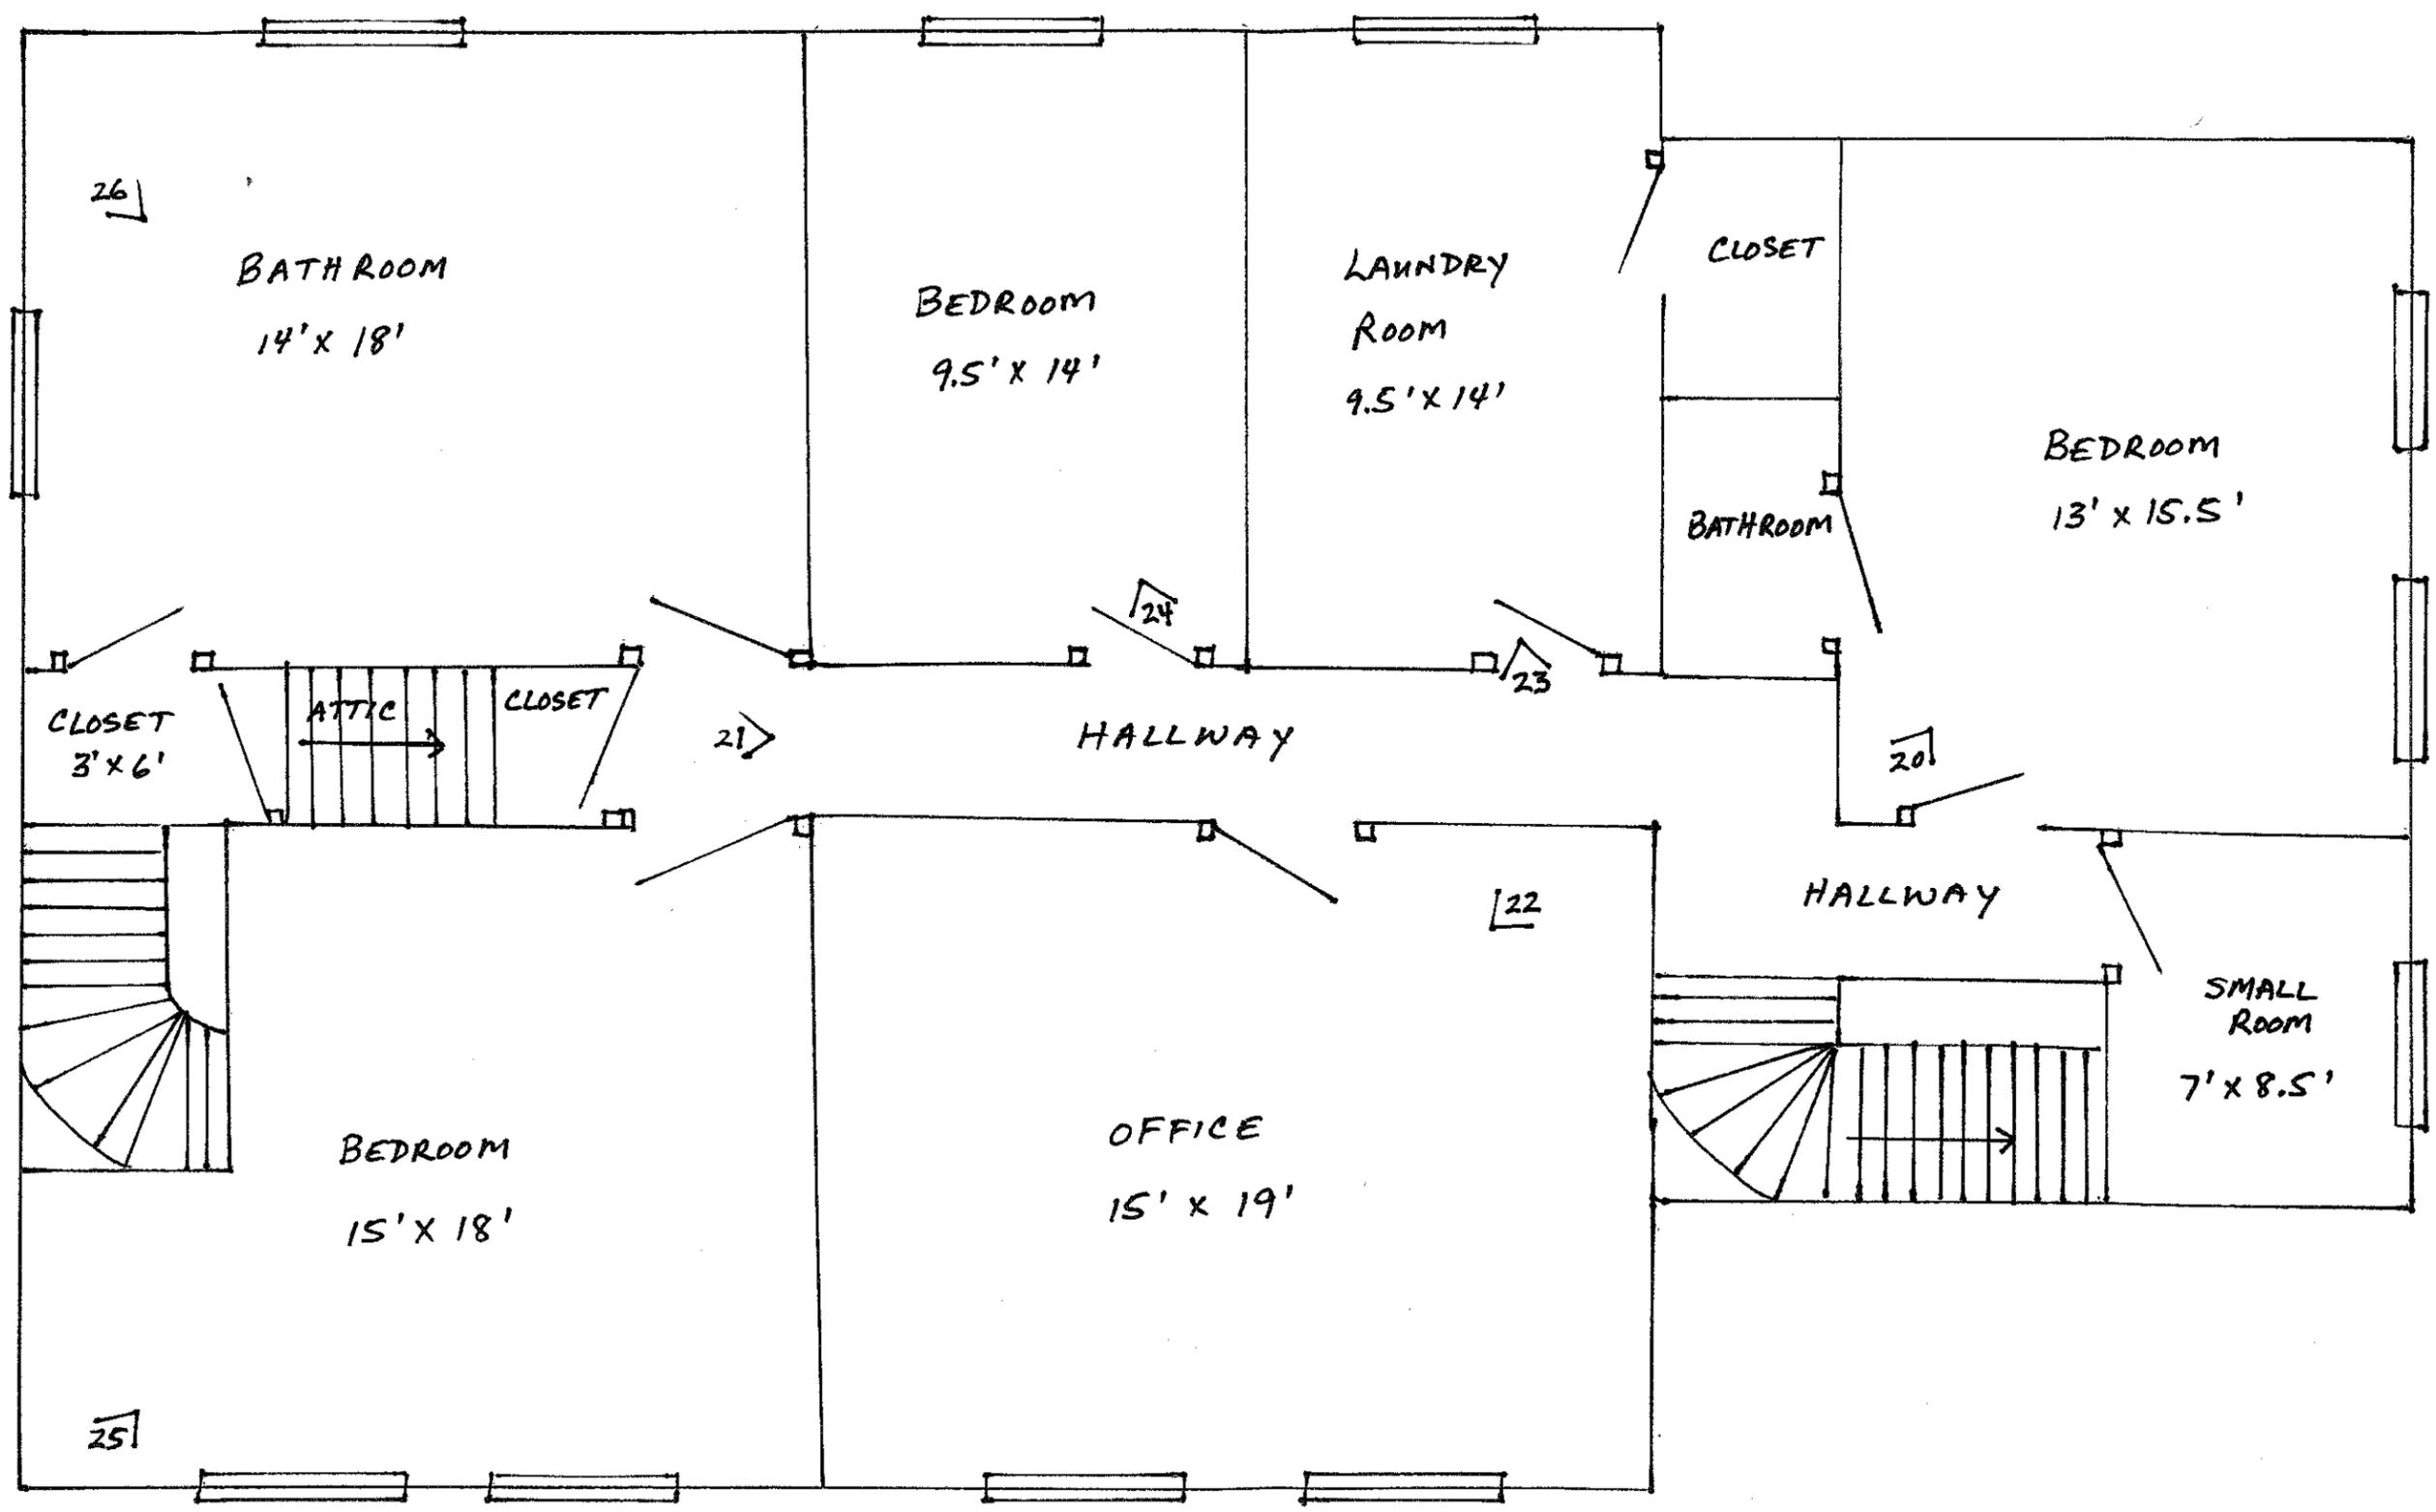
LEVI AND LUCY MOREHOUSE FARM
FARMHOUSE - 2ND FLOOR LAYOUT

The second floor of the house contains seven rooms with two original closets and a front and central hallway. Four of the second floor rooms and the front and central hallways are in original condition. The stairway from the first floor front hallway leads to a small landing and the two east-facing bedrooms on the second floor. The larger east-facing bedroom (photo 20) has an original closet next to a chimney and a half-bath with a toilet and a circa 1890 dresser with a white marble top and vessel sink was added inside the closet. The second east-facing bedroom is very small and original to the house.

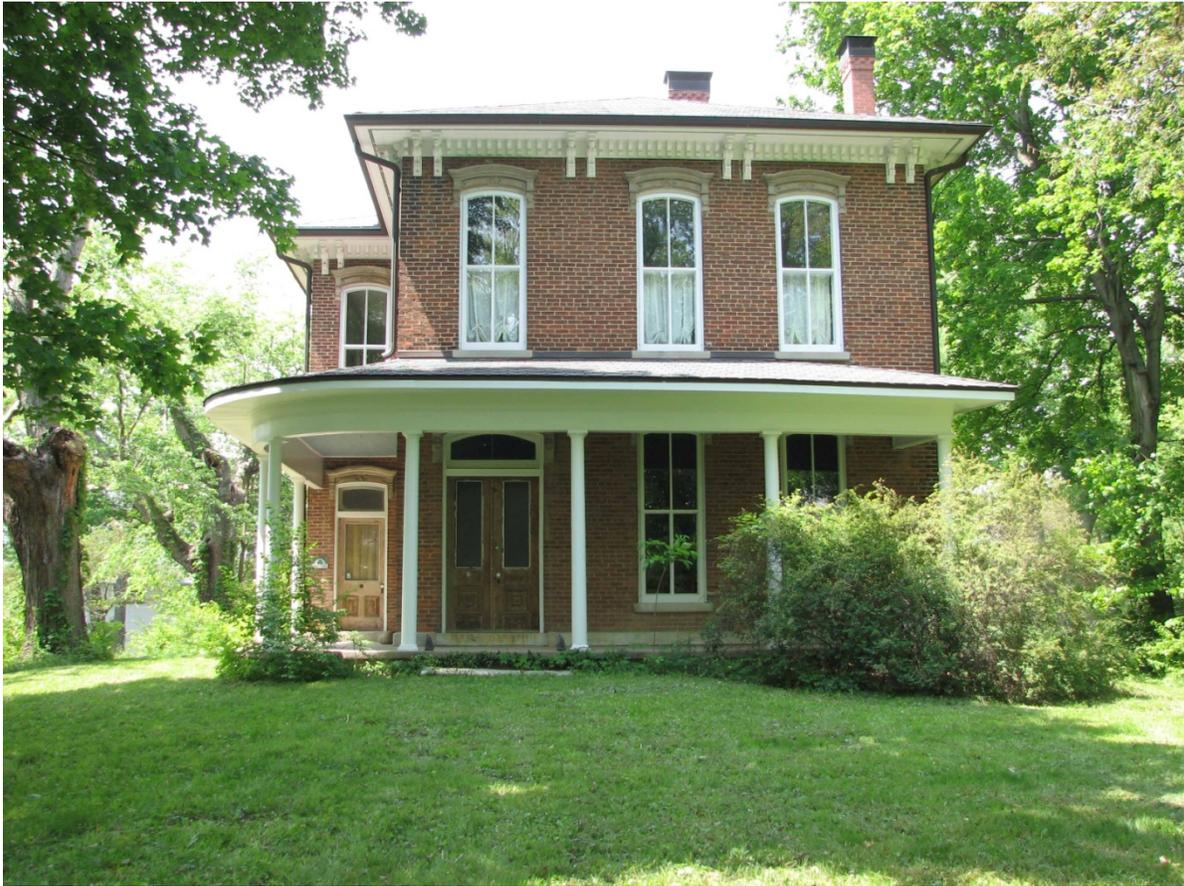
Morehouse Farm, Tippecanoe Co, #0001

The farmhouse is a two story red brick Italianate style house (photo 1) with a low-pitch hip roof. The house sits on a slight rise with the front side of the house facing east and Morehouse Road. This road is a relatively busy county road that joins Tippecanoe County and White County to the north and was used as a route by Levi Morehouse and others to Chicago. The south side of the house faces County Road 500 North where a few neighboring houses are partially visible. Slightly to the southwest of the farmhouse, a dairy-style barn is located. Directly west of the dairy-style barn is a portal barn and west of the portal barn is a small pond. The springhouse, metal machine shed, and metal hog house are located slightly northwest of the house. The house and outbuildings are clustered together in a rectangular area for efficiency of daily farm activities and all the buildings are visible from the west door of the farmhouse (photo 2) (see Surveyor Location Report, sheet 2). Mature trees surround the house, rendering the house invisible in an aerial photograph taken in the summer (attachment 1). Farmland adjoins the property to the west, north, and east.

Eight large double hung windows face south (photo 3) and six large double hung windows face east (photo 1). The two downstairs windows to the east open to the front parlor. Two downstairs windows to the south open to the central main parlor on the east end and two open to the kitchen on the west end. Seven large double hung windows face north (photo 9) and open to the kitchen on the west end and two smaller rooms in the middle section of the house downstairs. Five of the twelve upstairs windows open up to bedrooms and two of the north-facing windows open up to a bathroom and laundry room. Two of the eight large double hung windows in the garage addition face north, two face east, and four windows face south (photos 6, 7).

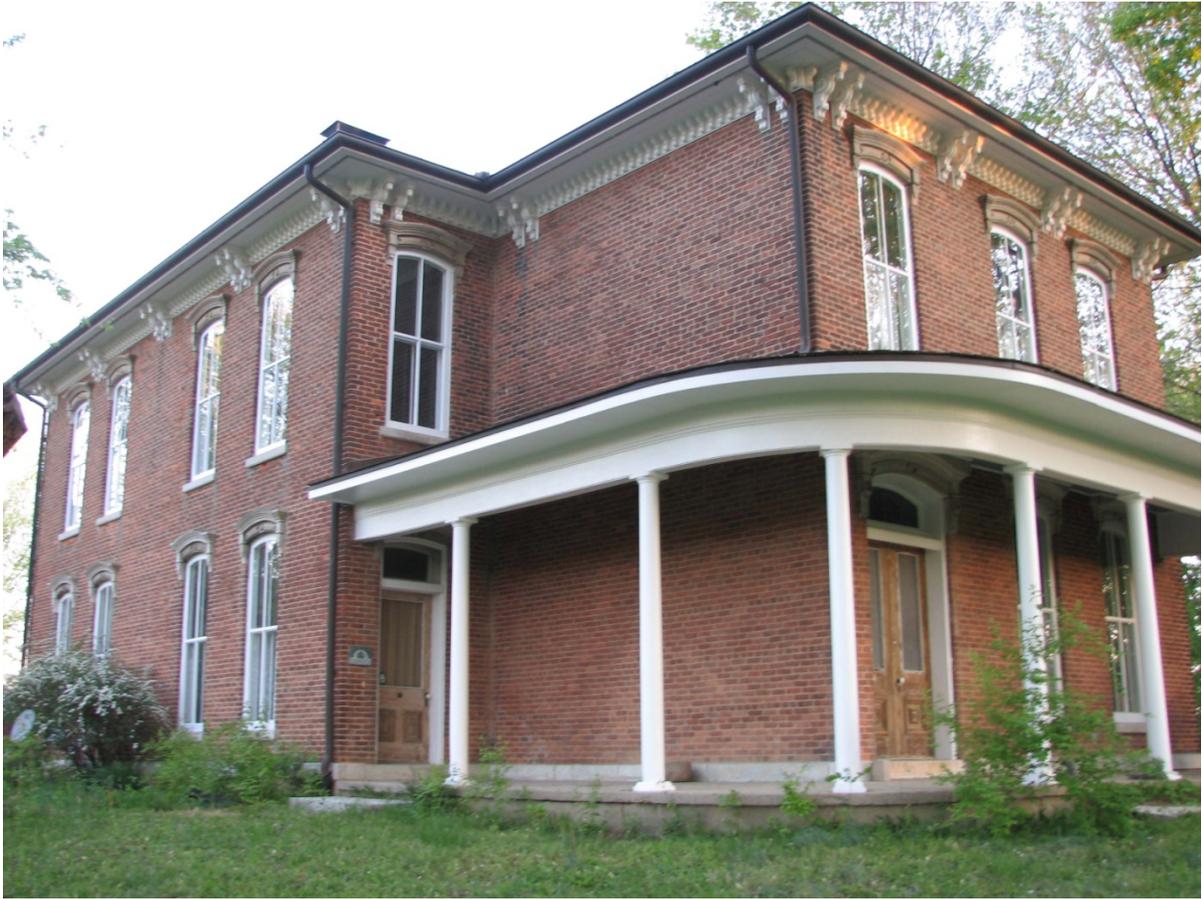
Morehouse Farm, Tippecanoe Co, #0003

The farmhouse has four exterior entranceways, with two facing east and two facing west. The main east entrance leading into the front stairwell hallway of the house consists of a double-door entryway with a large, arched transom and arched decorative limestone hood above (photo 4). The other east exterior entranceway is a single door that has an accompanying arched limestone hood and transom window above. This door is located on the southeast porch (photo 3) and opens into the central main parlor.
