Eye-Opening Discovery Leads to New Stop Sign Option

District traffic divisions now have the option of installing solar-powered blinker stop signs, thanks to some sleuthing by Crawfordsville District Traffic Investigations Engineer Nathan Awwad and a few of his INDOT cohorts.

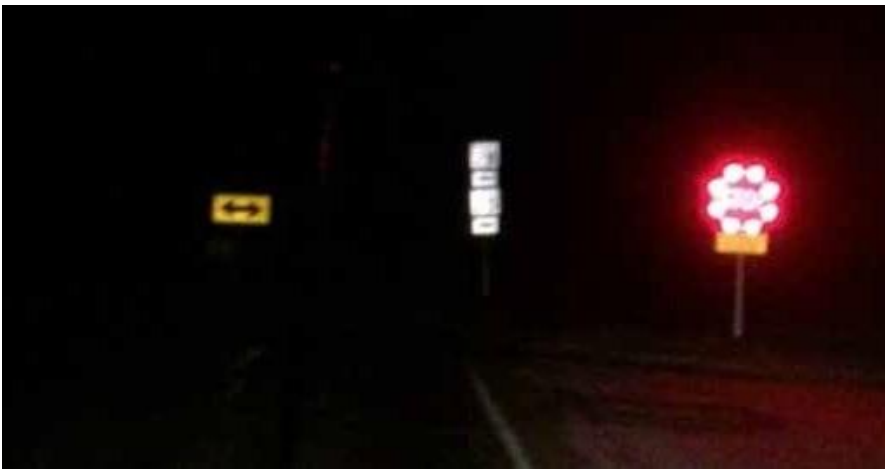
The solar-powered blinker stop sign lights up State Road 28 at State Road 25 in Tippecanoe County during the middle of the night.

In spring 2014, the district installed five of these stop signs – which feature an array of bright light-emitting diode (LED) lights that flash in unison from all eight corners of the octagonal sign – in Boone, Montgomery and Tippecanoe counties. INDOT’s Traffic Administration group wanted to test the signs, which manufacturer Traffic & Parking Control Co. claims provide high-visibility, advanced warning to drivers and are ideal for intersections with high accident rates.

“The signs were very noticeable and, essentially, they became 36-inch flashing beacons,” said Awwad. “When I was far away, I couldn’t even tell there were individual LEDs in the sign. This large beacon was especially noticeable at night, when it could be seen from much farther away than the standard 12-inch overhead flashing beacons.”

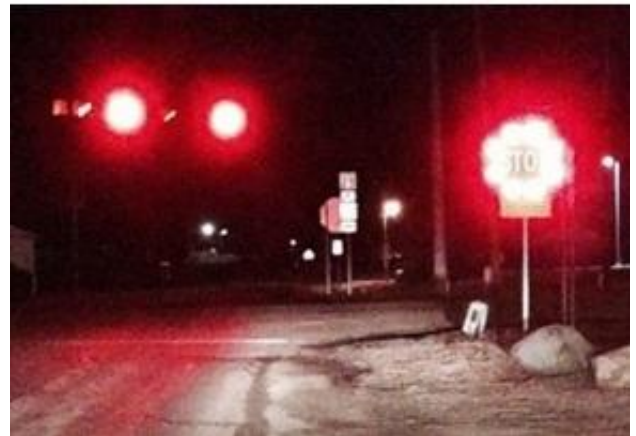
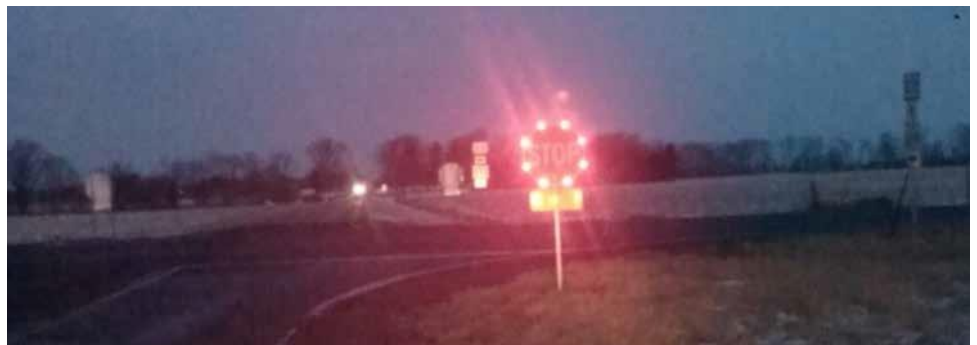
The solar-powered blinker stop sign on northbound State Road 75 at State Road 32 in Boone County (right photo) is as visible as two overhead flashers; the blinker on State Road 234 at U.S. 231 in Montgomery County (bottom photo) is noticeable at dusk.
