## Pipeline Safety Division Investigation Report

### Investigation regarding: John Burford

**Synopsis:** A natural gas service was damaged during grading of the drive.

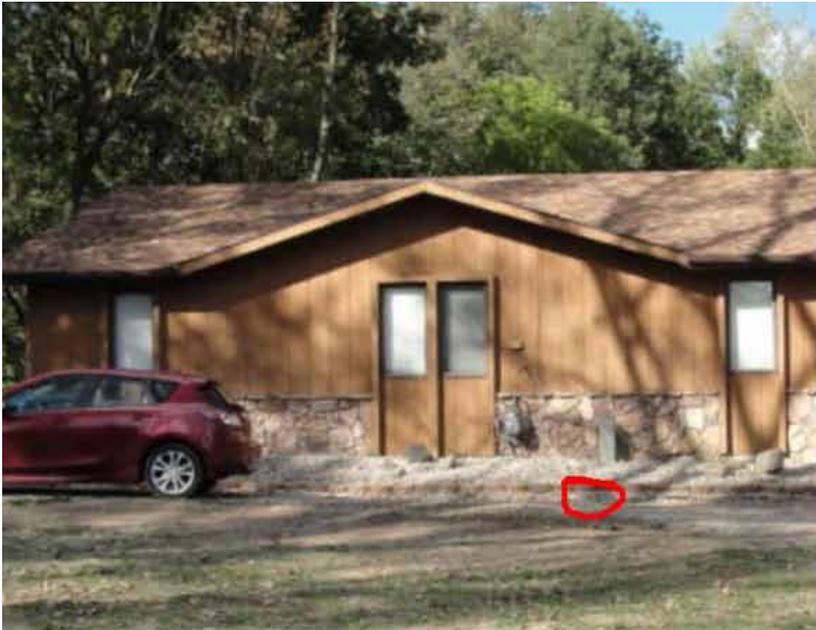
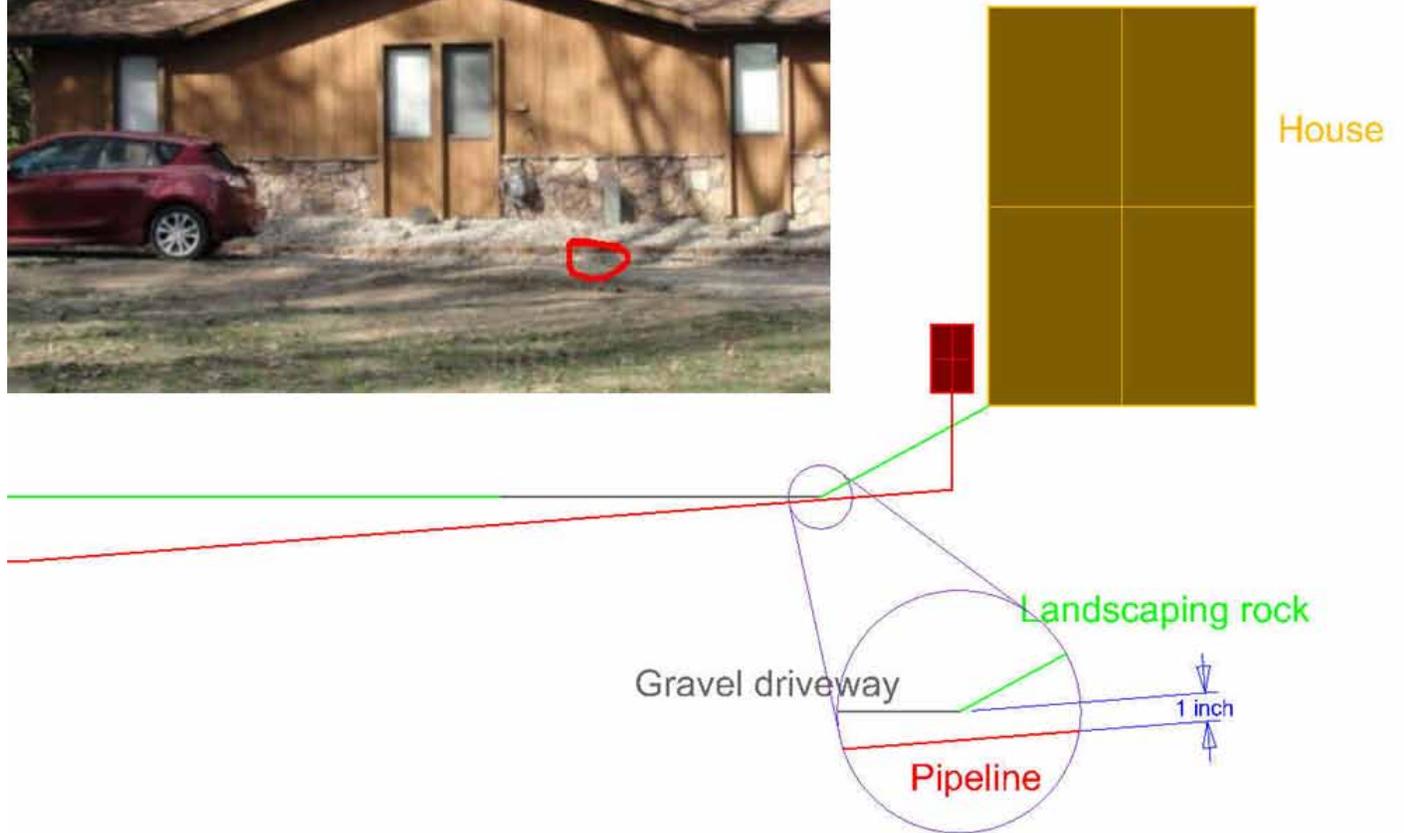
The damaged pipeline was a result of a failure to construct the pipeline to proper code in the 1950s when the house was built. The pipeline should have been two feet deep. Instead the pipeline was just below surface of the driveway. It was unreason to expect the pipeline to be so shallow.

I have attached a drawing and a picture to better show where the incident occurred and where the pipeline was found during the repair. Note: the incident occurred in front of the cable box.
